## Safety Recall Launch Notification

Campaign #	NHTSA ID	Campaign Codeword	<b>Retrofit Cover on Airbag Control Unit</b>
2026030003	26V070	VS2KORSRS

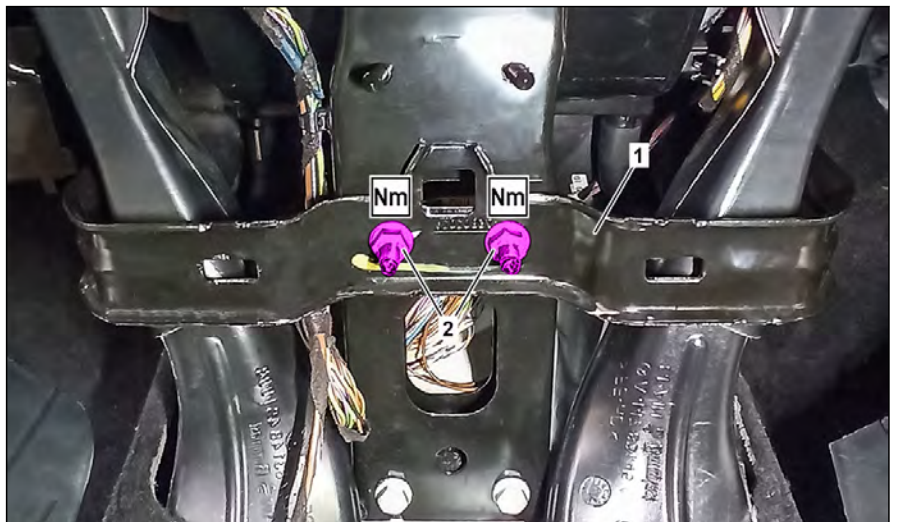
S68.10-A089-75

1 Holder

2 Nuts

6.1 	Remove trim at bottom for center instrument panel.	Model 447 except code FJ3 (double cup holder, cockpit center)	AR68.10-S-1498E
6.2 	Remove cup holder.	Model 447 with code FJ3 (double cup holder, cockpit center)	AR68.00-S-1000E
7	Remove holder (1).	To do this, unscrew nuts (2).	
	<b>Retrofit</b>		
8	Retrofit protective cover (3) over the supplemental restraint system (SRS) control unit (N2/18).	Install protective cover (3) without knocking other component parts. Otherwise, noises may occur while driving. Position protective cover (3) centrally between supplemental restraint system (SRS) control unit (N2/18) and air conditioner box. Attach protective cover (3) to crossmember using two cable ties (4).	
9	Glue mat (5) to front area of air conditioner box.	The bonding area must be completely dust and grease-free. Otherwise, adhesion problems may occur. Cut mat (5) to correct length and glue in diagonally (from top left to bottom right, as shown).

<b>Install</b>		
10	Install holder (1).	Tighten nuts (2) to specified tightening torque. M8×1	BA00.10-Z-1001-02KOA
11.1 	Install cup holder.	Model 447 with code FJ3 (double cup holder, cockpit center)	AR68.00-S-1000E

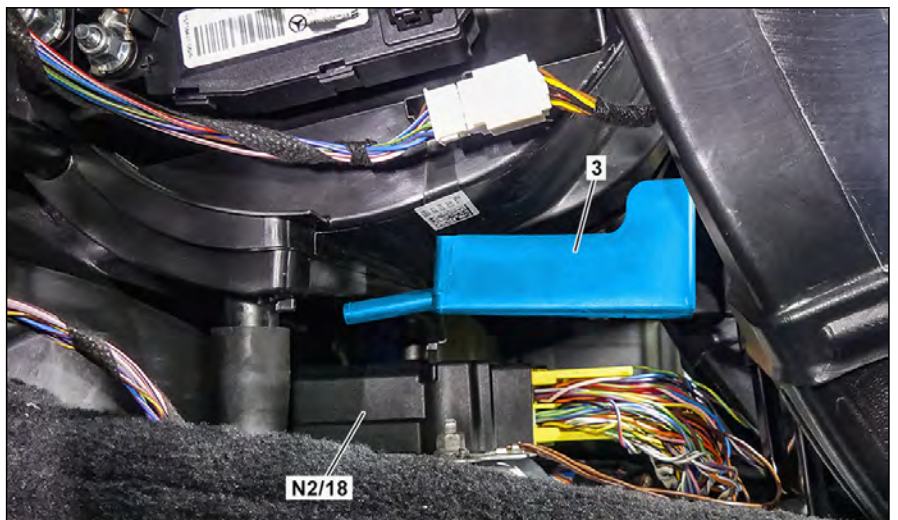
S91.60-A187-75

3 Protective cover  
N2/18 Supplemental Restraint System (SRS) control unit

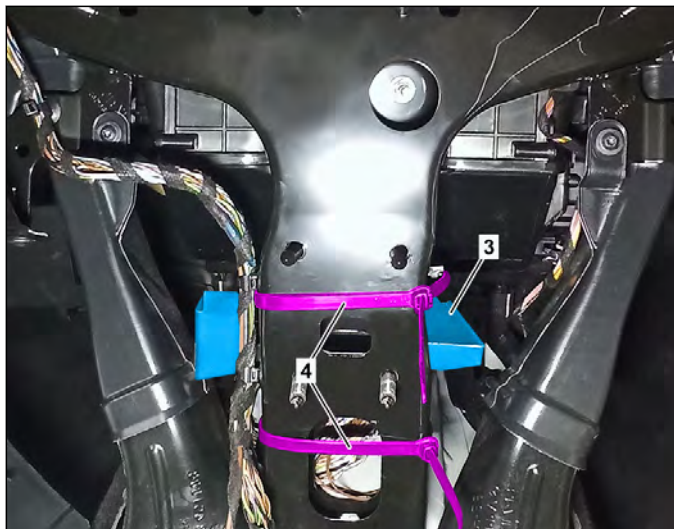
S68.10-A090-81

- 3 Protective cover
- 4 Cable ties

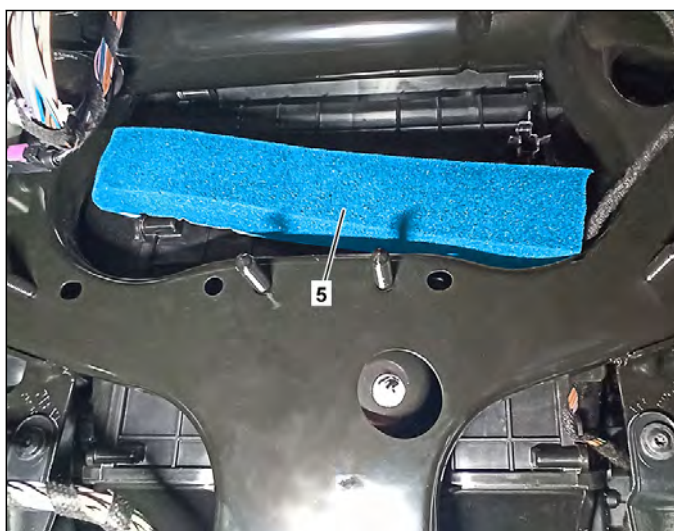
S68.10-A091-81

- 5 Base
