**To:** All Subaru Retailers  
**From:** Subaru of America, Inc. – Service Quality  
**Date:** February 23, 2026  
**Re:** WRD-26 Fuel Filler Cap Gasket Safety Recall – Stop Sale Repair Procedure

**STOP SALE SERVICE PROCEDURE INFORMATION**

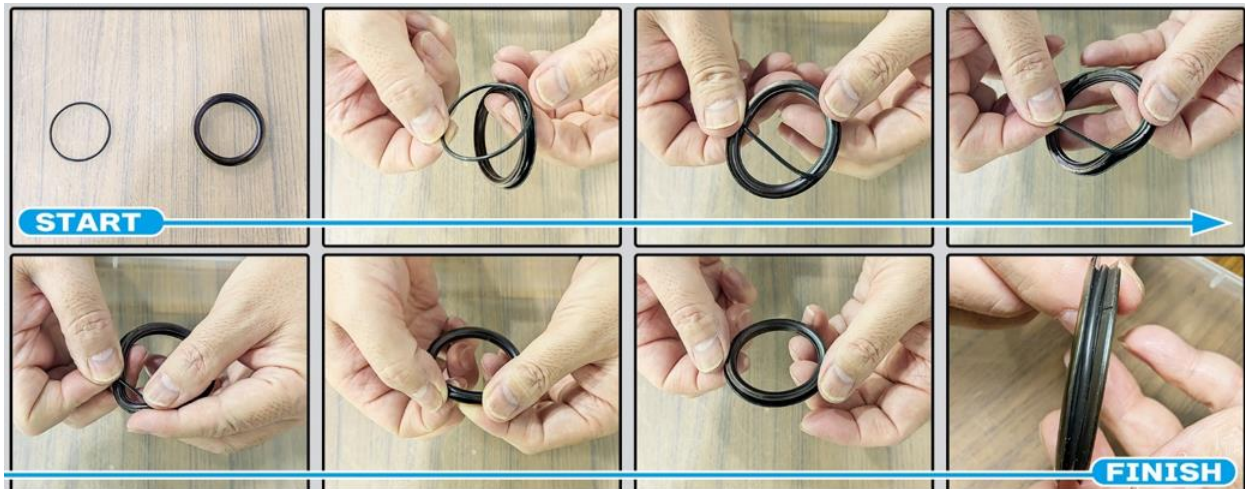
**STEP 1:** Prepare the new gasket by installing the O-ring inside the groove of the gasket. Once completed, inspect the installation and confirm the O-ring is installed evenly around the circumference of the gasket. Refer to the 00:00 minute of the Tips Video.

**CAUTION: DO NOT** excessively pull the O-ring or deform the gasket.

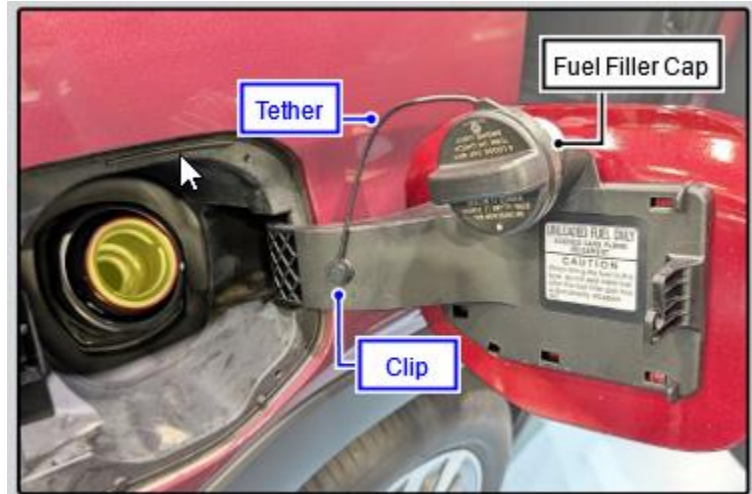
**STEP 2:** Open the fuel door and remove the fuel filler cap.

**NOTE:** It is not required to disconnect the fuel filler cap tether and clip.

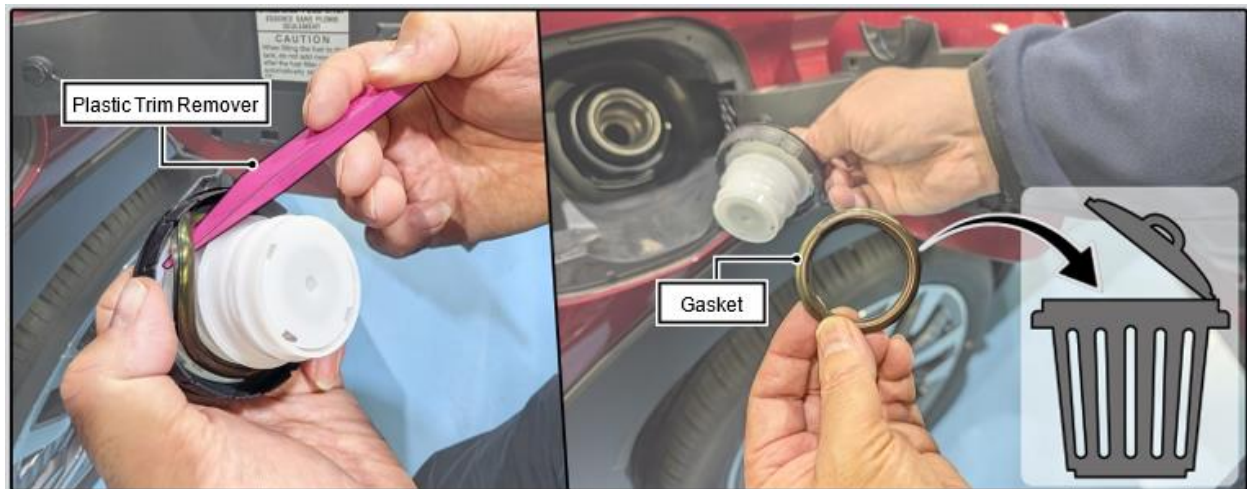
Using a plastic trim tool, remove the fuel filler cap gasket. Discard the original gasket. Refer to the 00:25 minute of the Tips Video.

**CAUTION: DO NOT** use any metal tools under any circumstances. **DO NOT** allow any foreign material to enter the fuel filler pipe.

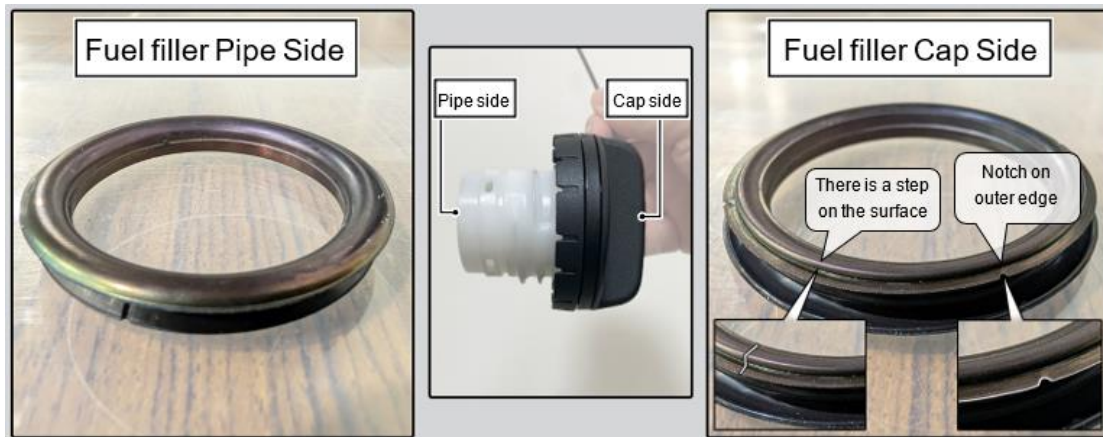
**STEP 3:** Confirm the installation direction of the preprepared replacement gasket.

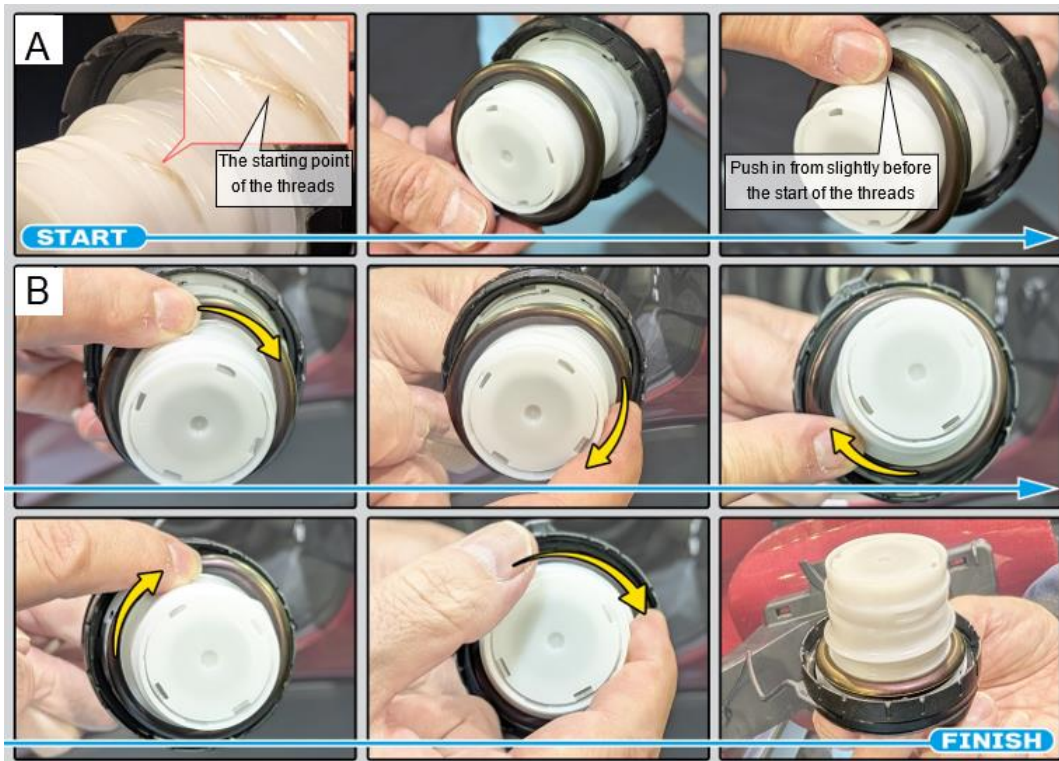
**A:** Start to install the gasket onto the fuel filler cap with the fuel filler **Pipe Side** facing you. Set the gasket at the starting point of the threads.

**B:** Using your fingers, press the gasket along the thread while turning the gasket in a clockwise direction. Continue until the gasket is fully seated in the fuel filler cap. Refer to the 00:47 minute of the Tips Video.

**CAUTION:** Installing the gasket along the thread will help prevent the previously installed O-ring from separating. Be CAREFULL not to damage the fuel cap tether by twisting or pulling during the gasket replacement.

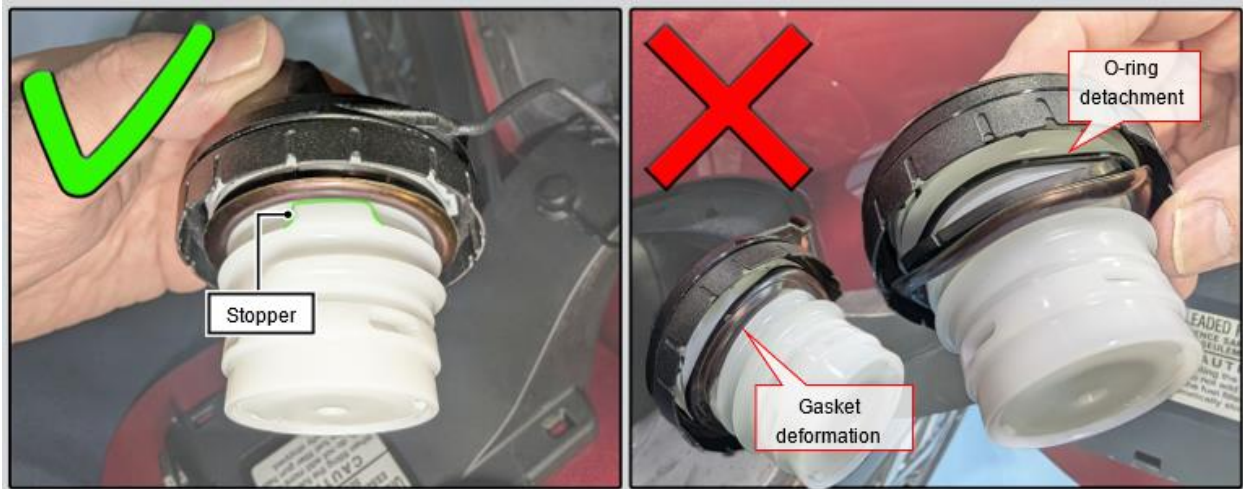
**STEP 4:** Confirm the gasket is securely and fully seated to the proper depth beyond the stopper portion of the cap. Ensure the gasket is not deformed and the O-ring is properly aligned.

**CAUTION:** If the gasket is not installed correctly, there is a risk of gasket deformation, or the O-ring can become damaged. If this occurs, the parts **MUST NOT** be reused. Any deformation and/or damage to the gasket or O-ring will require new parts to be installed correctly.

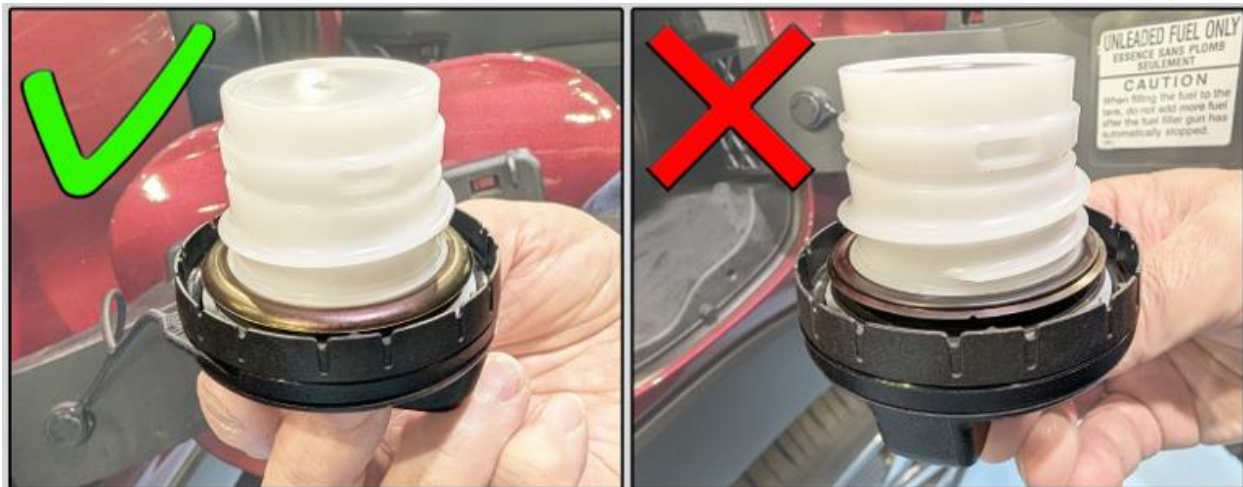
Confirm the gasket is installed in the correct orientation and is not reversed.

**CAUTION:** If the gasket is installed in the wrong position, it is possible for the gasket and O-ring to be damaged. If installed incorrectly, new parts will be required with correct installation.
