Safety Recall Launch Notification

Campaign #	NHTSA ID	Description	Check and Correctly Install Bowden Cable Release Mechanism
2026030005	26V134	26P7296003

CAMPAIGN NO.	2026030005
CAMPAIGN DESC.	26P7296003
NHTSA ID	26V134
SUBJECT	Check and Correctly Install Bowden Cable Release Mechanism
MODEL(S)	GLA (247 platform)
MODEL YEAR(S)	2026
CAMPAIGN POPULATION	10

Campaign Technical Instructions

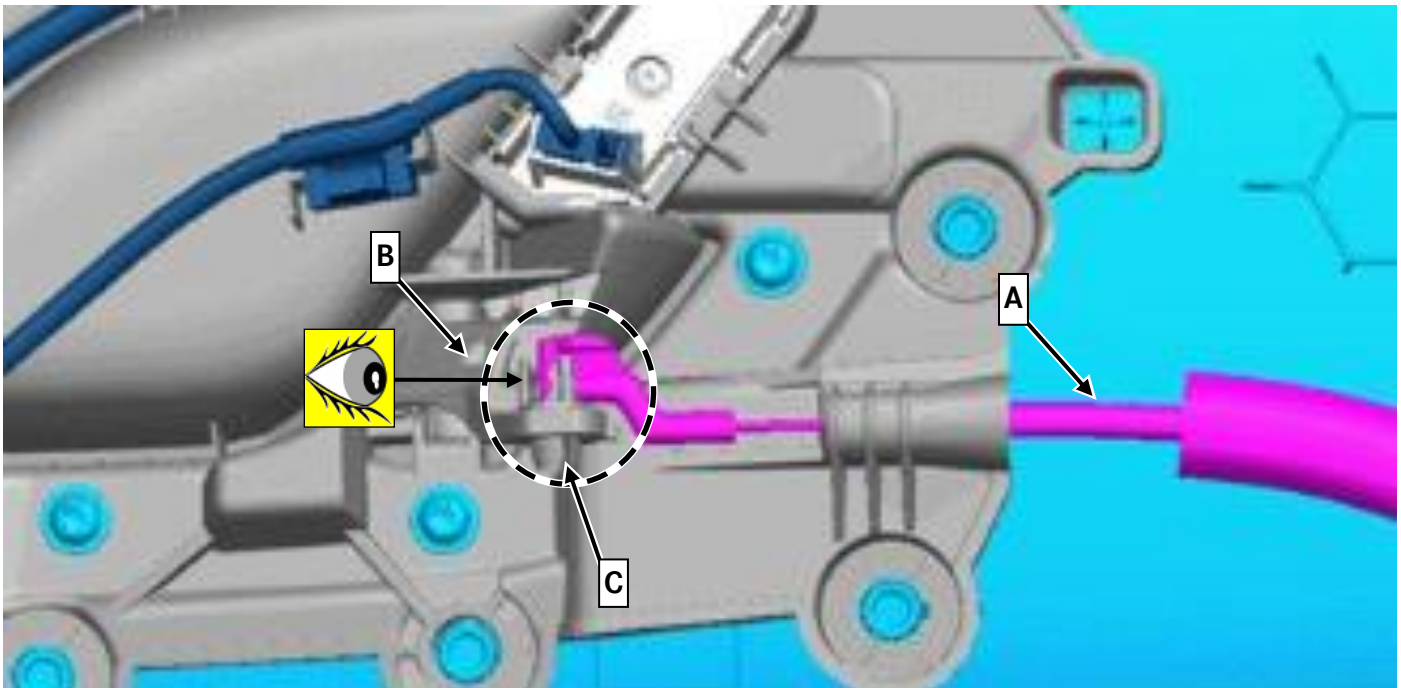
Figure 1

2. Check the bowden cable for the interior door opener (Figure 1, A) is correctly mounted in the crown clip (Figure 1, C) at the interior door release mechanism (Figure 1, B).

- a. If the bowden cable for the interior door handle is **correctly** hooked on and clipped into place:
 - Check all doors and then end the measure.
- b. If the bowden cable for the interior door handle is **not correctly** hooked on and clipped into place:
 - Perform **Work Procedure** for the affected interior door handle(s).

1. Hook and clip the interior door handle bowden cable correctly into the crown clip (Figure 1, C).
i Check bowden cable and door lock for proper function.
2. Assemble in reverse order.
