IMPORTANT SAFETY RECALL

NHTSA Recalls No. 26V-167, 26E-016

| SAFETY NOTICE NHTSA: 26V-167 | SN-737 |

SUBJECT: *Pole Guide 450543 Plate Weldment*

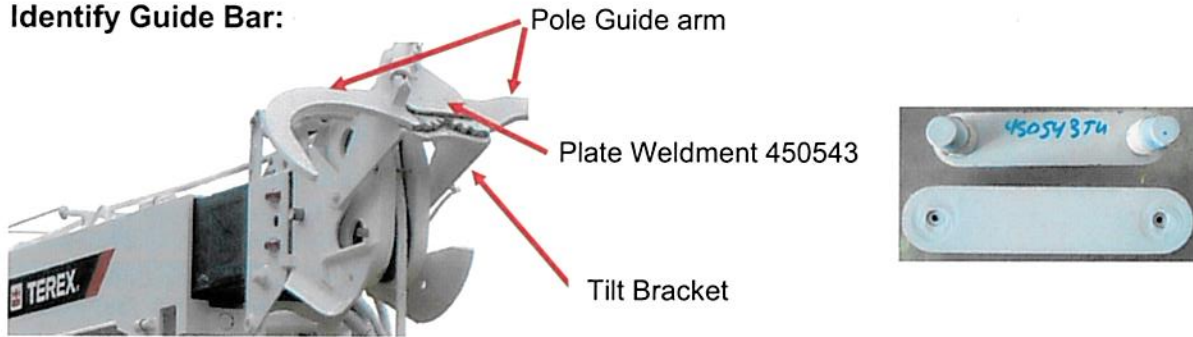
Identify Guide Bar:

Affected Guide bars: (see Inspection Procedures below)

1. The top surface of the bar will have a grease zerk.
2. The grease zerk will be on the upper side above the pole guide arms not recessed.

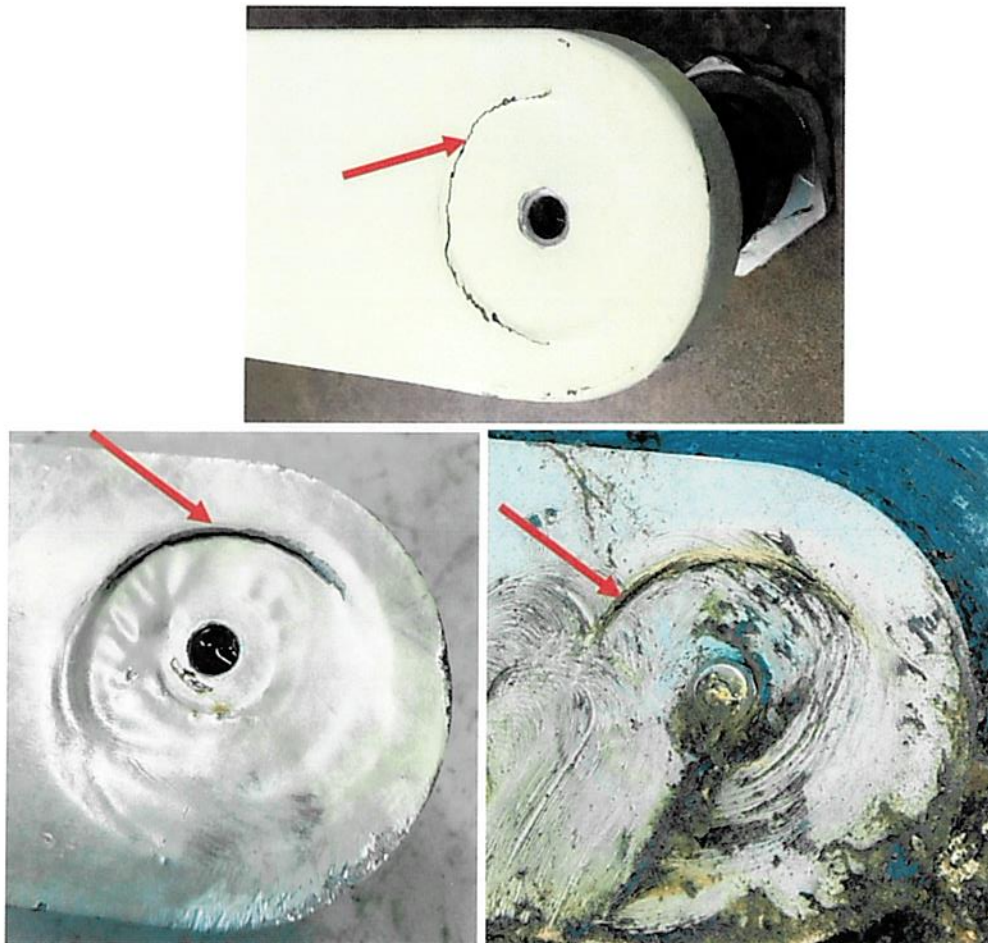
Examples of cracks:

The 450543 Plate Weldment attaching the pole guide arms to the pole guide tilt bracket may have an issue with weld quality on units built and replacement parts purchased from January 2019 to February 10, 2026. All plate weldments must be inspected for cracks and replaced if cracks are found. **If cracks develop the stud holding the pole guide arm can separate and allow the pole guide arm to fall. If the pole guide arm falls it can cause injury to ground personnel.**

1. Inspect for cracked welds as shown in Inspection Procedure below. If cracks are found, do not use the pole guide. Contact Terex Utilities as noted below.
2. Inspect the digger derrick pole guide plate weldment 450543 using the criteria below for weldments subject to this bulletin.

Terex will provide a replacement plate weldment (Z1523) for parts which show a crack at no cost to the owner, for a period of 4 years from the issuance of this safety notice..

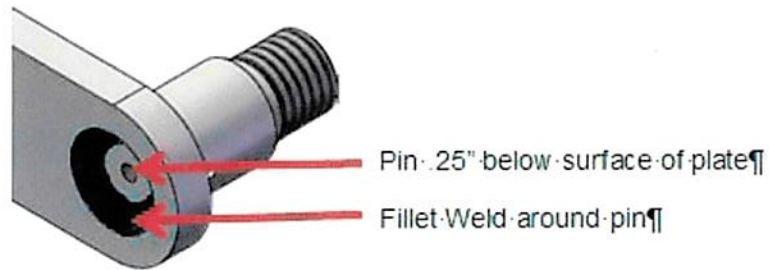
1. Weldments with a fillet weld around the pin and the top of the pin recessed below the surface of the bar.

Fillet weld around recessed pin

The following are not included in this bulletin but must still be inspected as part of the daily preshift inspection.

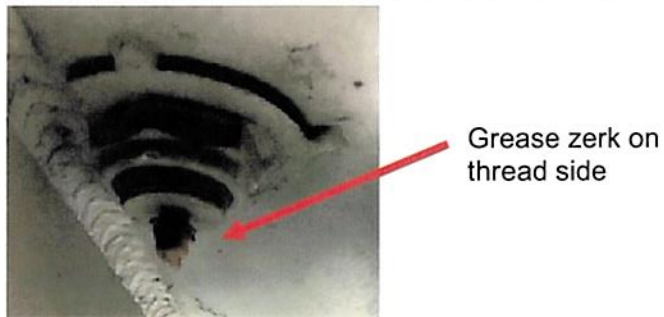
2. The zerk is on the threaded side next to the nut, or there is no zerk on either end of both pins.

Grease zerk on thread side
