Terex Utilities

SAFETY NOTICE

SN-737

SUBJECT: Pole Guide 450543 Plate Weldment

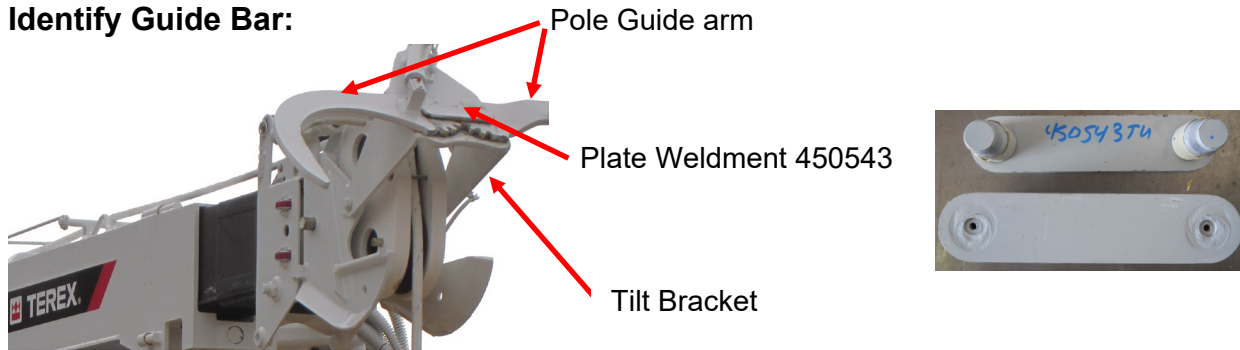
Identify Guide Bar:

1. The top surface of the bar will have a grease zerk.
2. The grease zerk will be on the upper side above the pole guide arms not recessed.

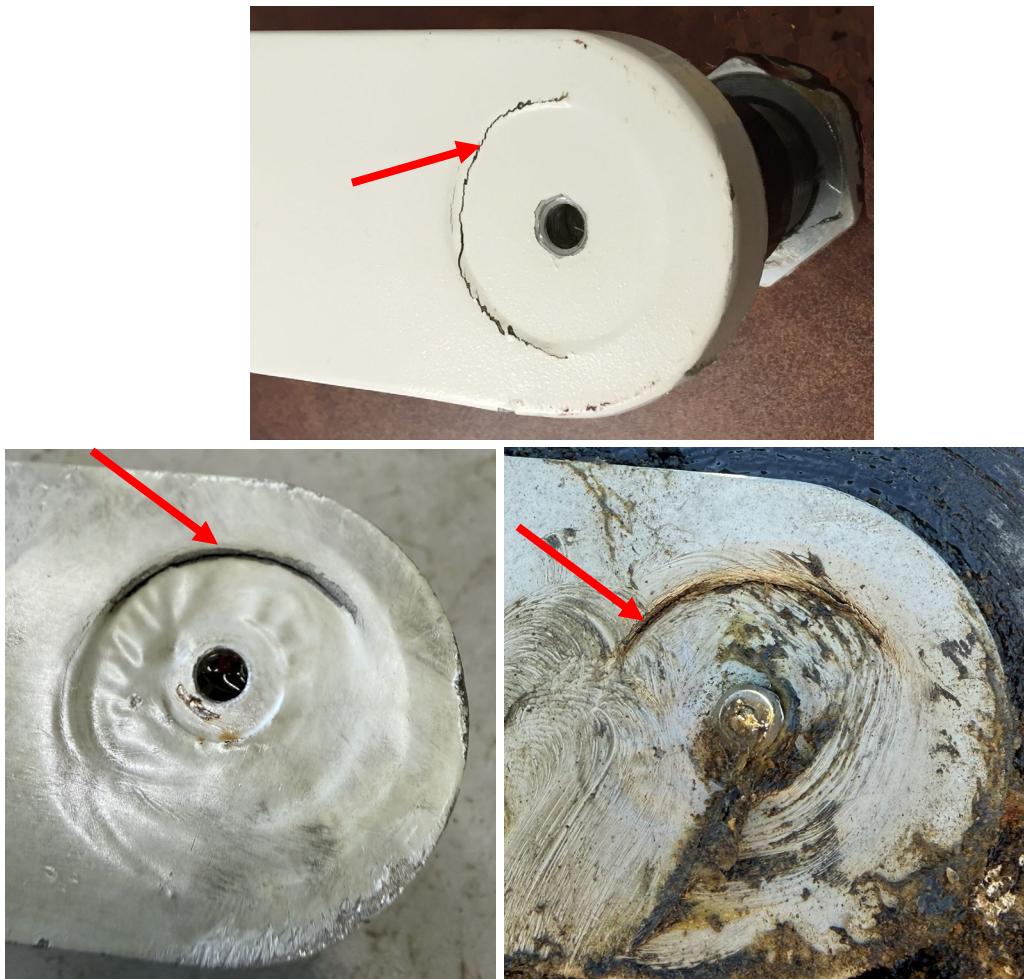
Examples of cracks:

The 450543 Plate Weldment attaching the pole guide arms to the pole guide tilt bracket may have an issue with weld quality on units built and replacement parts purchased from January 2019 to February 10, 2026. All plate weldments must be inspected for cracks and replaced if cracks are found. **If cracks develop the stud holding the pole guide arm can separate and allow the pole guide arm to fall. If the pole guide arm falls it can cause injury to ground personnel.**

1. Inspect for cracked welds as shown in Inspection Procedure below. If cracks are found, do not use the pole guide. Contact Terex Utilities as noted below.
2. Inspect the digger derrick pole guide plate weldment 450543 using the criteria below for weldments subject to this bulletin.

Terex will provide a replacement plate weldment (Z1523) for parts which show a crack at no cost to the owner, for a period of 4 years from the issuance of this safety notice..

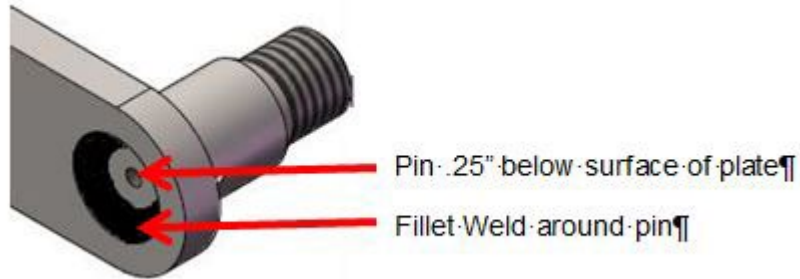
1. Weldments with a fillet weld around the pin and the top of the pin recessed below the surface of the bar.

Pin .25" below surface of plate

Fillet Weld around pin

Fillet weld around recessed pin

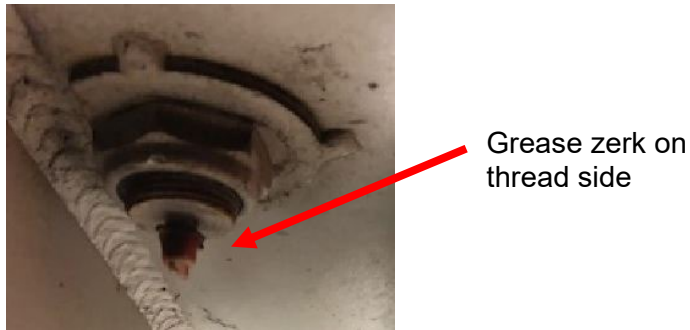
2. The zerk is on the threaded side next to the nut, or there is no zerk on either end of both pins.

Grease zerk on thread side
