**IMPORTANT SAFETY RECALL NOTICE – RECALL # C-26001**

**SUBJECT: SAFETY RECALL NOTICE - DEMONSTRATION / DELIVERY HOLD / DO NOT DRIVE  
2026 NISSAN FRONTIER PRO-4XR BALL JOINT / TIE ROD TORQUE VERIFICATION**

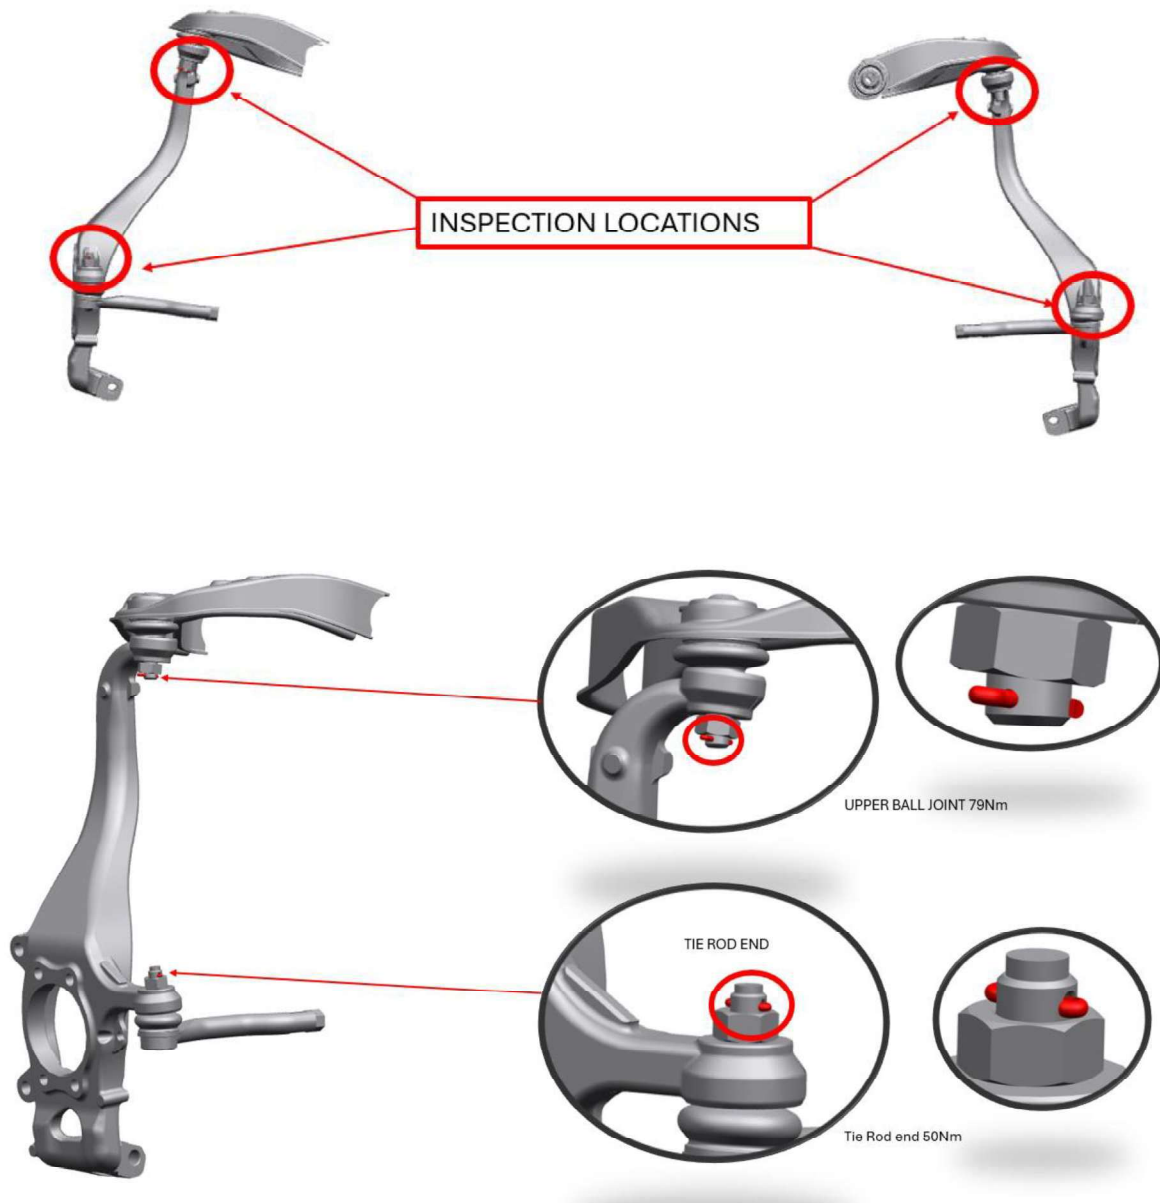
Inspect Driver & Passenger Side Upper Control Arm ball joints & Tie rod ends for proper fastener torque according to the procedure listed below.

- 1) Remove front wheels
- 2) Inspect for the presence of a properly installed cotter pin in the locations as noted above. Record findings.
- 3) UCA BALL JOINT: Was driver side cotter pin present? ( YES or NO )
- 4) UCA BALL JOINT: Was passenger side cotter pin present? ( YES or NO )
- 5) UCA BALL JOINT: Remove cotter pin from Upper Control Arm Ball Joint
- 6) UCA BALL JOINT: Torque castle nut to **79 NM**
- 7) UCA BALL JOINT: Install new cotter pin (Nissan part # 08921-3202A) as shown in in figure A below.
