Safety Recall: 26V337  
May 2026

## IMPORTANT SAFETY RECALL

Alliance RV has decided that a defect which relates to motor vehicle safety exists in some 2025 thru 2026 Alliance RVs. Units impacted are select Paradigm 5<sup>th</sup> Wheels.

## \*\*\*Product Safety Notice\*\*\*

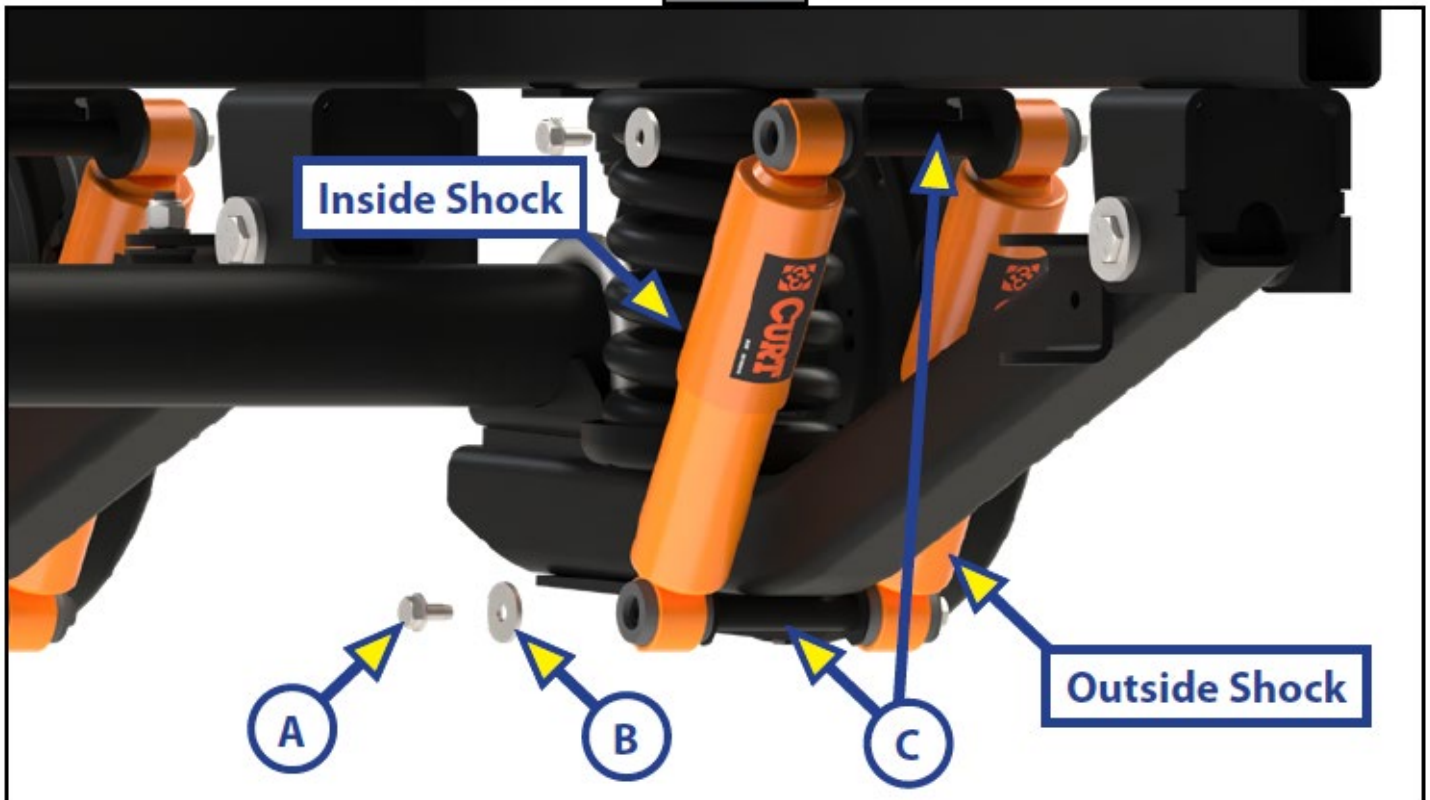
Fig. 1

Alliance RV has determined that certain 2025 – 2026 Paradigm units equipped with CURT Touring Coil Suspension systems may contain shock retaining bolts that were improperly tightened during production of the suspension assembly. Under certain operating conditions, the retaining bolt head may fracture which could allow the retaining washer and/or bolt head to detach from the vehicle and become road debris, increasing the risk of a crash.

1. Starting with the inside shocks, loosen and remove the two existing 3/8"-16 x 3/4" thread forming screws (Fig. 1A) and washers (Fig. 1B) securing each shock absorber onto its posts (Fig. 1C). Retain washers (PN 249853) for reinstallation in Step 2.
