Safety Recall Launch Notification

| Campaign # | NHTSA ID | Description | Retorque Rear Seat Belt Bolt Connection |

# Recall Campaign Bulletin

| SUBJECT | Bolting Connection of the Rear Seat Belt |

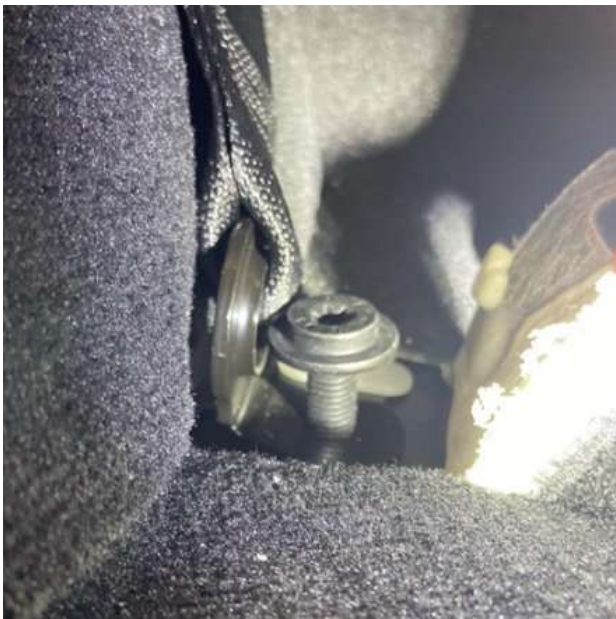
**Illustration 1** (Example of seat belt bracket)

| Issue | Mercedes-Benz AG ("MBAG"), the manufacturer of Mercedes-Benz vehicles, has determined that on certain Model Year ("MY") 2026 GLE/GLS (167 platform) vehicles, the rear seat belt bolt connection to the vehicle body might not meet current production specifications. In this case, the bolting connection of the seat belts might loosen, and as a result, the restraint effect might be impaired. This could increase the risk of injury for the vehicle occupants. | | |

1. Tighten screws for seat belt bracket (Illustration 1) of both outer seat belts in rear passenger compartment to a **tightening torque of 35 Nm**.
