Service Engineering Operations  
Customer Service Division

September 23, 2026

**SUBJECT:** **NEW VEHICLE DEMONSTRATION / DELIVERY HOLD**  
**Safety Recall 26S55 – Supplement #3**  
Certain 2021 - 2026 Model Year Bronco  
Engine Compartment Wiring Harness Repair

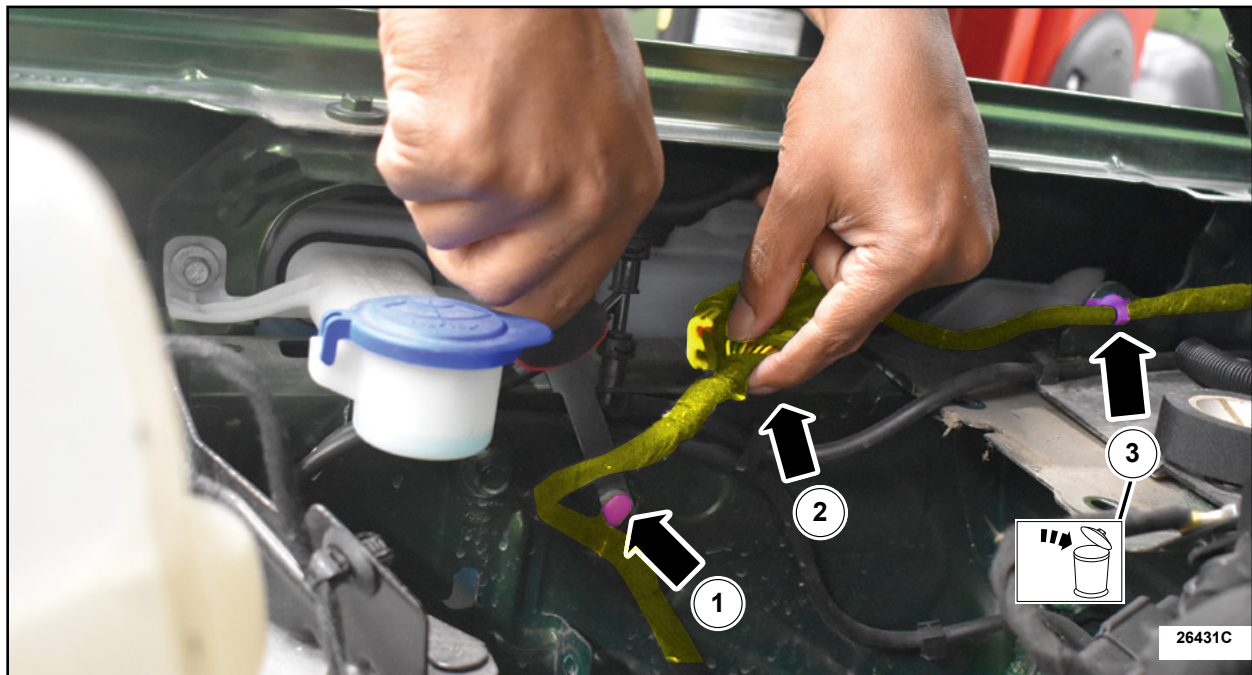
**FIGURE 3**

5. Starting at retainer (1), inspect the harness for broken wires or signs of chafing. See Figures 3 and 4.

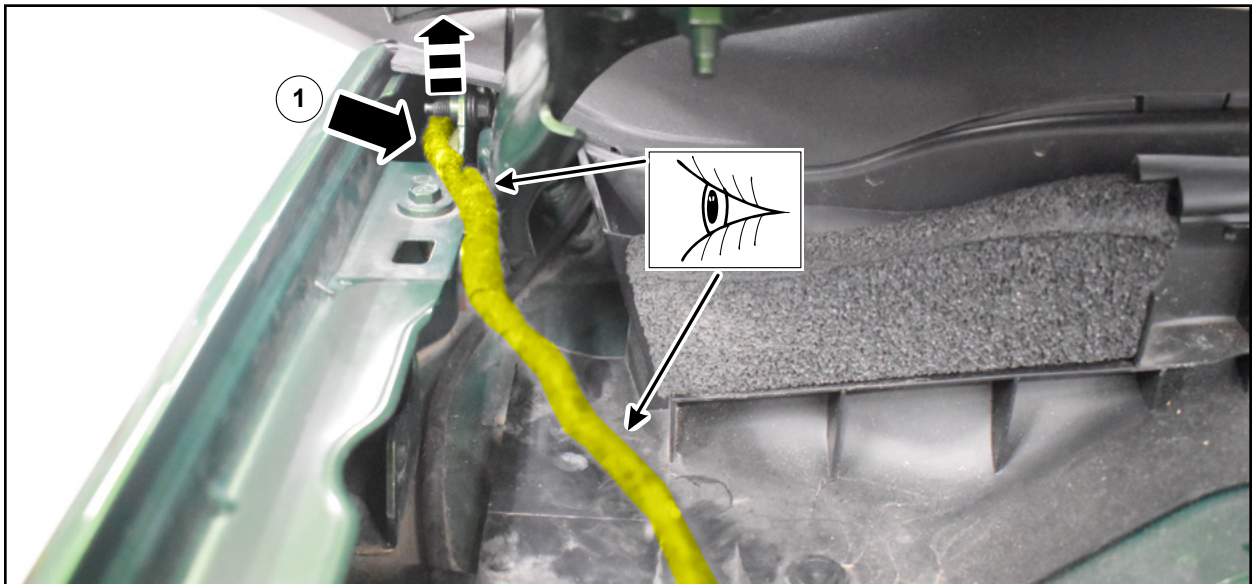
**FIGURE 4**

6. Does the wire harness have any broken wires or signs of chafing present?

Scenario 1 - If a wire is broken or chafing is present, repair the wire(s). Follow the Professional Technician System (PTS) [www.fordtechservice.dealerconnection.com/](http://www.fordtechservice.dealerconnection.com/) procedures under Wiring Tab>005 Connector Repair Procedures. Once completed, proceed to Step 7.

Scenario 2 - If the coaxial cable is damaged, you must contact the Special Service Support Center (SSSC). Once completed, proceed to Step 7.

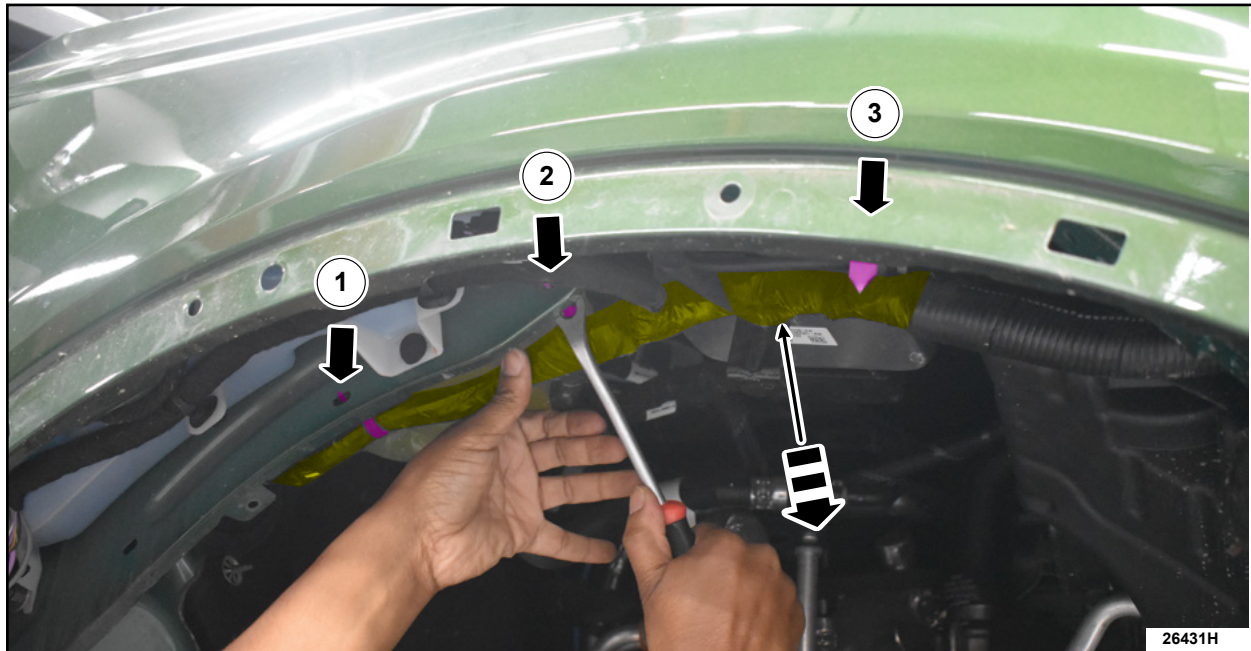
**FIGURE 8**

16. Starting behind retainer (1) and ending after retainer (3). Inspect the harness for broken wires or signs of chafing. See Figure 8.

20. Reconnect the 3 retainers from Step 15. See Figure 8.

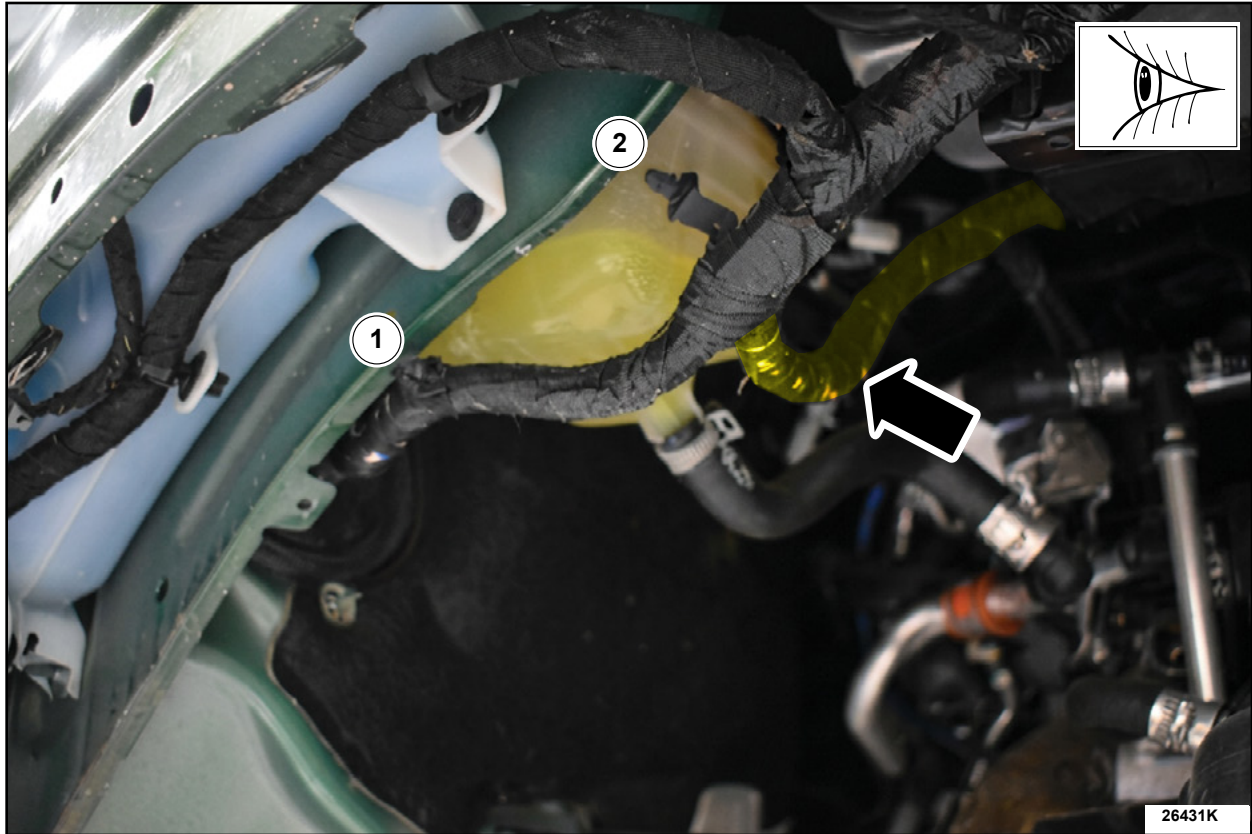
**FIGURE 9**

17. Starting at retainer (2), inspect the portion of the harness that goes up past the degas bottle.  
See Figure 9.

18. Does the wire harness have any broken wires or signs of chafing present?

- Yes - If a wire is broken or chafing is present, repair the wire(s). Follow the Professional Technician System (PTS) [www.fordtechservice.dealerconnection.com/procedures](http://www.fordtechservice.dealerconnection.com/procedures) under Wiring Tab>005 Connector Repair Procedures.  
Once completed, proceed to Step 19.
- No - Proceed to Step 19.

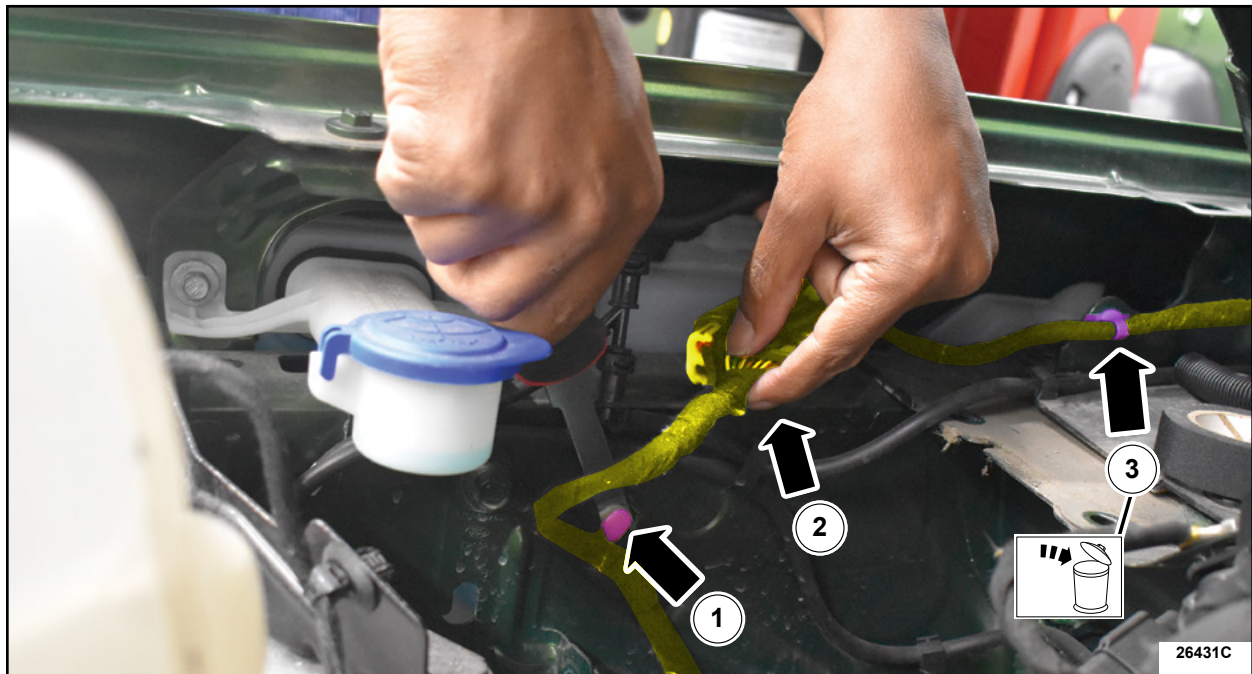
**FIGURE 3**

5. Starting at retainer (1), inspect the harness for broken wires or signs of chafing. See Figures 3 and 4.

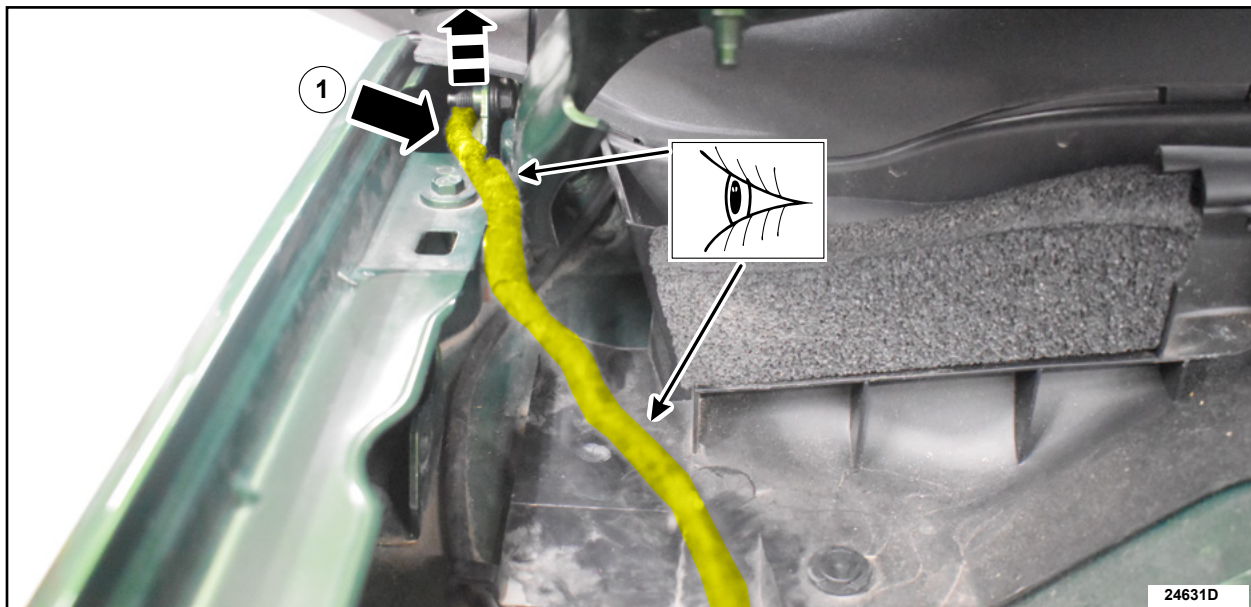
**FIGURE 4**

6. Does the wire harness have any broken wires or signs of chafing present?

Scenario 1 - If a wire is broken or chafing is present, repair the wire(s). Follow the Professional Technician System (PTS) [www.fordtechservice.dealerconnection.com/](http://www.fordtechservice.dealerconnection.com/) procedures under Wiring Tab>005 Connector Repair Procedures. Once completed, proceed to Step 7.

Scenario 2 - If the coaxial cable is damaged, you must contact the Special Service Support Center (SSSC). Once completed, proceed to Step 7.

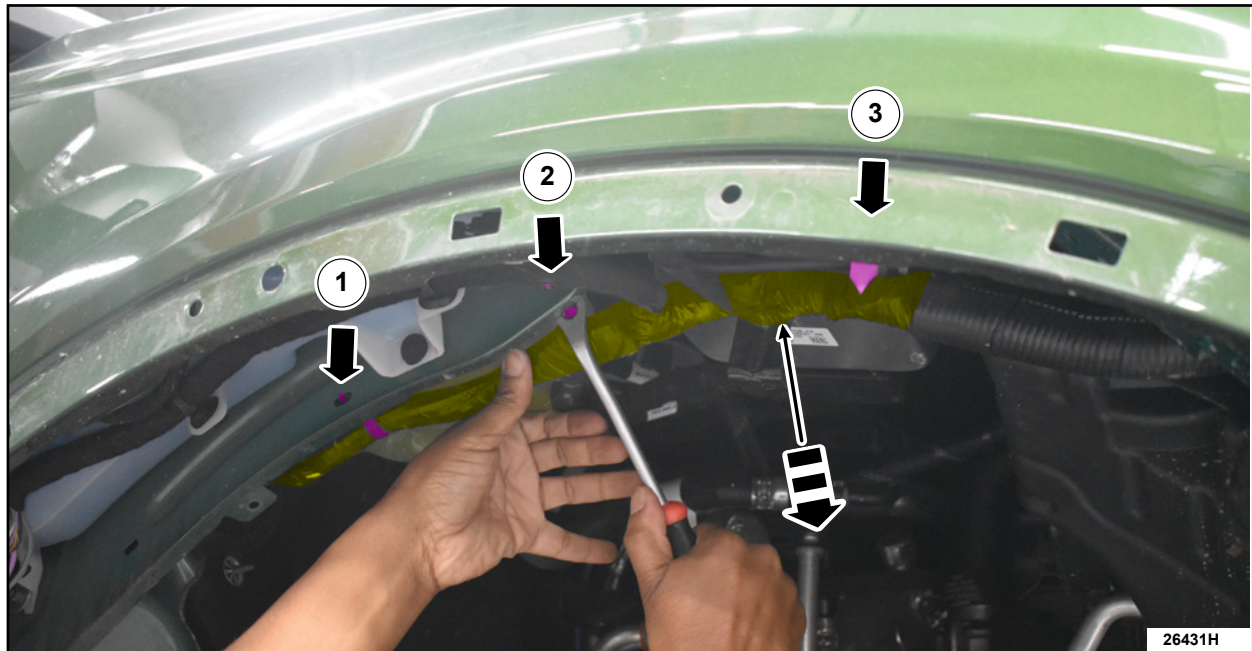
**FIGURE 8**

16. Starting behind retainer (1) and ending after retainer (3). Inspect the harness for broken wires or signs of chafing. See Figure 8.

20. Reconnect the 3 retainers from Step 15. See Figure 8.

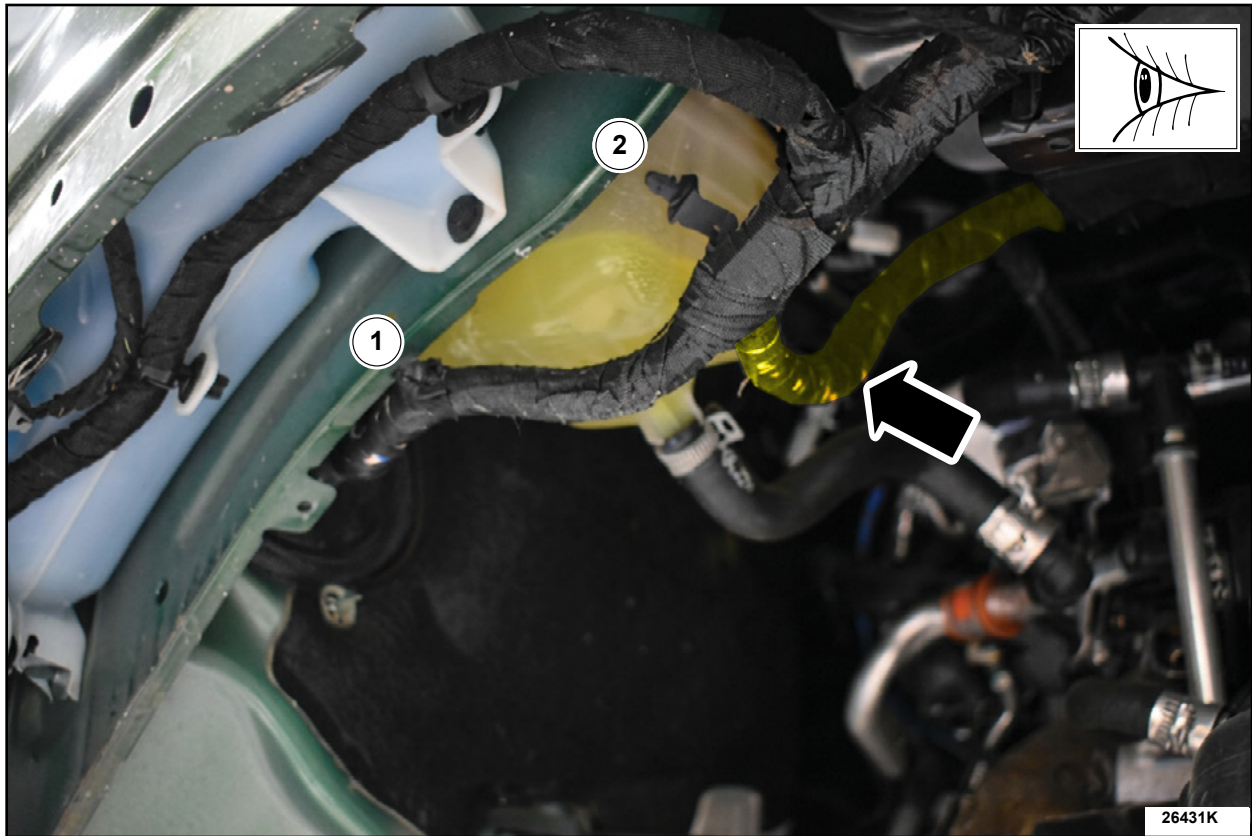
**FIGURE 9**

17. Starting at retainer (2), inspect the portion of the harness that goes up past the degas bottle.  
See Figure 9.

18. Does the wire harness have any broken wires or signs of chafing present?

- Yes - If a wire is broken or chafing is present, repair the wire(s). Follow the Professional Technician System (PTS) [www.fordtechservice.dealerconnection.com/](http://www.fordtechservice.dealerconnection.com/) procedures under Wiring Tab>005 Connector Repair Procedures.  
Once completed, proceed to Step 19.
- No - Proceed to Step 19.
