IMPORTANT SAFETY RECALL

NHTSA Recall No. 26V-006

Terex Utilities	
SAFETY NOTICE	SN735

SUBJECT: Upper Control Valve – Enable Cavity Plugs

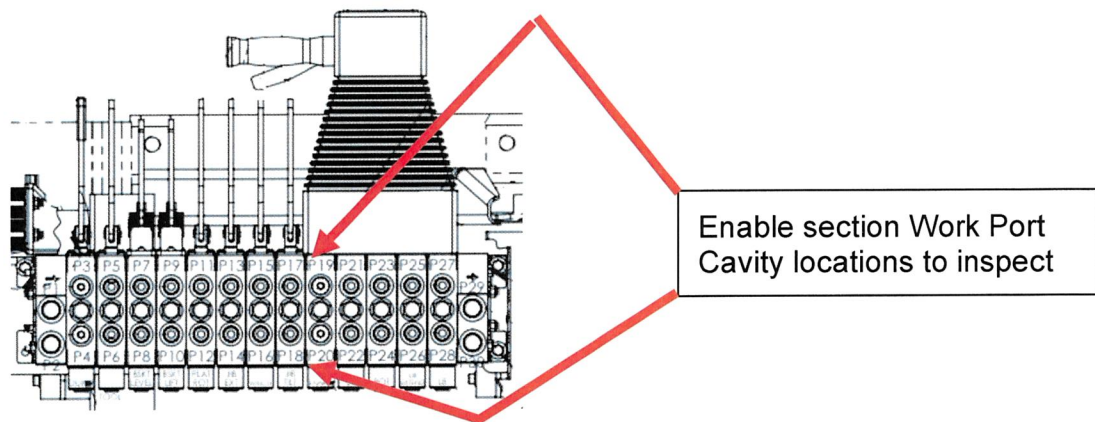
There are three methods to determine if a unit is subject to this recall. In doubt use method 2 to determine if the correct plug is installed in the enable section work port cavities or if Z1765 is required. Position the platform and rotate the platform out if needed, and remove covers if necessary to see the upper control valve as shown in Figure 1.

• **Figure 1 - Typical location to inspect of upper control valve enable section**
