IMPORTANT SAFETY RECALL

NHTSA Recall Number: 26V170

Altec Identifier: CSN-3295

Freightliner Adapter Harness

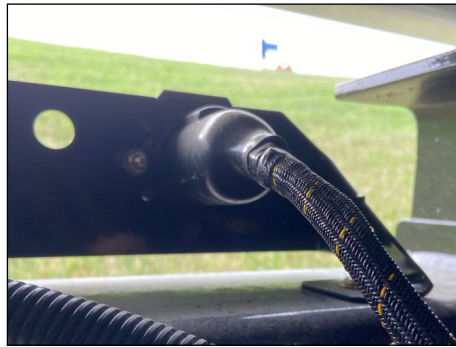
Figure 1 — Trailer Plug

- Normal mechanic's hand tools
1. Read and understand all steps of the instructions before beginning the procedure. Wear appropriate personal protective equipment (PPE) following your employer's requirements.
 2. Position the unit on a level surface, apply the parking brake, and turn off the engine. Remove the key from the ignition, and secure it following your employer's vehicle lockout/tagout (LOTO) procedure. Chock the wheels.
 3. Under the tailshelf, locate the electrical harness to the Altec-supplied trailer plug (refer to Figure 1).

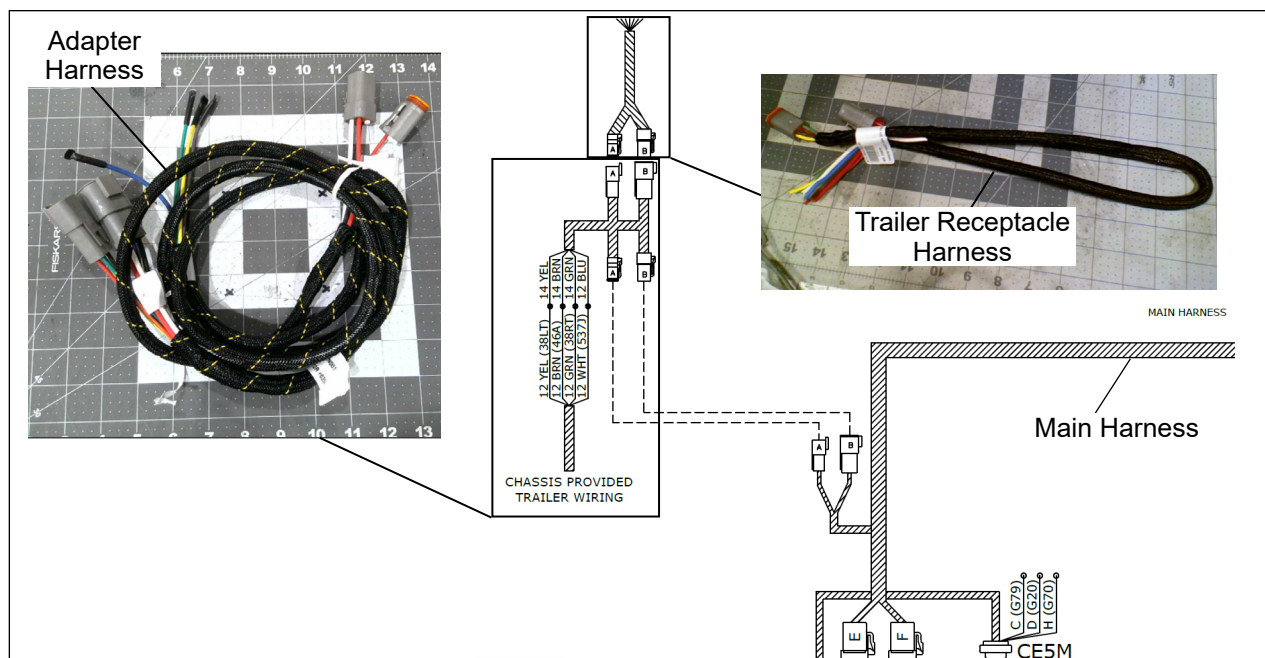
Figure 2 — Inspecting the Electrical Harness

4. Follow the length of the harness from the trailer plug to the trailer receptacle harness. Confirm if the trailer receptacle harness is connected to the adapter harness shown in Figure 2.
 - If the adapter harness is installed, no repair is required. Proceed to step 5.
 - If the adapter harness is not installed, repair is required. Proceed to step 6.
 - If the unit is equipped with a different electrical configuration than is shown in Figure 2, contact Altec Technical Support at 1-877-GO ALTEC (1-877-462-5832) option 4 for further instruction. Do not complete the remaining steps in this inspection.

6. Repair is required.
 - a. Put the unit back into service while awaiting repairs. Do not operate the unit in low light conditions until the repair is complete.
 - b. Order the Freightliner Adapter Harness Installation Kit, part number 992095117.
 - c. Arrange for the installation of the required kit using one of the following methods.
 - Contact Altec Service to schedule the installation of the kit.
 - Contact Altec Parts to order the kit, and schedule for your own technician or your third party provider to install the kit.
 - d. Do not complete the Inspection Sheet at the end of this notice. Completion of the notice will be documented after the vehicle is repaired.
 - e. Install the kit upon receipt.
 - f. Put the unit back into service.
