## SAFETY ADVISORY # 26-479

### Coleman Bed Securement

**Models Included:** 2026 Coleman 13T

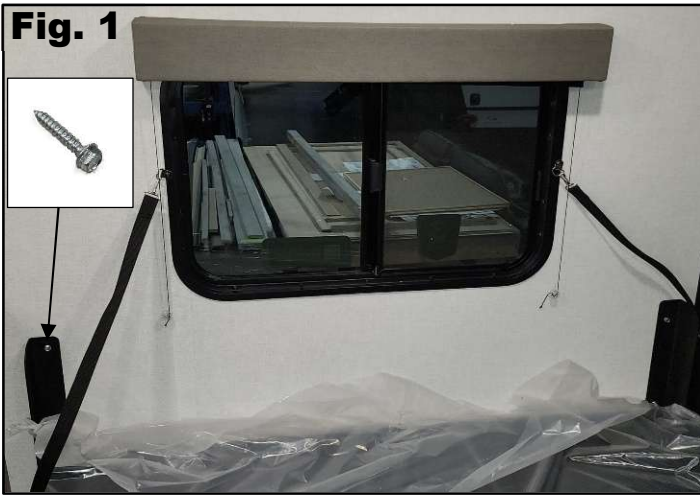
**Fig. 1** shows the wall brackets with 3/8" x 1 1/2" hex washer head screws and the strap installed.

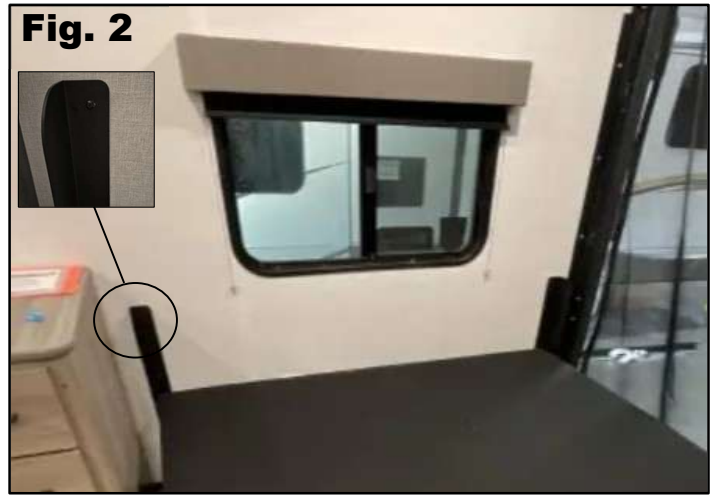
Keystone is conducting a voluntary RECALL notification campaign in accordance with the National Highway Transportation and Safety Act. It has been decided that the vehicles in the recall population may have Murphy beds with insufficient securement of the bed brackets to the wall. Under certain conditions when the Murphy bed is in the vertically stored position, the bed brackets may pull free from the wall leading to an increased risk of personal injury. The following procedure describes how to repair the installation.

**Fig. 2** shows the wall brackets installed without 3/8" x 1 1/2" hex washer head screws and no strap.

The remedy is to identify the location of the wall studs or backers and secure the bed wall brackets at the proper location.

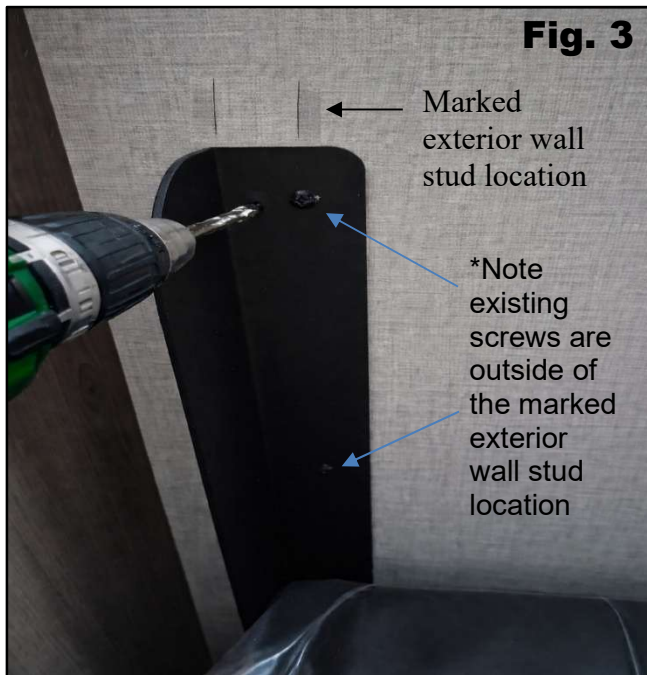
If the existing screws in the Murphy bed wall bracket are misaligned with the marked exterior wall stud location, proceed to Step 5. See Fig. 3

If the existing screws have engaged with the exterior wall stud, but the 3/8" x 1 1/2" hex washer head screws weren't used, then use a screw gun to remove the existing screw and replace it with a 3/8" x 1 1/2" hex washer head screw ensuring contact with the exterior wall stud. Do this to all four screws and repeat the process on the opposite side wall bracket. Proceed to Step 6.

Use a drill with a 1/4" drill bit to drill pilot holes into the Murphy bed wall bracket, centered to the marked stud location and adjacent to the existing four screws (Do not drill into the exterior wall stud). Use a screw gun with a 3/8" impact bit and 3/8" x 1 1/2" hex washer head screws to secure the bed wall bracket to the wall, ensuring contact with the exterior wall stud. Repeat the process on the opposite side wall bracket.
