## SV-RCL-025-017.2 FST Adventure Brake Line Inspection Recall

### NHTSA Campaign Number: 26V-048

MY24, 25 & 26 FST Adventure Platform Motorcycles

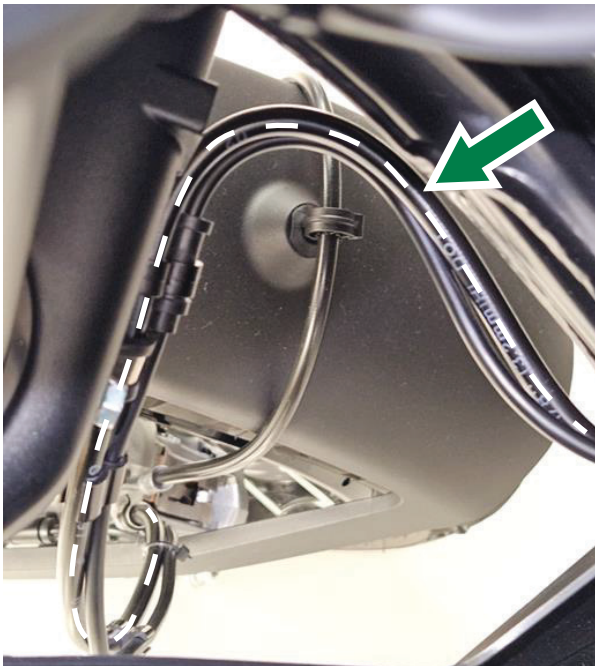
Top View Normal

1. Inspect the brake line from the top of the motorcycle.
  - **Normal:** The brake line has enough slack and is positioned below the frame with slack between the p-clamp and the caliper.
  - **Twisted:** The brake line is tight with little slack causing the line to be positioned next to the frame. There is little to no slack between the p-clamp and the caliper.

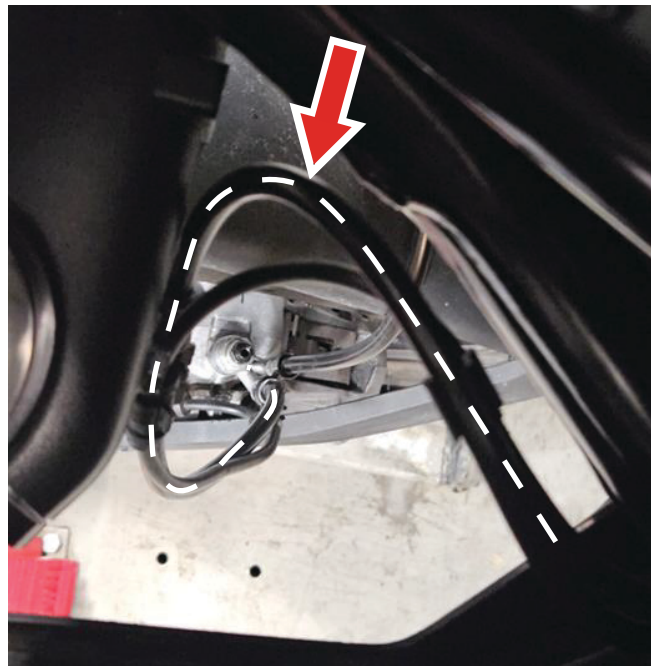
Top View Twisted

This document identifies improper installation of the front brake line between the hydraulic control unit (HCU) and the left front caliper. This issue can occur if either the front brake line was installed 180 degrees off during HCU sub-assembly or if the brake line was twisted 360 degrees during installation of the front brake line to the caliper.

3. Inspect the brake line at the HCU.
  - **Normal:** The part number of the brake line will be facing outward.
  - **Twisted:** The part number of the brake line will be facing inward.
4. If the brake line is twisted, proceed to ["Brake Line Replacement" on page 5](#) to replace the line. If not twisted, the motorcycle can be returned to service.

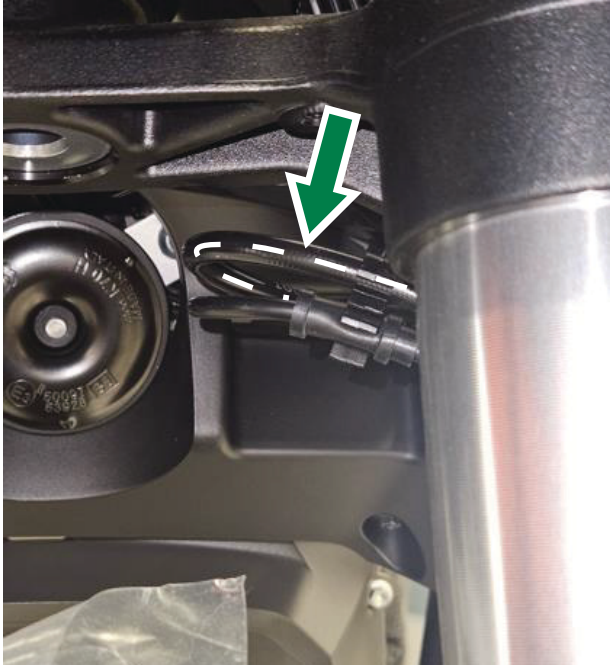
Front View Normal

2. Inspect the brake line from the front of the motorcycle with the wheel pointed straight forward.
  - **Normal:** The bend in the brake line is pointed towards the horn and is nearly horizontal. There is slack between the p-clamps and there is minimal tension between the p-clamp on the triple clamp and the brake line.
  - **Twisted:** The brake line is more vertical and is pointed up towards the frame, out of alignment with the p-clamp. The bend will not be visible as it is above the fork triple clamp next to the frame. There is a lot of tension between the brake line and the p-clamp.

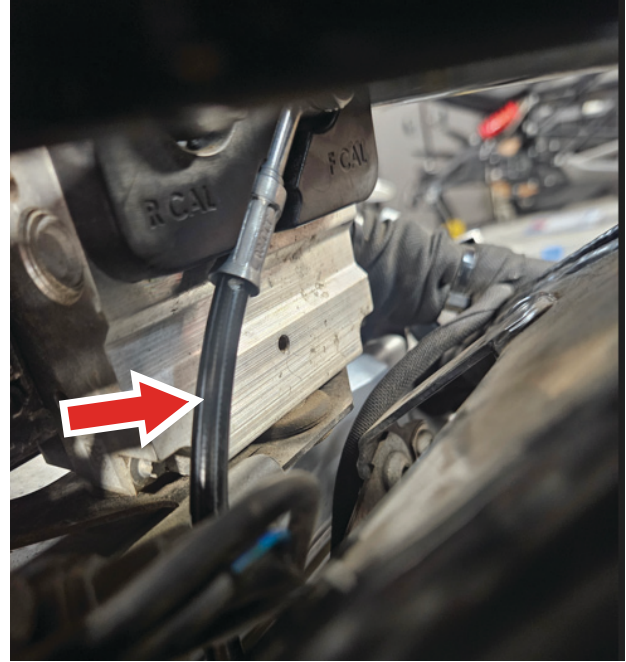
Part Number Inward

**Detailed Description** ● The subject motorcycles may have been produced with the front brake line from the HCU to front calipers twisted 180°, which restricts the designed flexibility through the "p-clamp" causing it to rub and damage the outer layers of the brake line potentially leading to brake fluid leakage and possible loss of brake pressure.

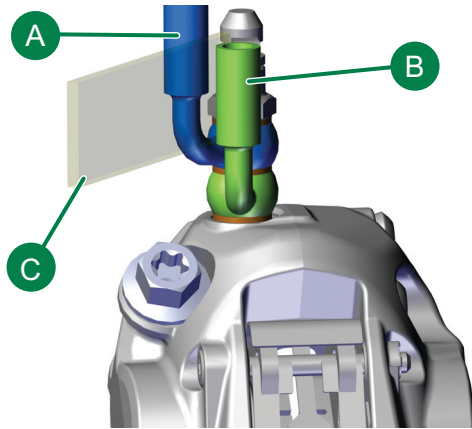
- A. New brake line - On top, angled toward the outside.  
 B. Jumper line - On bottom, angled toward rear of bike.  
 C. Wedge

- Route the brake line to the caliper as outlined in the previous section.
- Install the two p-clamps in the same location as removed.

- Install the brake line, banjo bolt and new crush washers onto the caliper as shown. Use a small piece of plywood or similar non-marring wedge device to keep the brake lines from contacting each other when tightening. Torque: 20 lb·ft (27 Nm)
- Bleed the brake system (front and rear) as outlined in the service manual.
