HYUNDAI Technical Service Bulletin

| GROUP RECALL | NUMBER 26-01-030H |

SUBJECT: HV BATTERY BUS BAR BOLTS INSPECTION & RETIGHTENING OR BSA REPLACEMENT (RECALL 294)

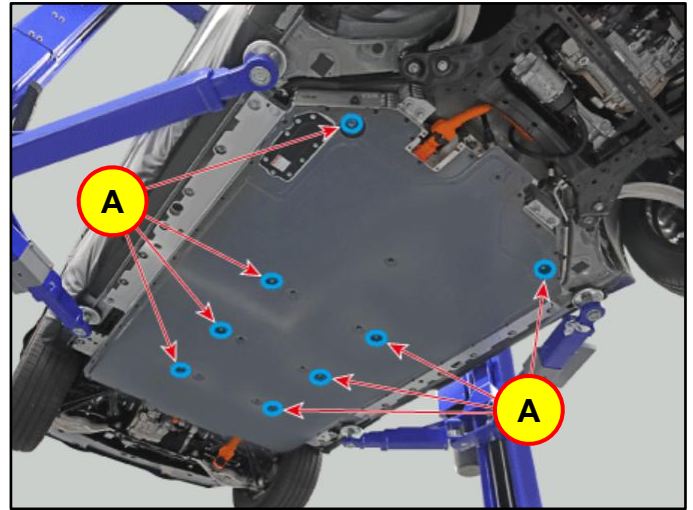
3. Shut **OFF** the high-voltage circuit then remove the BSA (A) by referring to the shop manual:
 - **Battery Control System > High Voltage Battery System > Battery System Assembly (BSA) > Removal and Installation**

Discard the original bolts as they are one time use and use new bolts (P/N: 37535-G1050) when reinstalling the BSA.

Torque the bolts to the recommended torque spec. listed in the shop manual.

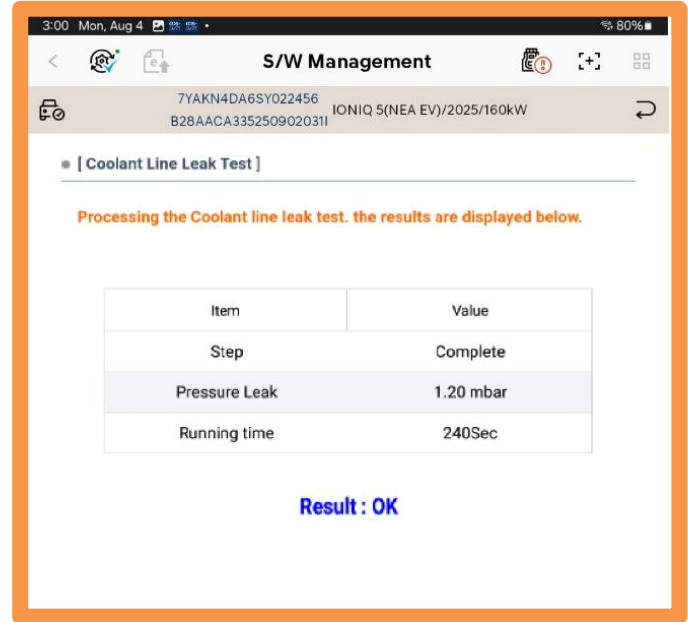
Using the tablet or GDS screen capture function, take a screenshot of the “OK” coolant line leak test result.

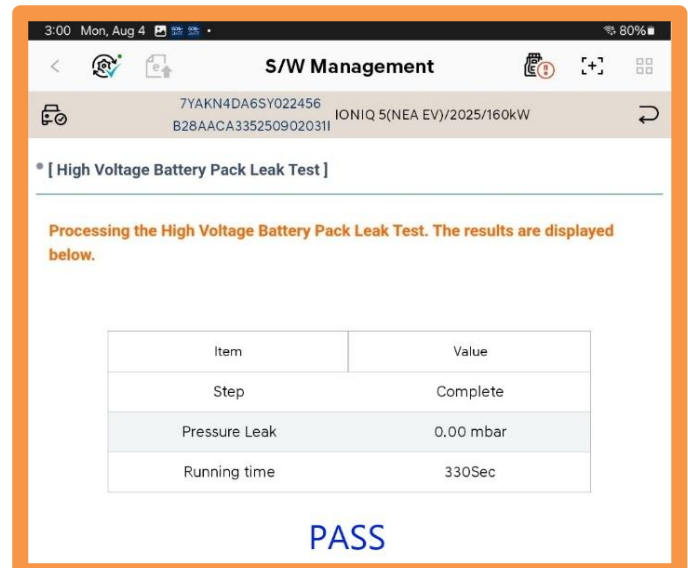
Using the tablet or GDS screen capture function, take a screenshot of the “PASS” air tightness test result.

If the BSA air tightness test **FAILS**, MOBIS will replace the gasket. Repeat **Step 7**.

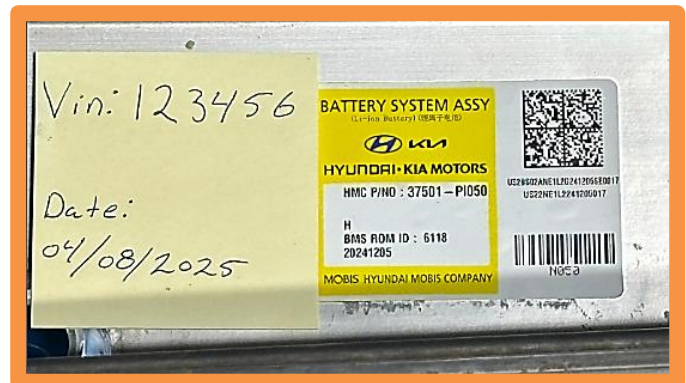
Using the STUI camera function, take a photo of the new BSA's part label.
