Technical Service Bulletin

GROUP RECALL	NUMBER 26-01-014H
DATE FEBRUARY 2026	MODEL(S) KONA (SX2)

SUBJECT: FRONT STEERING KNUCKLE INSPECTION
(RECALL 295)

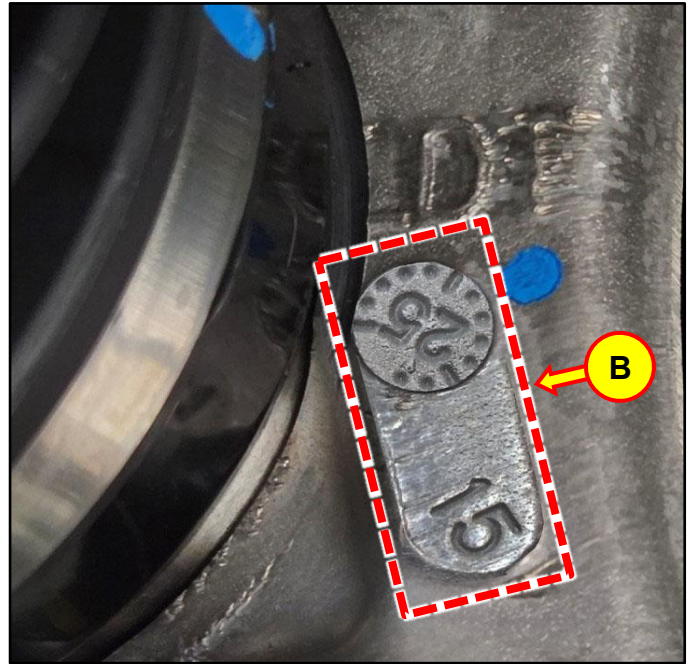
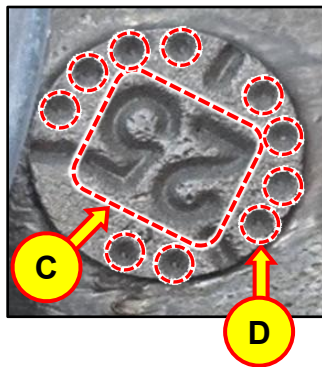
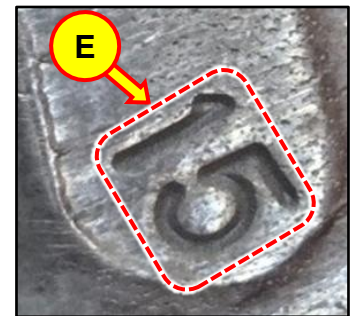
3. Check the lot code (B) to identify the production year, month, and day as described below.

- C = Production Year: 2025
- D = Production Month: October (10 dots)
- E = Production Day: 15

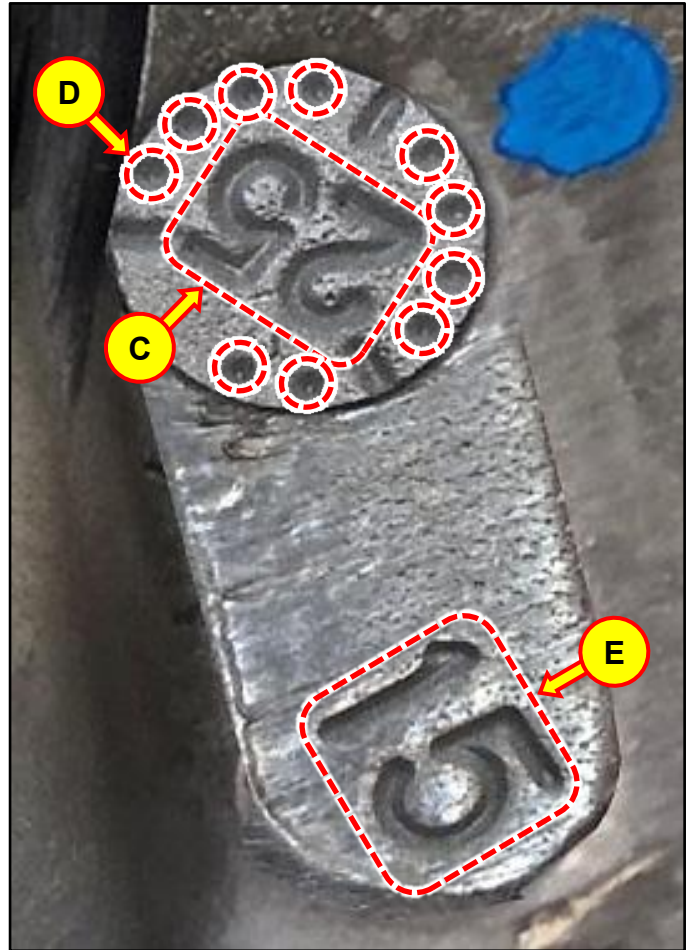
5. If the lot code is **October 15, 2025**, or if the code is **NOT** readable, proceed to the [Front Steering Knuckle Mold Number Inspection](#) procedure.
- C = Production Year: 2025
 - D = Production Month: October (10 dots)
 - E = Production Day: 15
6. If the lot code is **NOT** October 15, 2025 (e.g., any other date combination), then the front steering knuckles are **OK**.

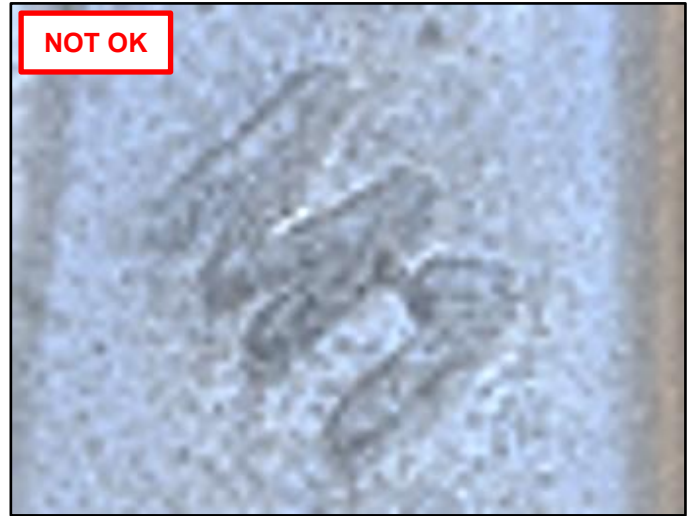
5. If the mold number is **M1** on **either** the LH or RH side, or if the code is **NOT** readable, **HOLD** the vehicle.

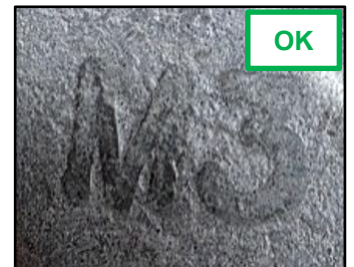
If the mold number is **NOT** M1 (e.g., any other number), then the front steering knuckle is **OK**.
