# ***SERVICE PROCEDURE***

**26501R2  
May 2026**

## **SUBJECT: SAFETY RECALL**

**2026 and 2027 International® MV™ Series trucks built 11/13/2025 thru 12/08/2025, with Bendix® Fusion™ 3.0 Collision Mitigation, ACC Stop & Driver Go (feature code 0008TRM), and Allison 2000 or 3000 Series™ Generation 6 Transmission (feature codes 0013BAU, 0013BAV, 0013BBA, 0013BBG, 0013BBJ, 0013BBK, 0013BCS, and 0013BDR).**

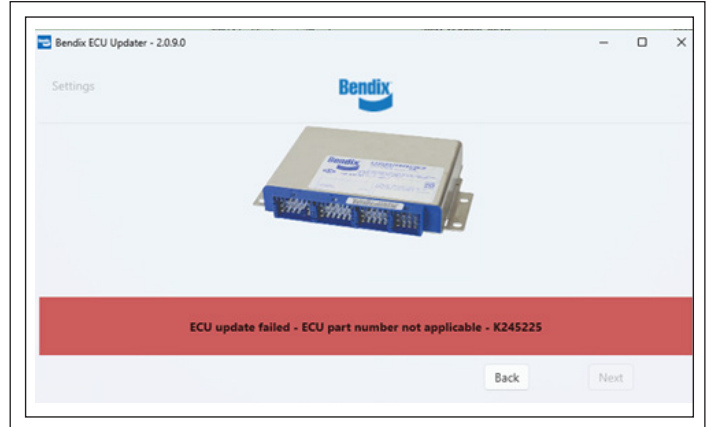
**Figure 4 – ECU Ineligible for Software Update**

12. If the detected ECU is not eligible for an update, an ECU failure message may appear and no further action is required. See *Figure 4*.

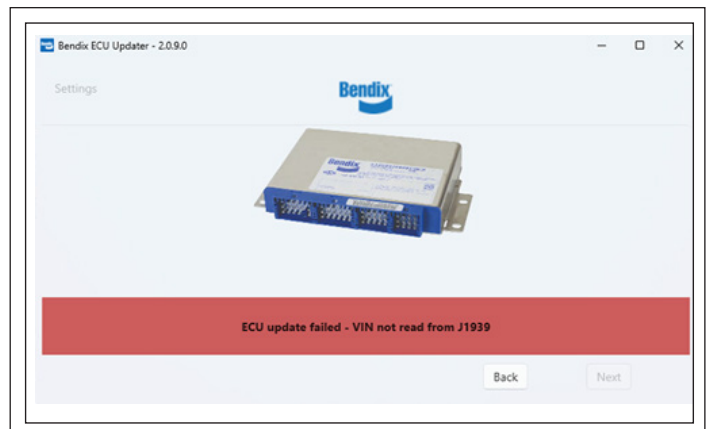
**Figure 5 – VIN Not Included in Software Update**

13. If the VIN of the vehicle is not in the impacted population, there will be indication that the VIN is either not received or VIN is not included in the software update. No further action is required. See *Figure 5*.

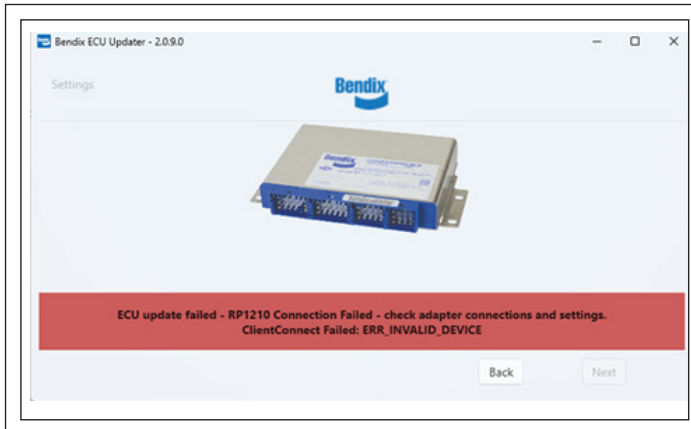
**Figure 6 – RP1210 Configuration Error**

14. If the utility is having issues connecting to the adapter or there is a configuration error, an error message similar to *Figure 6* or *Figure 7* may appear.

b. Open the settings within software and verify the appropriate adapter, baud, and channel are selected. See *Figure 8* for an example of the Configuration settings.

a. Verify the adapter has power and is reading the vehicle data. Refer to applicable adapter manufacturer's technical documentation for more information.

c. Disconnect and reconnect the adapter from both the USB port and the vehicle diagnostic port.

d. Close all open diagnostic programs and reattempt the software update from *Step 4*.
