SERVICE PROCEDURE

SUBJECT: SAFETY RECALL

2026 and 2027 International® MV™ Series trucks built 11/13/2025 thru 12/08/2025, with Bendix® Fusion™ 3.0 Collision Mitigation, ACC Stop & Driver Go (feature code 0008TRM), and Allison 2000 or 3000 Series™ Generation 6 Transmission (feature codes 0013BAU, 0013BAV, 0013BBA, 0013BBG, 0013BBJ, 0013BBK, 0013BCS, and 0013BDR).

Subject: Bendix® EC-80™ Software Update for International® Motors

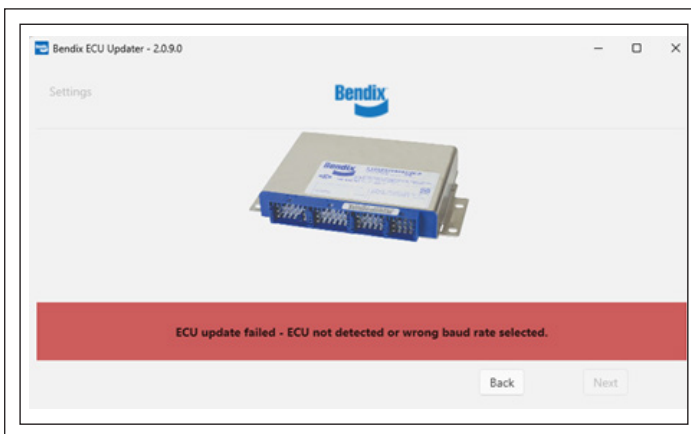
Figure 7 – ECU Not Detected/Wrong Baud Rate Error

- **(Figure 7) Wrong Baud Rate Error** - Configuration settings are not correct. See *Step 14*.

14. If the utility is having issues connecting to the adapter or there is a configuration error, an error message similar to *Figure 6* or *Figure 7* may appear.

b. Open the settings within software and verify the appropriate adapter, baud, and channel are selected. See *Figure 8* for an example of the Configuration settings.

Perform the following troubleshooting steps:

a. Verify the adapter has power and is reading the vehicle data. Refer to applicable adapter manufacturer's technical documentation for more information.

c. Disconnect and reconnect the adapter from both the USB port and the vehicle diagnostic port.

d. Close all open diagnostic programs and reattempt the software update from *Step 4*.
