**TECHNICAL INSTRUCTIONS**  
**FOR**  
**SAFETY RECALL 26LA01**  
**REPROGRAMMING FOR**  
**TRANSMISSION CONTROL COMPUTER ASSEMBLY**

**CERTAIN 2025 – 2026 LX 600 VEHICLES**

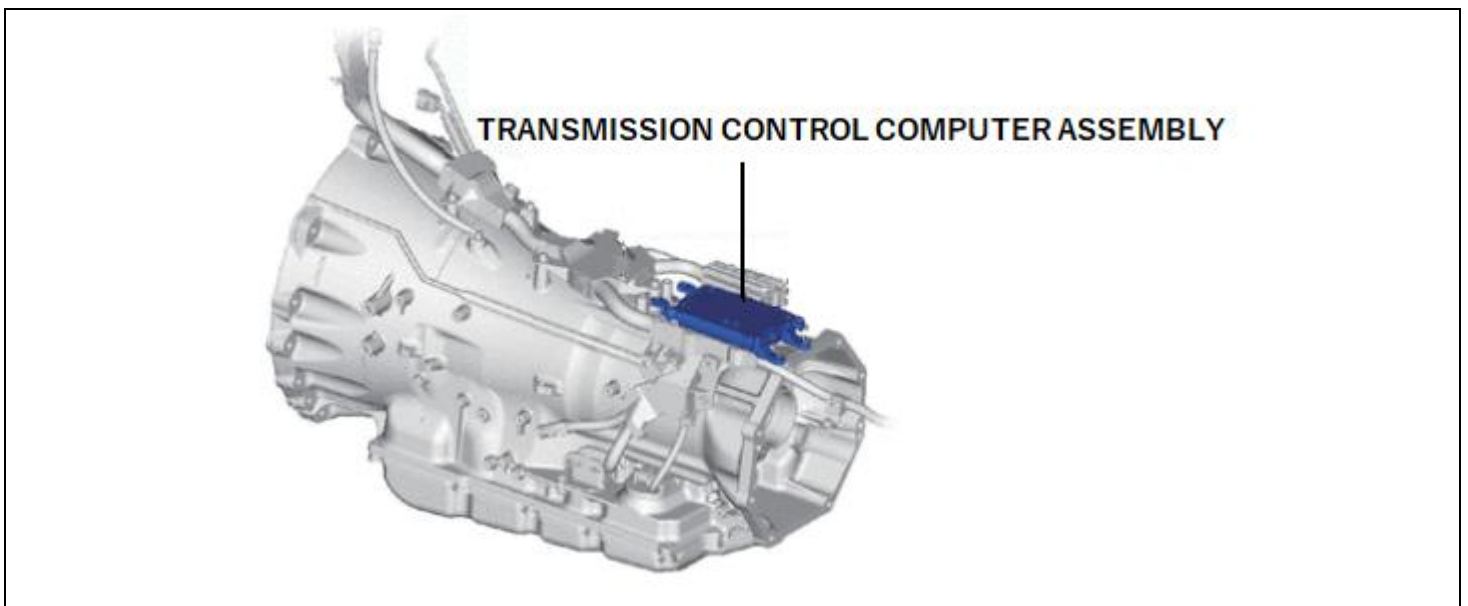
A software issue can allow the transmission to damage itself under certain conditions. This can lead to loss of motive power while driving at higher speeds, which can increase the risk of a crash. It can also lead to a transmission fluid leak that can increase the risk of vehicle fire in the presence of an ignition source.

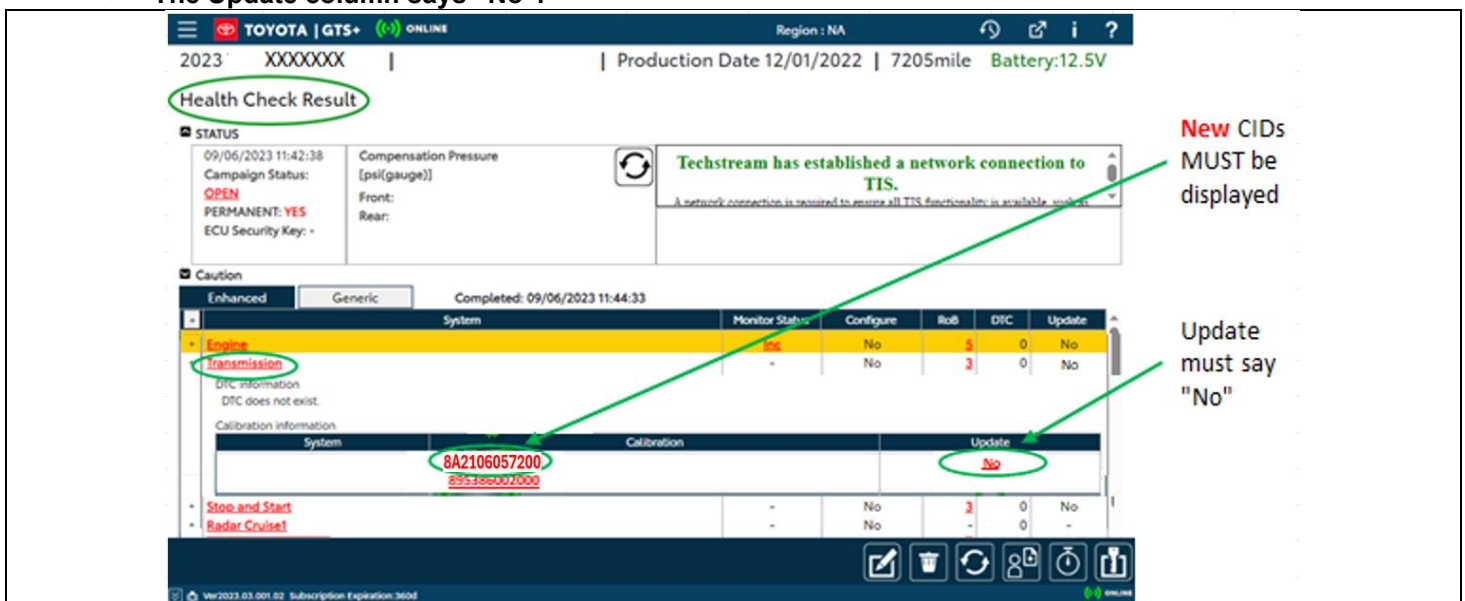
New CIDs MUST be displayed

Update must say "No"

Confirm the CIDs has been updated successfully to the **NEW CIDs** by someone other than the individual who performed the repair. Refer to page 5.
