SIB 64 01 26

RECALL 26V-096: CHECK AND REROUTE COCKPIT WIRING HARNESS

2026-03-06

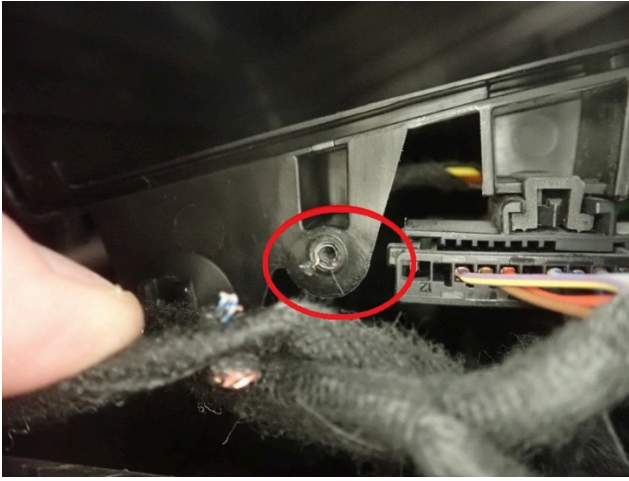
With the harness pulled out of the way, you can see the screw mounting hole for the cabin air filter cover.

Double check the routing of the harness prior to installing the screws for the cabin air filter cover.

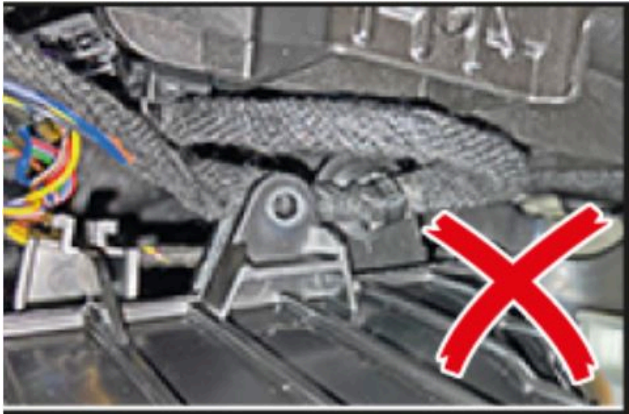
The upper photo has the harness visible through the mounting hole. This positioning is not acceptable- the harness must be moved out of the way of the mounting screw.

If the wiring harness has already been damaged during the installation of the cabin air filter cover, the damaged section of the wiring harness must be repaired.

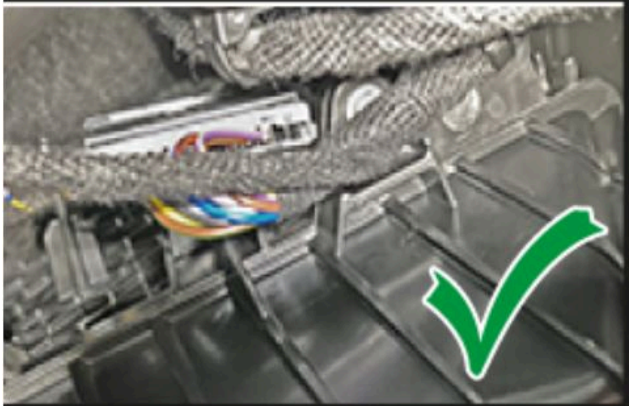
The lower photo shows the harness positioned in front of the mounting screw, which is an acceptable routing.
