## SIB 64 01 26

### RECALL 26V-096: CHECK AND REROUTE COCKPIT WIRING HARNESS

2026-03-03

## SIB 64 02 26

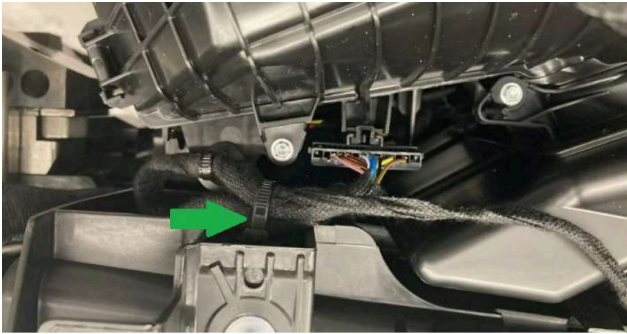
Inspect the harness routing, and add a retainer to the harness (arrow) to prevent it being pinched under the air filter plastic cover.

Use caution when re-installing the plastic cover for the cabin air filter to ensure no damage is done to the vehicle's wiring harness.

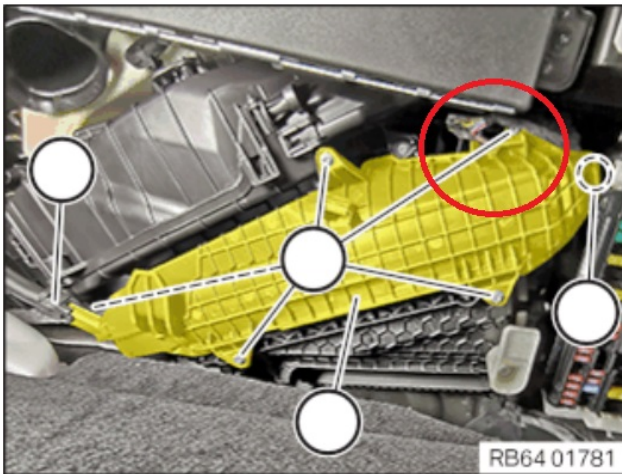
Check the vehicle wiring harness routing (circled) to ensure it is not pinched by the plastic cover over the filter.

Follow Repair Instructions REP 64 31010 to access the cabin air nanofilter.

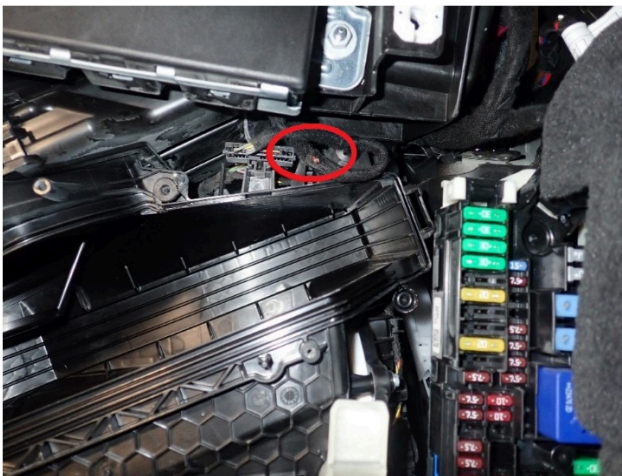
This is where the harness can be damaged when installing the cabin air filter cover screw.

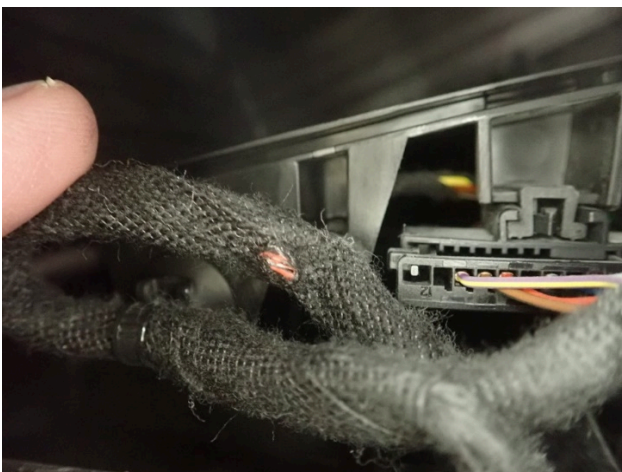
This shows the harness damage; the sheathing has been abraded.

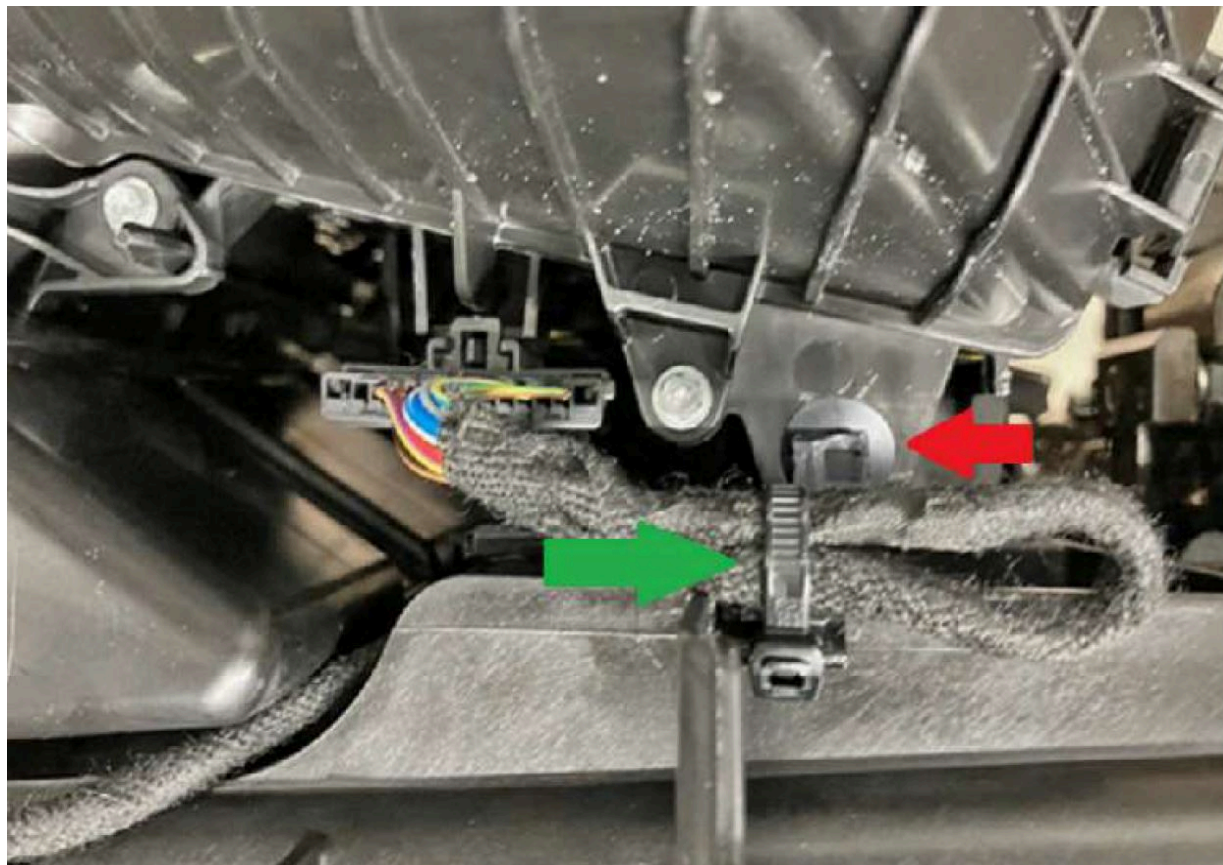
The original harness retainer must be disconnected. This is shown by the red arrow below. It can be left clipped into vehicle but must be disconnected from harness for strain relief.

Install a new harness retainer with cable strap on the instrument panel wiring harness, see green arrow.

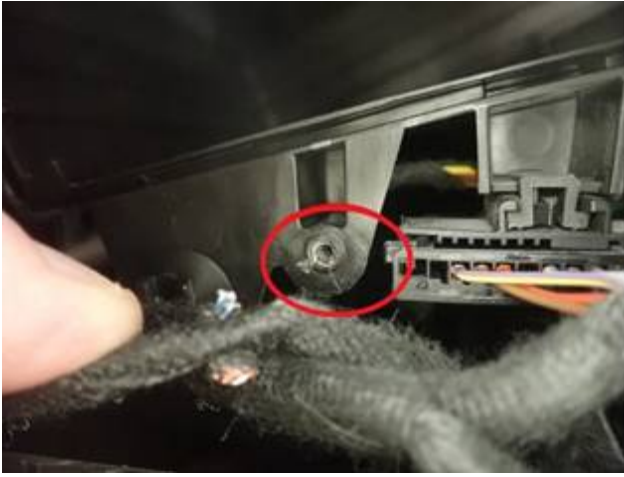
With the harness pulled out of the way, you can see the screw mounting hole for the cabin air filter cover.

Double-check the routing of the harness prior to installing the screws for the cabin air filter cover.

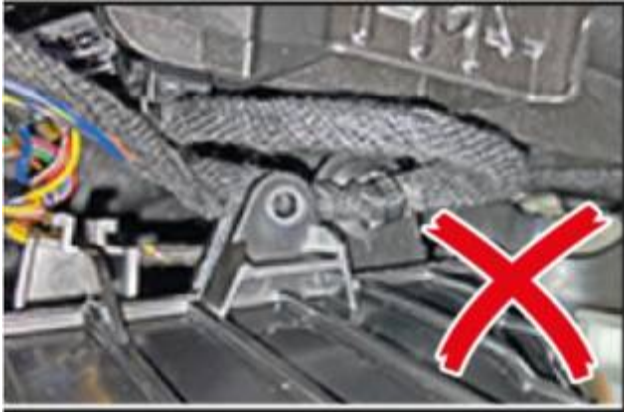
The upper photo has the harness visible through the mounting hole. This positioning is not acceptable- the harness must be moved out of the way of the mounting screw.

If the wiring harness has already been damaged during the installation of the cabin air filter cover, the damaged section of the wiring harness must be repaired.

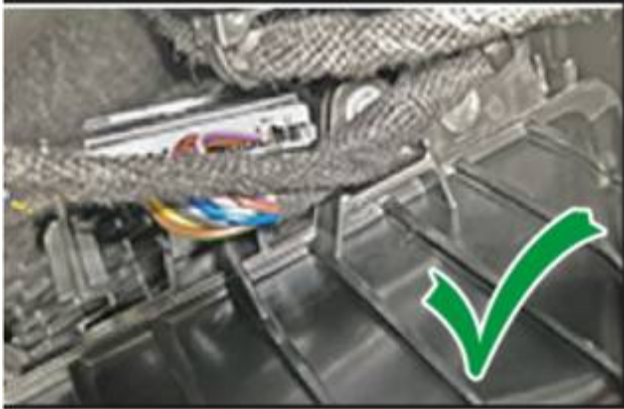
The lower photo shows the harness positioned in front of the mounting screw, which is an acceptable routing.

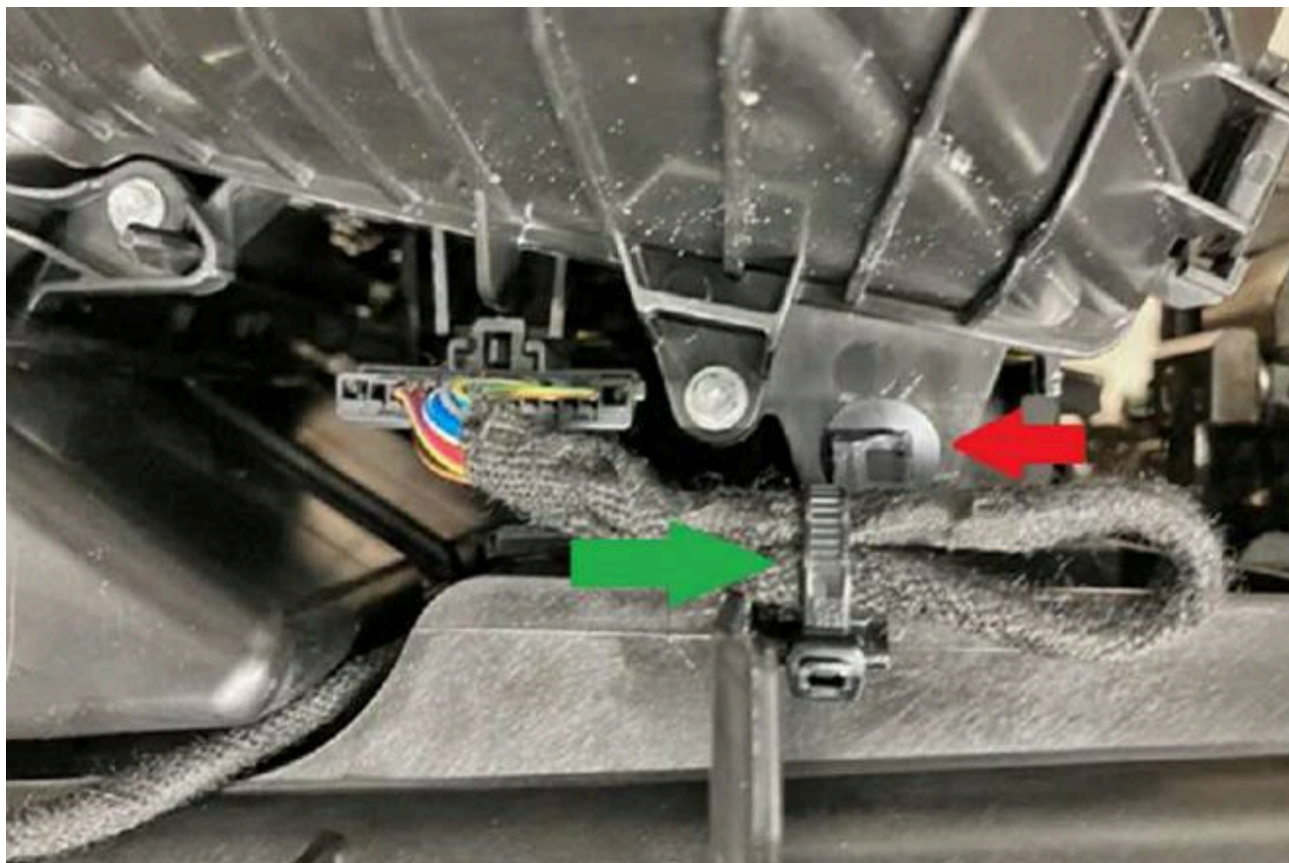
The original harness retainer must be disconnected. This is shown by the red arrow below. It can be left clipped into vehicle but must be disconnected from harness for strain relief.

Install a new harness retainer with cable strap on the instrument panel wiring harness, see green arrow.
