SIB 64 01 26

RECALL 26V-096: CHECK AND REROUTE COCKPIT WIRING HARNESS

2026-04-13

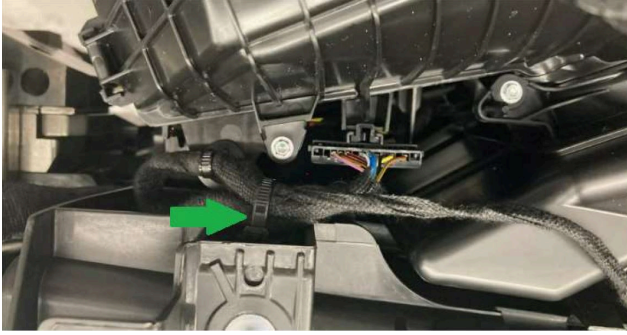
When servicing the cabin air microparticle nanofilter, it is possible to pinch and thereby damage the vehicle's wiring harness while re-installing the retaining screws for the cabin air nanofilter's plastic cover.

Inspect the harness routing, and add a retainer to the harness (arrow) to prevent it being pinched under the air filter plastic cover.

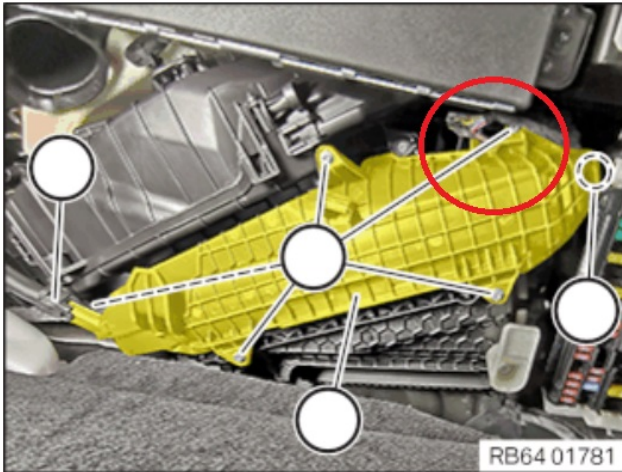
Check the vehicle wiring harness routing (circled) to ensure it is not pinched by the plastic cover over the filter.

Follow Repair Instructions REP 64 31010 to access the cabin air nanofilter.

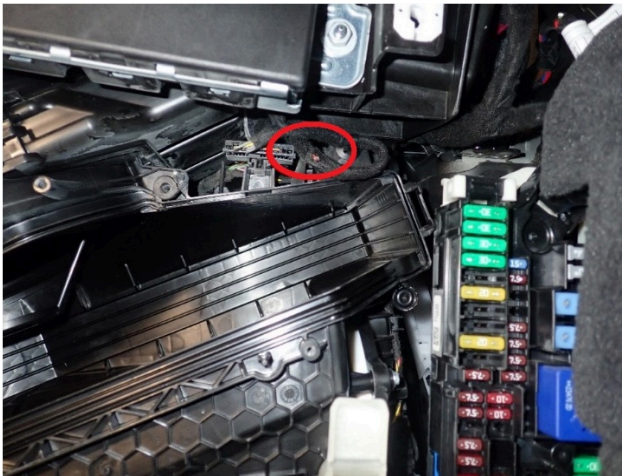
This is where the harness can be damaged when installing the cabin air filter cover screw.

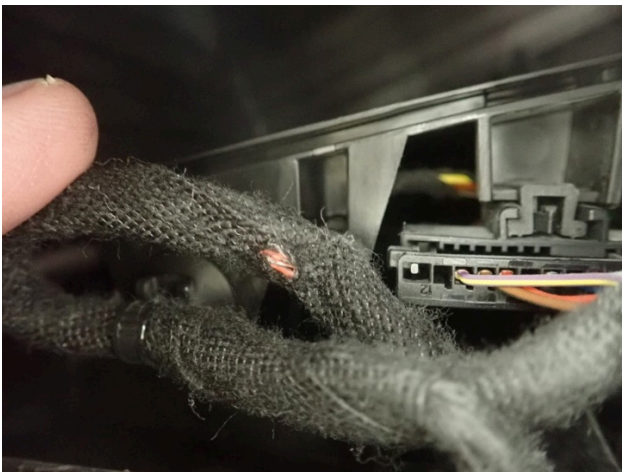
This shows the harness damage; the sheathing has been abraded.

If the wiring harness has already been damaged during the installation of the cabin air filter cover, the damaged section of the wiring harness must be repaired.

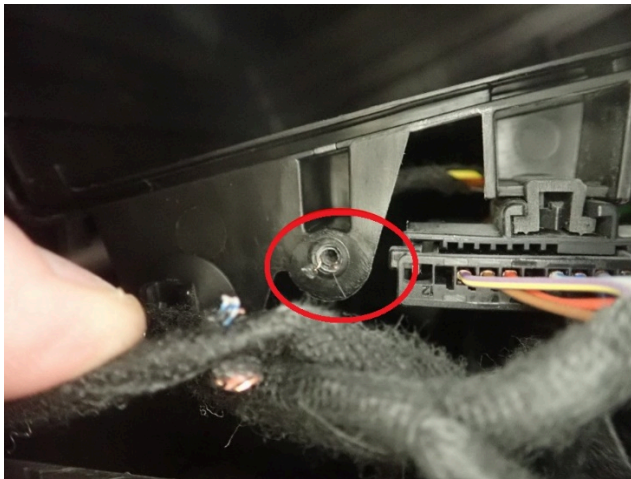
With the harness pulled out of the way, you can see the screw mounting hole for the cabin air filter cover.

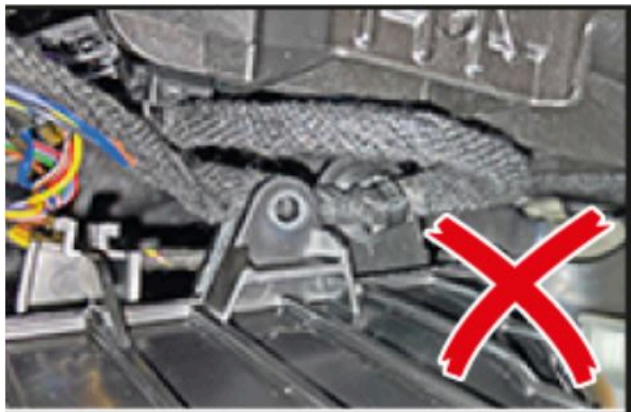
The upper photo has the harness visible through the mounting hole. This positioning is not acceptable- the harness must be moved out of the way of the mounting screw.

Double check the routing of the harness prior to installing the screws for the cabin air filter cover.

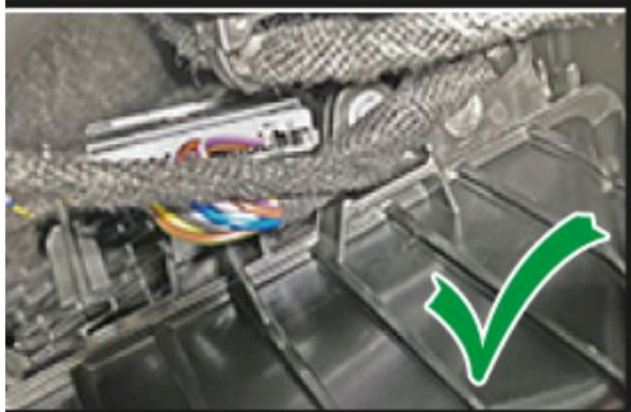
The lower photo shows the harness positioned in front of the mounting screw, which is an acceptable routing.

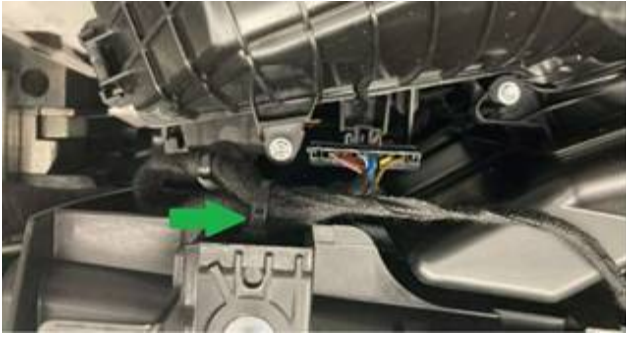
When servicing the cabin air microparticle nanofilter, it is possible to pinch and thereby damage the vehicle's wiring harness while re-installing the retaining screws for the cabin air nanofilter's plastic cover.

Inspect the harness routing and add a retainer to the harness (arrow) to prevent it being pinched under the air filter plastic cover.

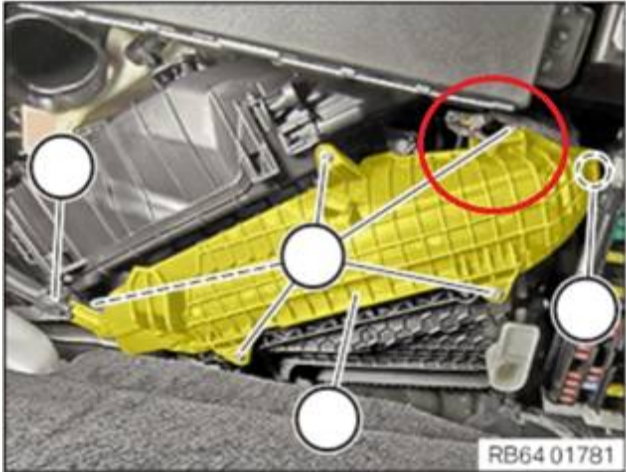
Check the vehicle wiring harness routing (circled) to ensure it is not pinched by the plastic cover over the filter.

Follow Repair Instructions REP 64 31010 to access the cabin air nanofilter.

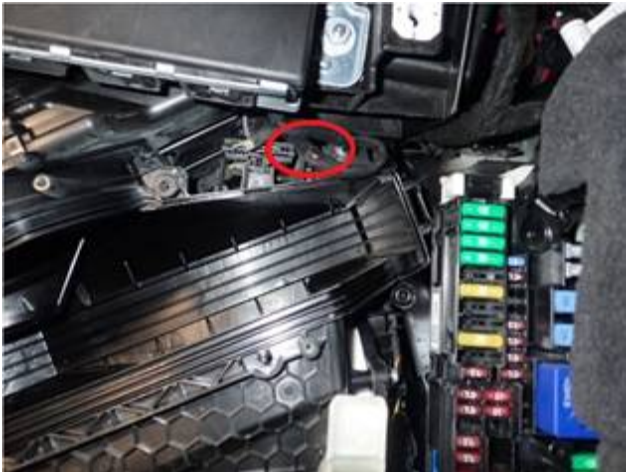
This is where the harness can be damaged when installing the cabin air filter cover screw.

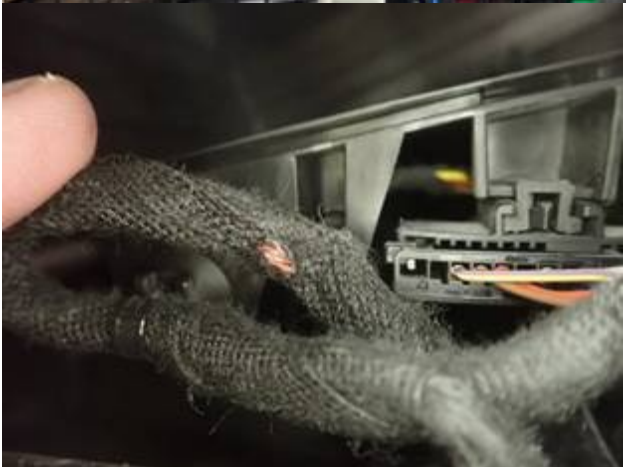
This shows the harness damage; the sheathing has been abraded.

If the wiring harness has already been damaged during the installation of the cabin air filter cover, the damaged section of the wiring harness must be repaired.

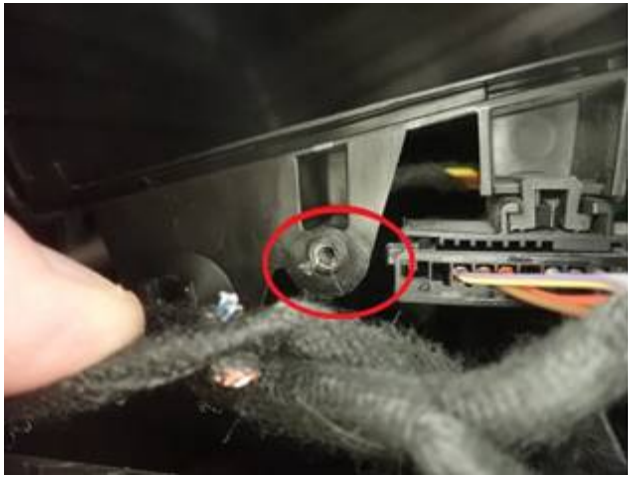
With the harness pulled out of the way, you can see the screw mounting hole for the cabin air filter cover.

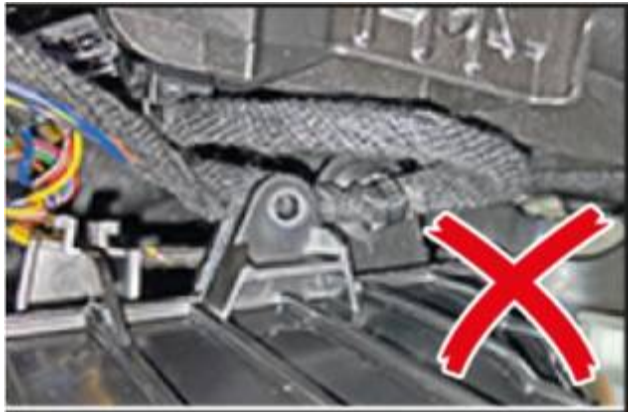
The upper photo has the harness visible through the mounting hole. This positioning is not acceptable- the harness must be moved out of the way of the mounting screw.

Double-check the routing of the harness prior to installing the screws for the cabin air filter cover.

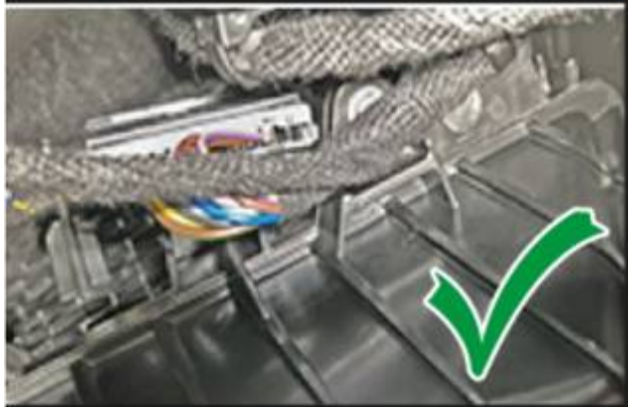
The lower photo shows the harness positioned in front of the mounting screw, which is an acceptable routing.
