SIB 64 01 26

RECALL 26V-096: CHECK AND REROUTE COCKPIT WIRING HARNESS

2026-03-12

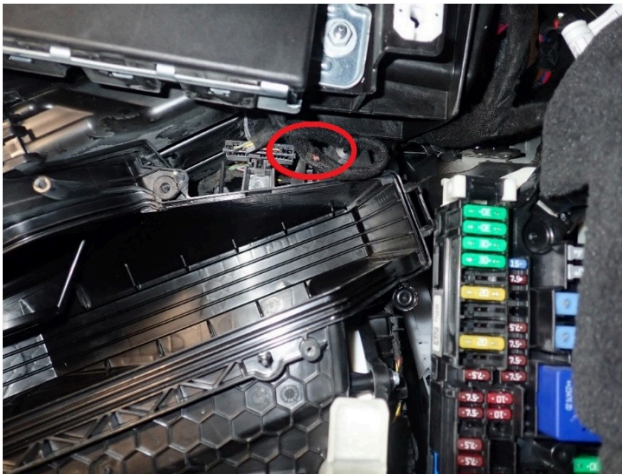
Check the vehicle wiring harness routing (circled) to ensure it is not pinched by the plastic cover over the filter.

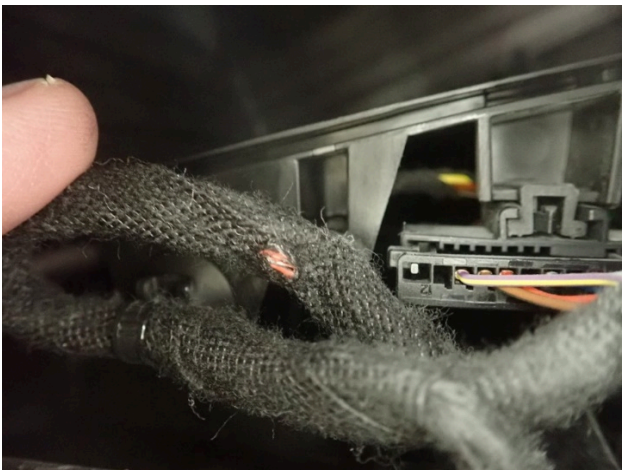
This is where the harness can be damaged when installing the cabin air filter cover screw.

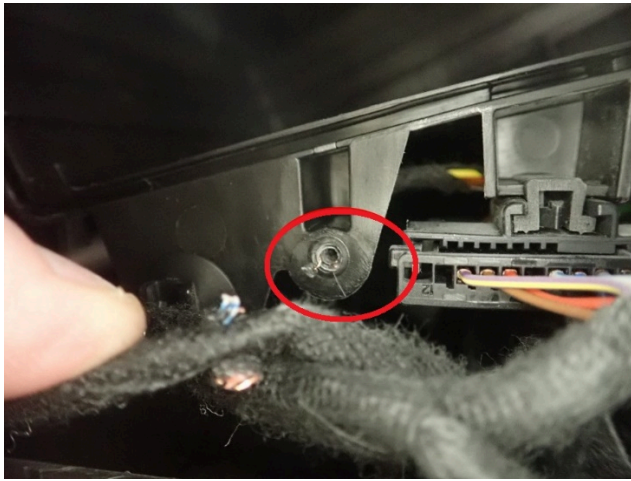
This shows the harness damage; the sheathing has been abraded.

If the wiring harness has already been damaged during the installation of the cabin air filter cover, the damaged section of the wiring harness must be repaired.

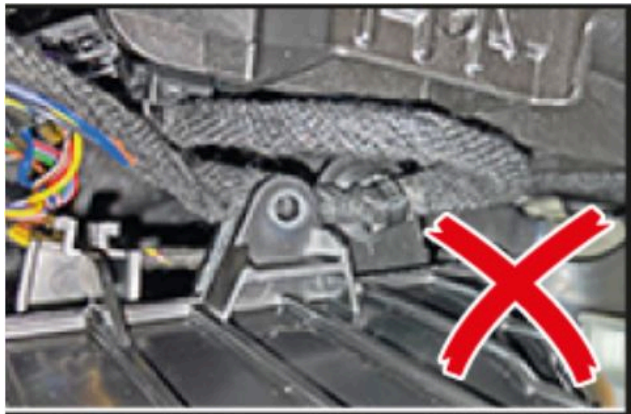
With the harness pulled out of the way, you can see the screw mounting hole for the cabin air filter cover.

Double check the routing of the harness prior to installing the screws for the cabin air filter cover.

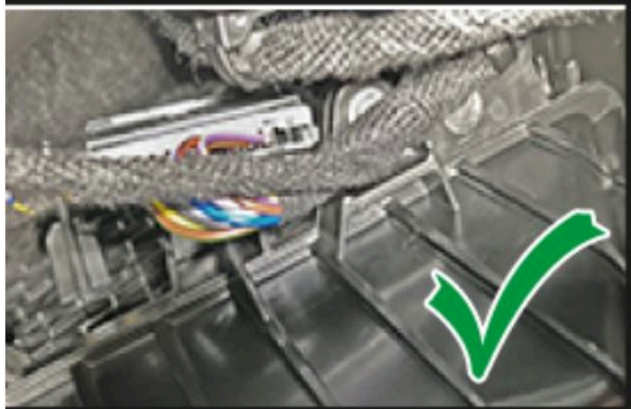
The upper photo has the harness visible through the mounting hole. This positioning is not acceptable- the harness must be moved out of the way of the mounting screw.

The lower photo shows the harness positioned in front of the mounting screw, which is an acceptable routing.
