SIB 64 01 26

**RECALL 26V-096: CHECK AND REROUTE COCKPIT WIRING HARNESS**  
2026-05-05

This Service Information Bulletin (Revision 6) replaces SI B64 01 26 **dated April 2026**.

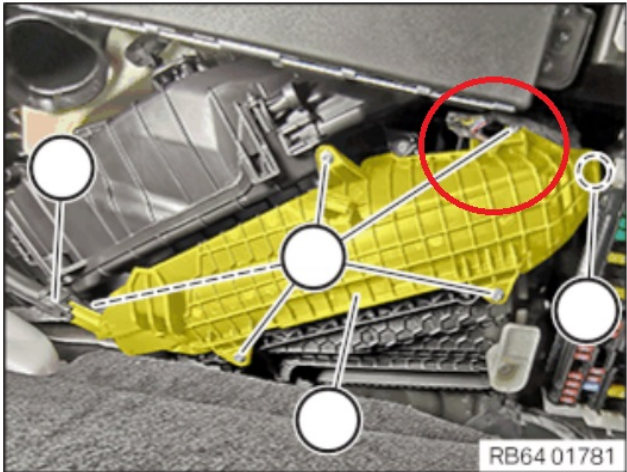
Check the vehicle wiring harness routing (circled) to ensure it is not pinched by the plastic cover over the filter.

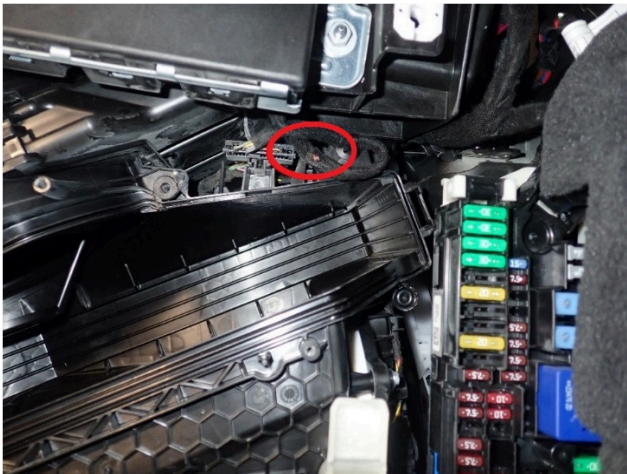
This is where the harness can be damaged when installing the cabin air filter cover screw.

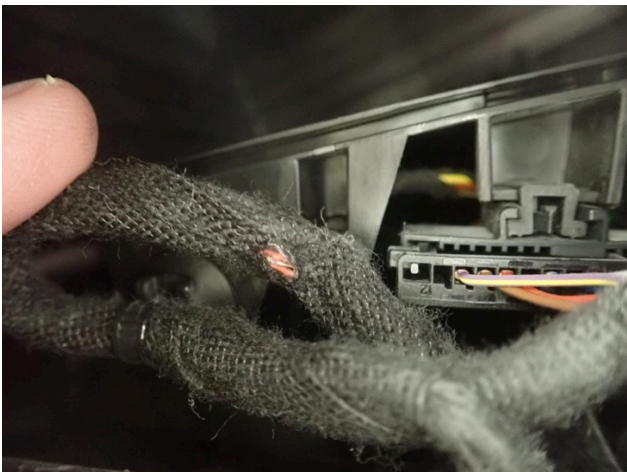
This shows the harness damage; the sheathing has been abraded.

If the wiring harness has already been damaged during the installation of the cabin air filter cover, the damaged section of the wiring harness must be repaired.

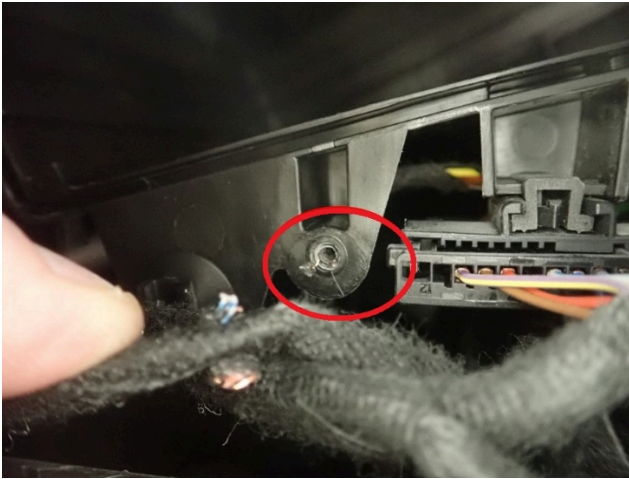
With the harness pulled out of the way, you can see the screw mounting hole for the cabin air filter cover.

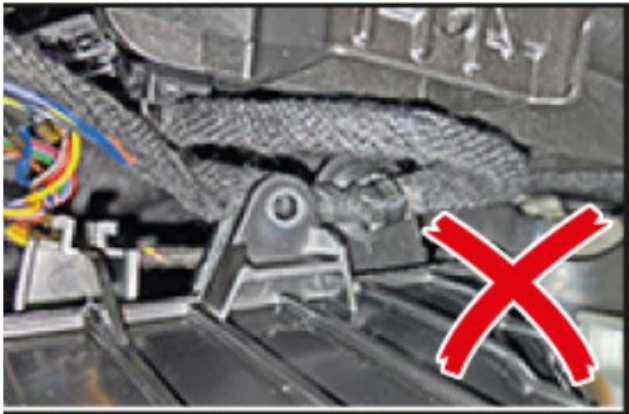
The upper photo has the harness visible through the mounting hole. This positioning is not acceptable- the harness must be moved out of the way of the mounting screw.

Double check the routing of the harness prior to installing the screws for the cabin air filter cover.

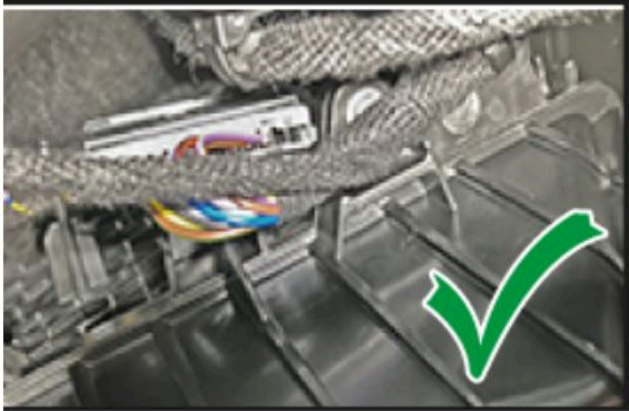
The lower photo shows the harness positioned in front of the mounting screw, which is an acceptable routing.

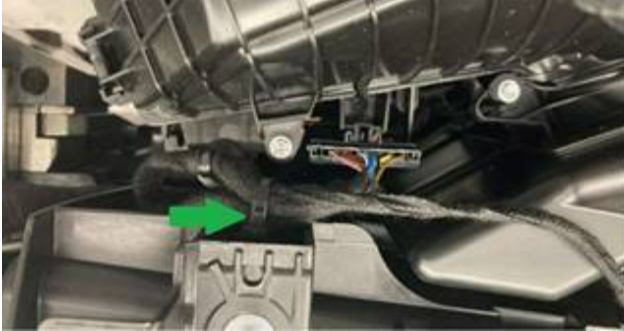
Inspect the harness routing and add a retainer to the harness (arrow) to prevent it being pinched under the air filter plastic cover.

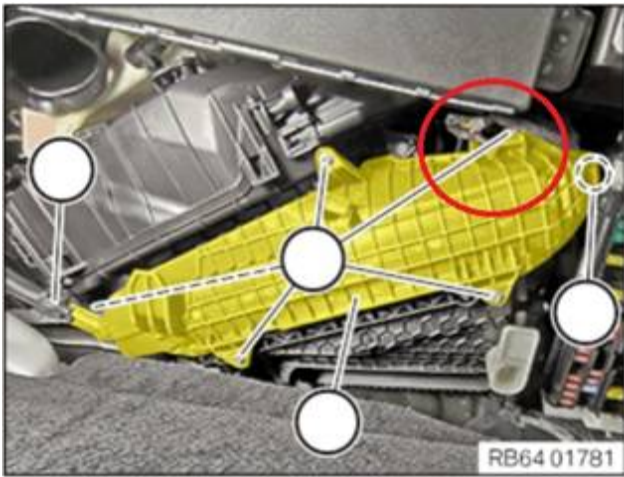
Check the vehicle wiring harness routing (circled) to ensure it is not pinched by the plastic cover over the filter.

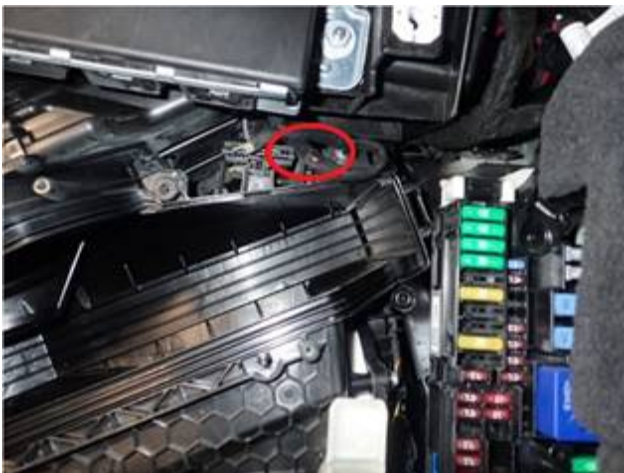
This is where the harness can be damaged when installing the cabin air filter cover screw.

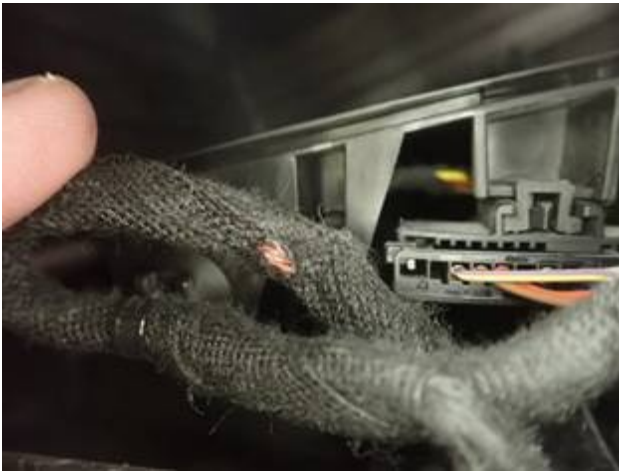
This shows the harness damage; the sheathing has been abraded.

If the wiring harness has already been damaged during the installation of the cabin air filter cover, the damaged section of the wiring harness must be repaired.

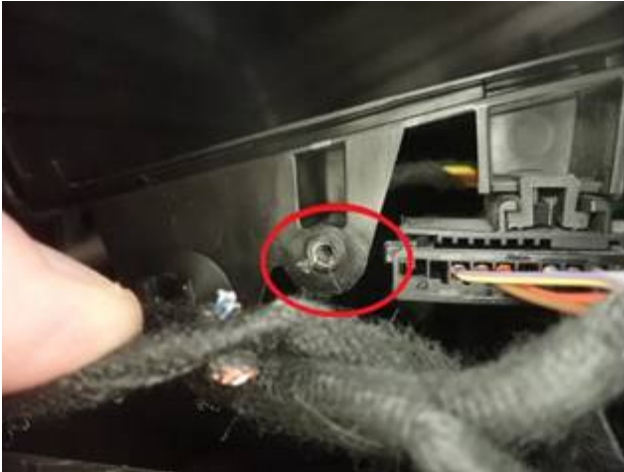
With the harness pulled out of the way, you can see the screw mounting hole for the cabin air filter cover.

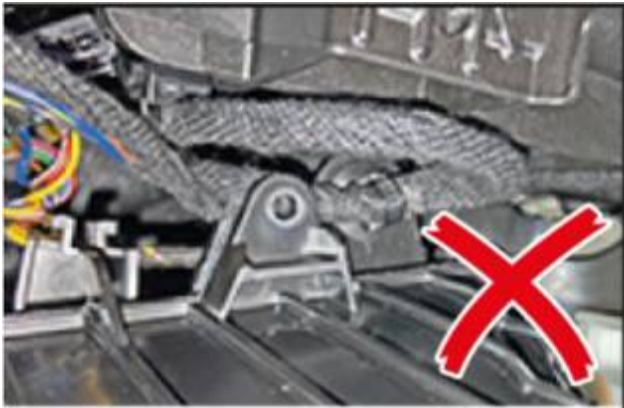
The upper photo has the harness visible through the mounting hole. This positioning is not acceptable- the harness must be moved out of the way of the mounting screw.

Double-check the routing of the harness prior to installing the screws for the cabin air filter cover.

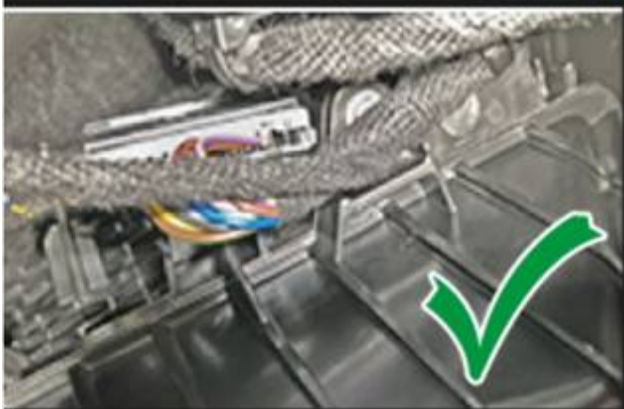
The lower photo shows the harness positioned in front of the mounting screw, which is an acceptable routing.
