SIB 64 01 26

RECALL 26V-096: CHECK AND REROUTE COCKPIT WIRING HARNESS

2026-02-20

SIB 64 02 26

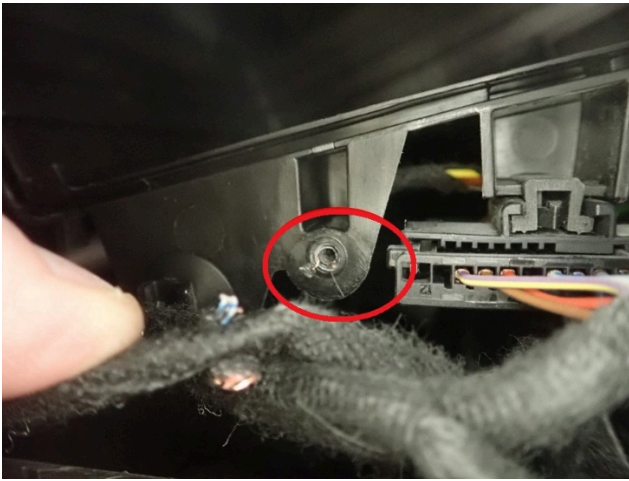
With the harness pulled out of the way, you can see the screw mounting hole for the cabin air filter cover.

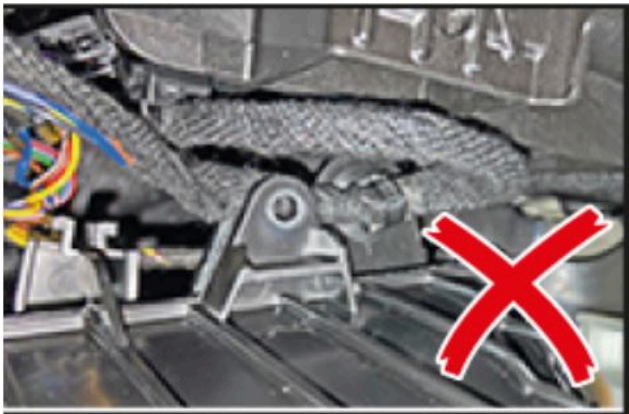
The upper photo has the harness visible through the mounting hole. This positioning is not acceptable- the harness must be moved out of the way of the mounting screw.

Double check the routing of the harness prior to installing the screws for the cabin air filter cover.

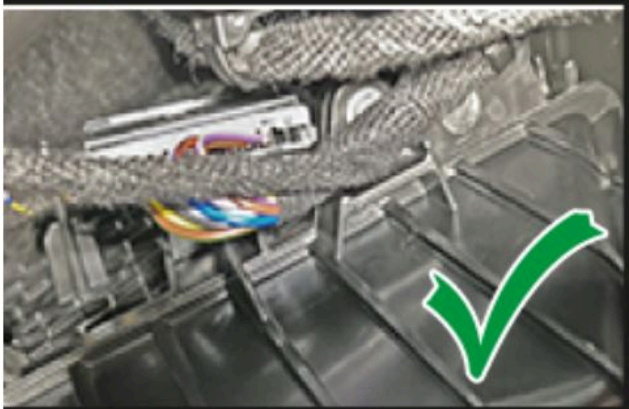
The lower photo shows the harness positioned in front of the mounting screw, which is an acceptable routing.

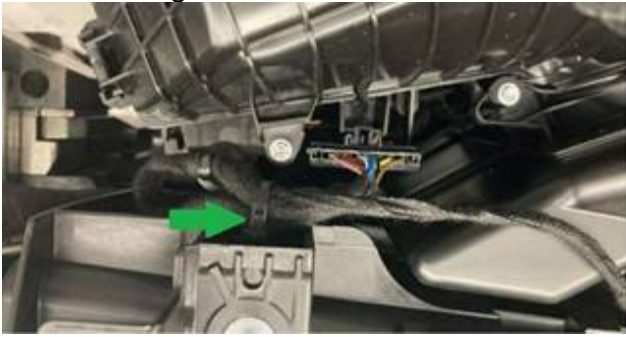
Inspect the harness routing and add a retainer to the harness (arrow) to prevent it being pinched under the air filter plastic cover.

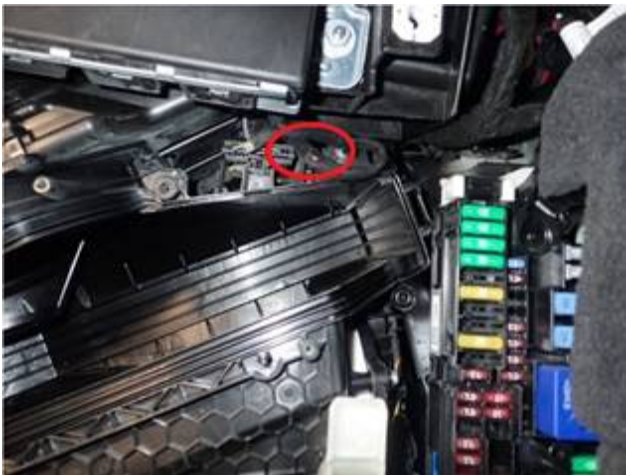
This is where the harness can be damaged when installing the cabin air filter cover screw.

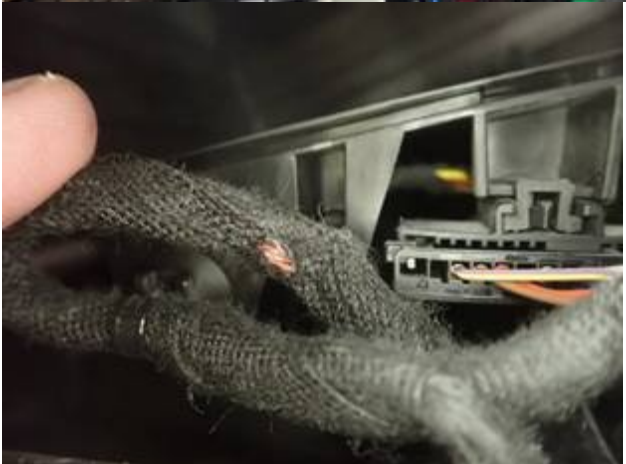
This shows the harness damage; the sheathing has been abraded.

If the wiring harness has already been damaged during the installation of the cabin air filter cover, the damaged section of the wiring harness must be repaired.
