PRODUCT CAMPAIGN BULLETIN

APPLICABILITY: 2026 MY Crosstrek SHEV
 2025 MY Forester SHEV

NUMBER: WRD-26
DATE: 03/26/26

SUBJECT: Safety Recall & Stop Sale: Fuel Filler Cap Gasket
NHTSA ID:

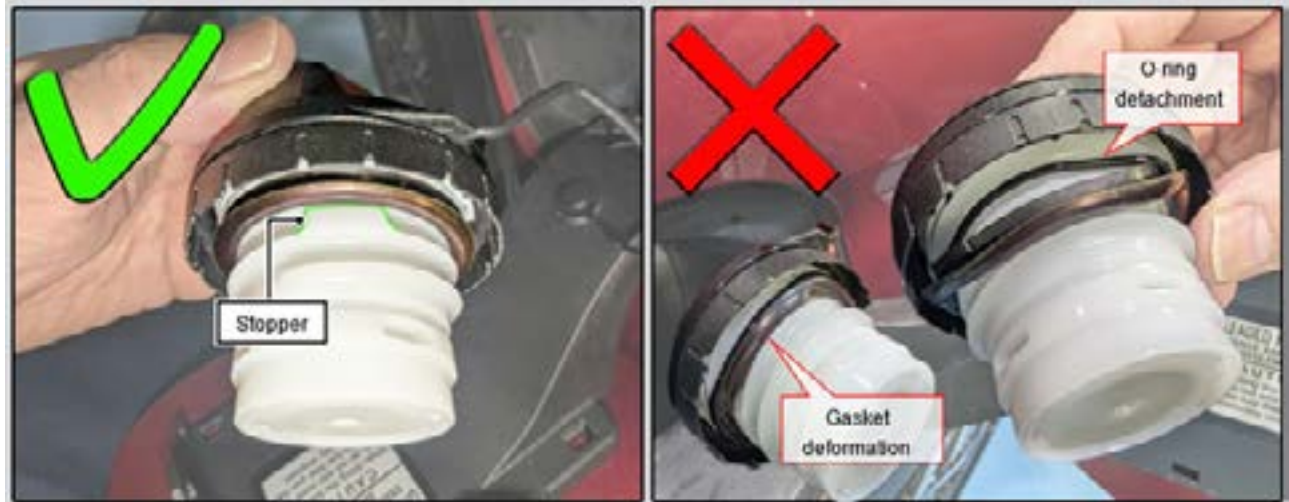
CAUTION: If the gasket is not installed correctly, there is a risk of gasket deformation, or the O-ring can become damaged. If this occurs, the parts **MUST NOT** be reused. Any deformation and/or damage to the gasket or O-ring will require new parts to be installed correctly.

STEP 4: Confirm the gasket is securely and fully seated to the proper depth beyond the stopper portion of the cap. Ensure the gasket is not deformed and the O-ring is properly aligned.

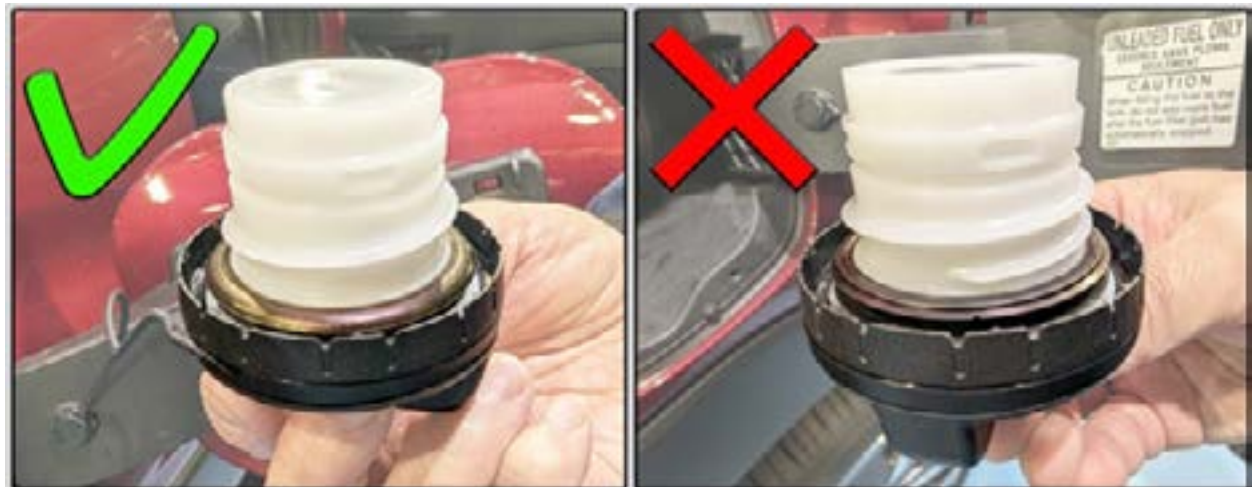
CAUTION: If the gasket is installed in the wrong position, it is possible for the gasket and O-ring to be damaged. If installed incorrectly, new parts will be required with correct installation.

Confirm the gasket is installed in the correct orientation and is not reversed.

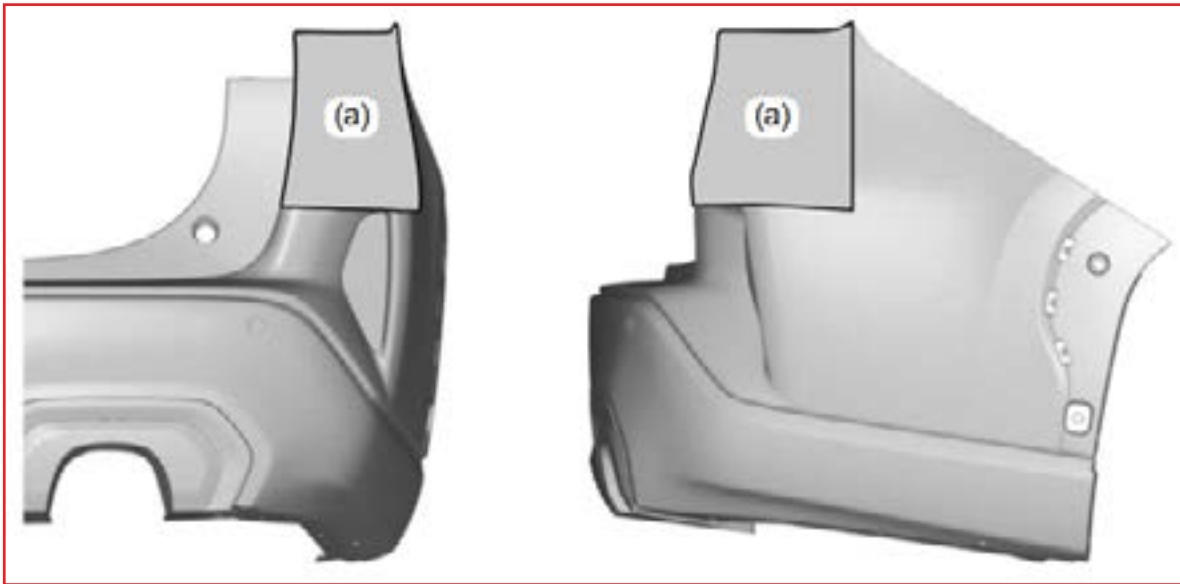
Prohibited Areas

In some rare cases, paint repair may be required on areas of the paint that may have had exposure to gasoline.

- Any presence of gasoline on painted surfaces should be removed immediately by flushing with a generous amount of water and use of mild soap as needed.
- In some cases mild staining can be removed by available paint safe cleaners or when necessary buffing and polishing
- More severe and aged staining may require sanding and refinishing
- Specific cautions apply if there is paint damage to the rear bumper surface in areas the Subaru Service Manual identifies as “Repair Prohibited Areas” (see image below). Damage in these areas requiring refinishing, will require rear bumper replacement. Cleaning, buffing and polishing is allowed in these areas (indicated as (a)).
