| | Safety Recall Campaign | 2026MY<br>K4 (CL4m) Hatchback<br>2027MY<br>Telluride (LQ2) |
| | SC364 | March 2026 |

SUBJECT: CENTER SEAT BELT ANCHOR BUCKLE  
INSPECTION AND/OR REPLACEMENT (SC364)

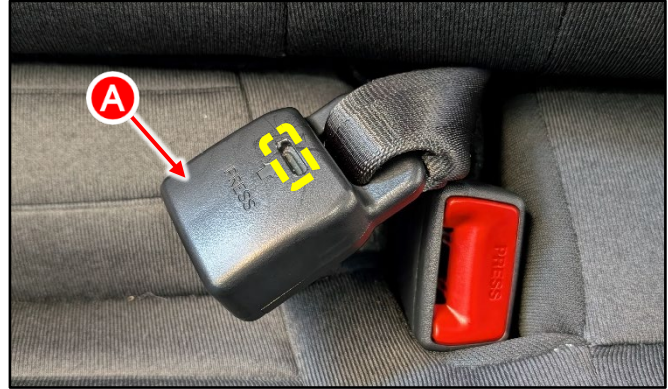
- 1a. **K4 (CL4m) Hatchback**  
Locate the rear center seat belt buckle (A).
  - 1b. **Telluride (LQ2)**  
Locate the 3<sup>rd</sup>-row center seat belt buckle.
  - 1c. **If needed**, release the seat belt from the seat belt buckle by pressing down the inner locking tab.
- Telluride: The extra seat belt buckle end may be inserted for use.
  - K4: The blade key or a flathead screwdriver may be used.
2. Separate the two (2) seat belt buckle (A) covers by inserting a non-marring pick tool between the center of the two areas shown.

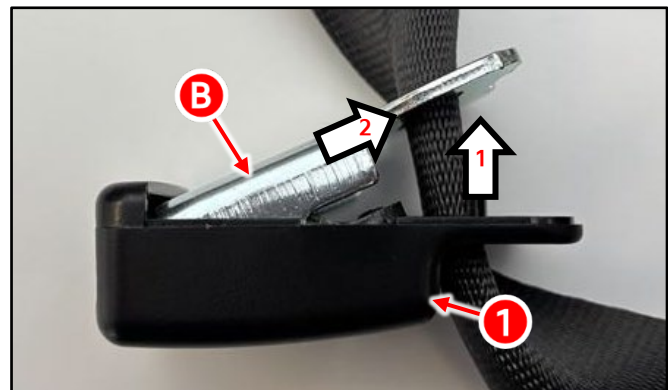
3. Slide the buckle cover (2) back
- 4a. First, lift the buckle plate assembly (B) up and away from the buckle cover (1).
  - 4b. Second, pull the buckle plate assembly (B) outward as shown to separate it from the buckle cover (1).

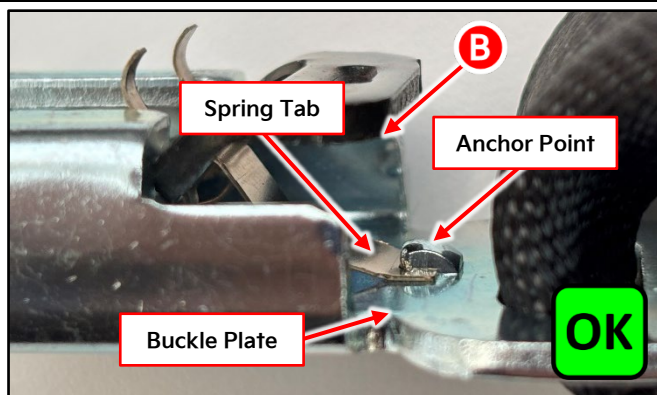
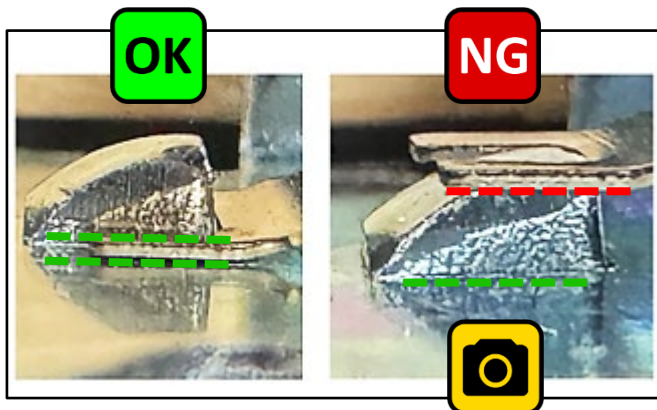
5. Locate the spring tab and anchor point area on the buckle plate assembly (B):

- The spring tab is properly seated against the anchor point and buckle plate surface (**OK**). If so, reassemble the seat buckle in the reverse order of removal and proceed to step 6.
- The spring tab is **not** properly seated against the anchor point and buckle plate surface (**NG**). If so, take a photo of the **NG** condition and attach it to the claim. Refer to the '**Repair Procedure**' below to replace the center seat buckle assembly and verify normal operation after replacement.

1. **K4 (CL4m):** Replace the **rear center** seat belt buckle assembly by referring to "Restraint → Seat Belt System → Seat Belt Reminder → Removal and Installation (Center)" in the applicable Shop Manual on KGIS.

**Telluride (LQ2):** Replace the **3<sup>rd</sup>-row center** seat belt buckle assembly by referring to "Restraint → Seat Belt System → Seat Belt Reminder → Removal and Installation" in the applicable Shop Manual on KGIS.

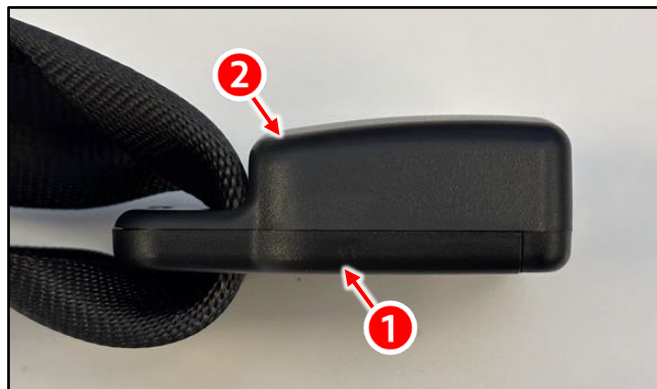
6. After reassembling the (**OK**) center seat belt buckle assembly, verify that the two (2) covers are properly aligned and secured (no gaps shown in between) and that the seat belt is properly looped through the buckle.
7. Verify normal operation of the center seat buckle assembly.
