# SAFETY RELATED RECALL

Global Recall Action  
Number: D113

| <b>Subject:</b><br><br><b>Defender 110 Third Row Seatbelt Mounting Bracket -<br/>Incorrect Specification</b> | Publication No.: D113 |
| | Model: Defender (LE) |

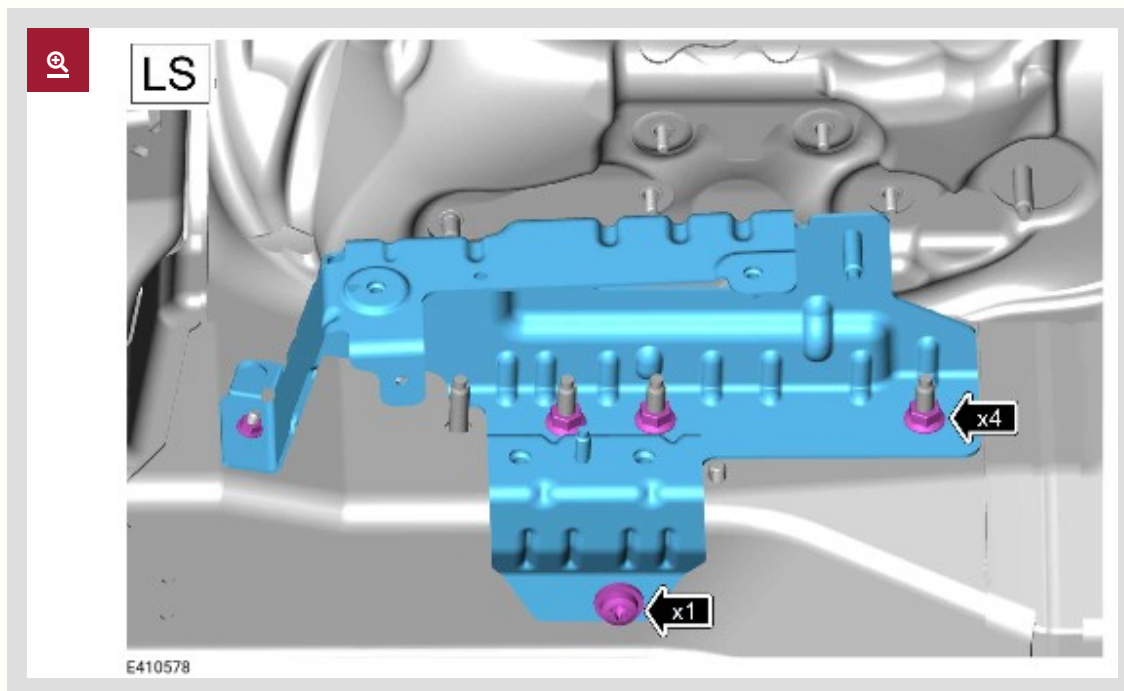
5. Remove the left side third row seatbelt anchor bracket.

- Remove the 4 nuts.
- Remove the bolt.

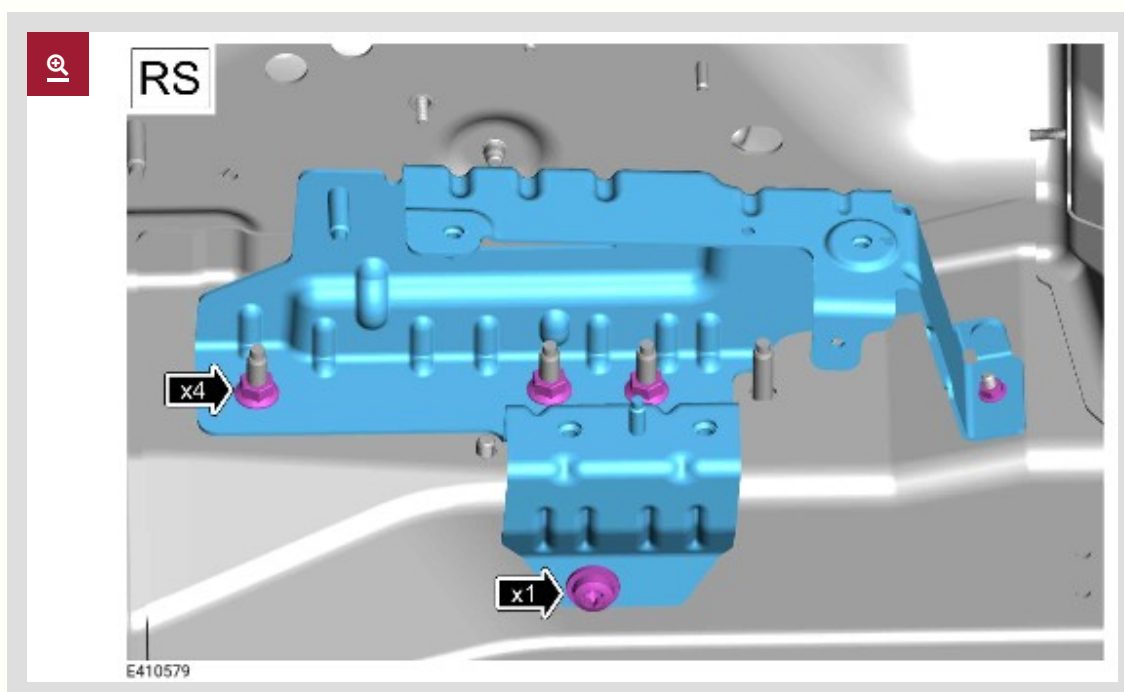
6. Remove the right side third row seatbelt anchor bracket.

- Remove the 4 nuts.
- Remove the bolt.

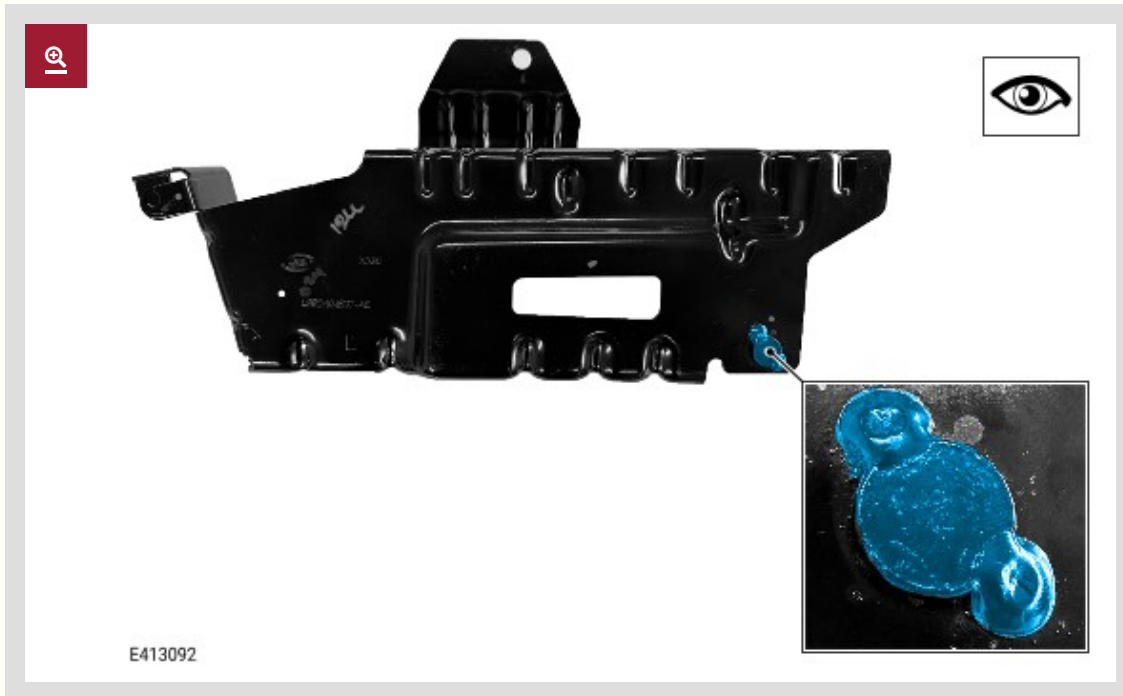
8. Identify the location of the existing stud to be reworked.

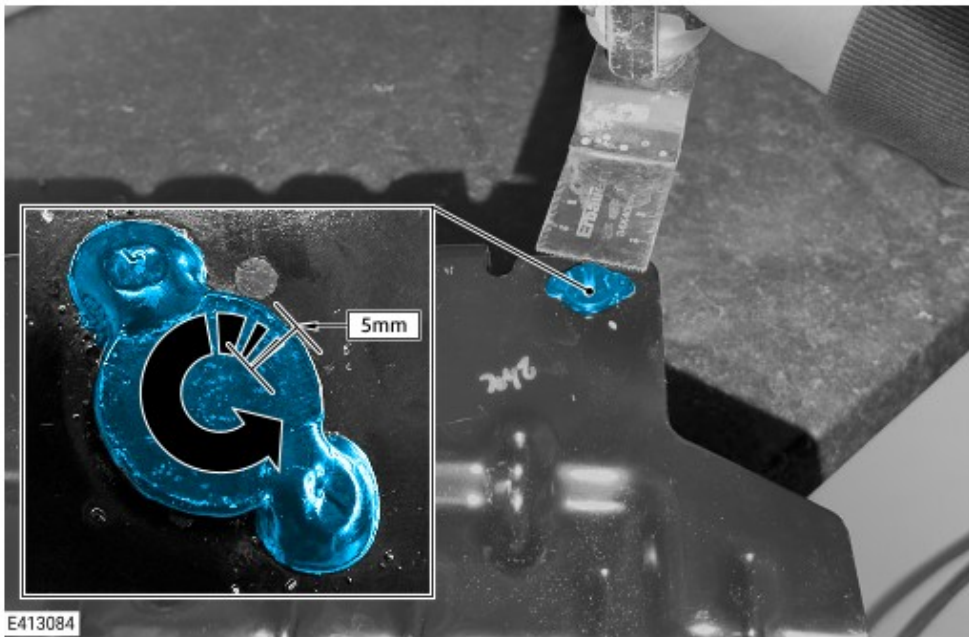
- Cut through the 2 welds securing the stud to the third row seatbelt anchor bracket.
- Cut a minimum of a 5 mm deep groove below the stud head and around the entire circumference of the stud.

- A titanium carbide or obsidian carbide oscillating multitool blade can help with this step but is not essential.
- The multitool blade must be flat to the surface of the third row seatbelt anchor bracket at all times.

Using an oscillating multitool with a suitable metal cutting blade, follow the instructions below.

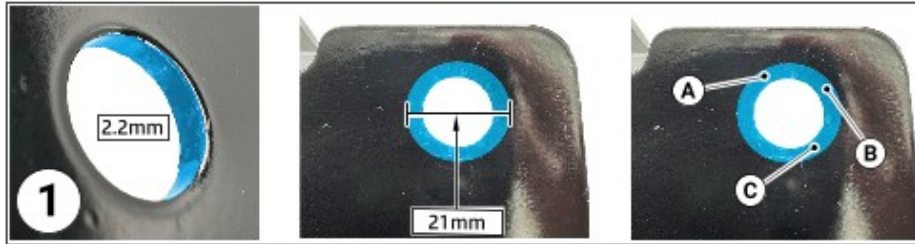
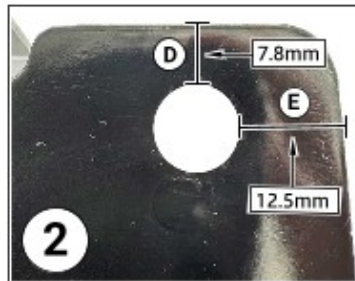
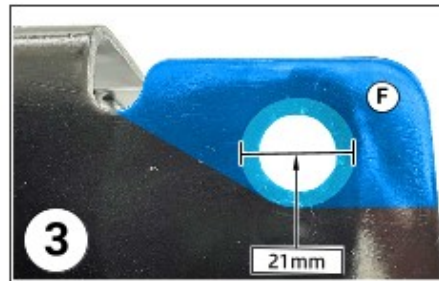
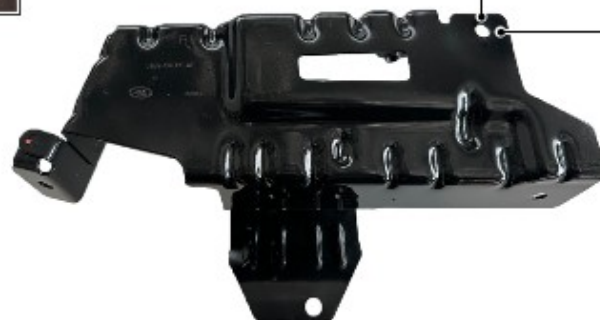
1. Using the images provided for reference, measure the thickness of the third row seatbelt anchor bracket. There must be a **minimum** thickness of 2.2 mm within the 21 mm perimeter around the drilled hole. Also, specifically measure the thickness of the areas marked A, B, and C. The deviation in thickness across points A, B, and C **MUST NOT** exceed 0.5 mm.

2. Measure from the edge of the drilled hole to the edge of the third row seatbelt anchor bracket, in the areas shown.
  - D) There **MUST** be a **minimum** of 7.8 mm from the edge of the drilled hole to the edge of the third row seatbelt anchor bracket, in the area shown.

- E) There **MUST** be a **minimum** of 12.5 mm from the edge of the drilled hole to the edge of the third row seatbelt anchor bracket, in the area shown.

3. Visually inspect the wider area of the third row seatbelt anchor bracket shown as Dark Blue in the illustration and marked F. Inspect for any incidental damage caused during steps 9 to 12. Any incidental damage present **MUST NOT** reduce the thickness of the third row seatbelt anchor bracket to less than 2.2 mm in the area shown.

4. Measure the diameter of the drilled hole. The diameter of the drilled hole **MUST** measure between 10.7 mm - 11.5 mm.

If **1 or more** of the below requirements cannot be achieved, a new third row seatbelt anchor bracket **MUST** be installed, continue to quarantine the vehicle and await a further communication. Do **NOT** install any third row seatbelt anchor bracket which does not meet **1 or more** of the below requirements.

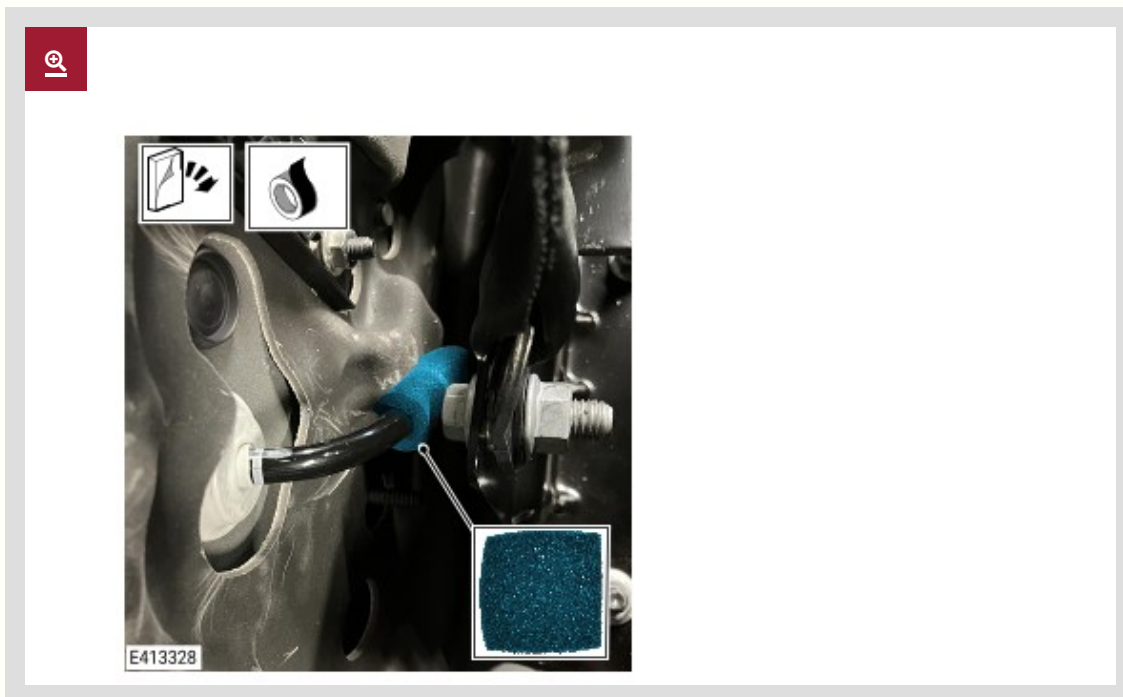
The energy absorbing foam tape foam is required prevent any contact between the air suspension pipe and the head of the bolt.

Install the energy absorbing foam tape.

- Install the energy absorbing foam tape onto the air suspension pipe, as shown in the illustration.
- Apply a suitable anti-abrasion tape to the foam [Noise, Vibration and Harshness \(NVH\)](#) pad.
