# SAFETY RELATED RECALL

Global Recall Action  
Number: **D113v1**

<b>Subject:</b>  <b>Defender 110 Third Row Seatbelt Mounting Bracket - Incorrect Specification</b>	<b>Publication No.:</b> D113v1
	<b>Model:</b> Defender (LE)
	<b>Model Year:</b> 2026
	<b>Date of Issue:</b> 13 April 2026

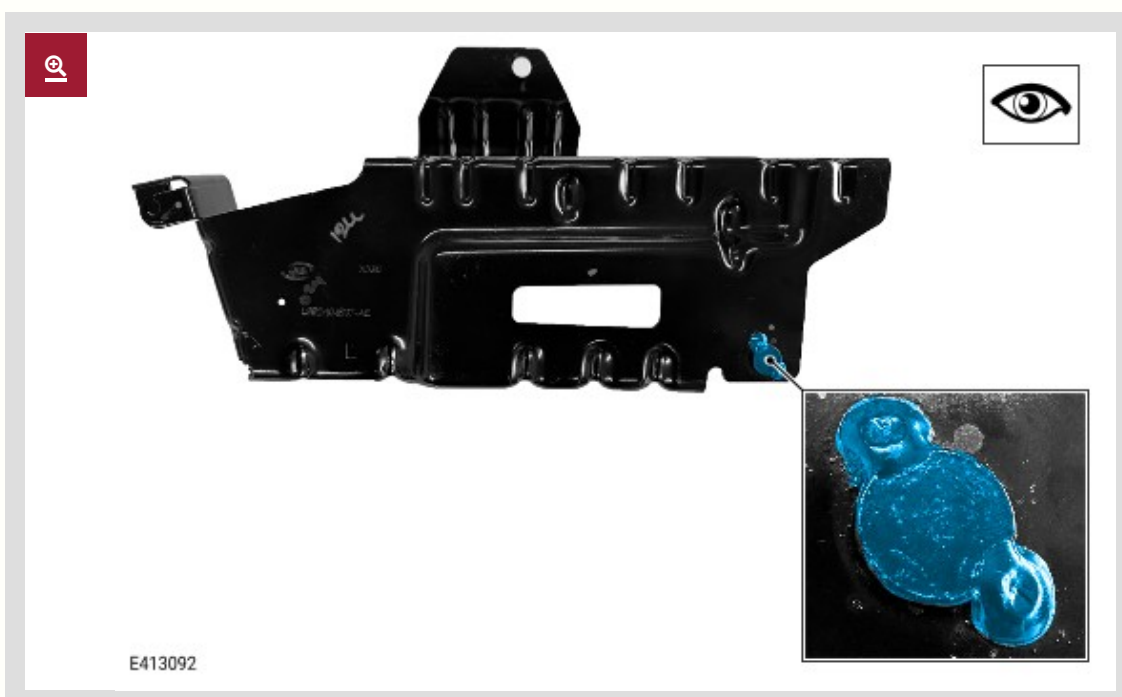
8. Identify the location of the existing stud to be reworked.

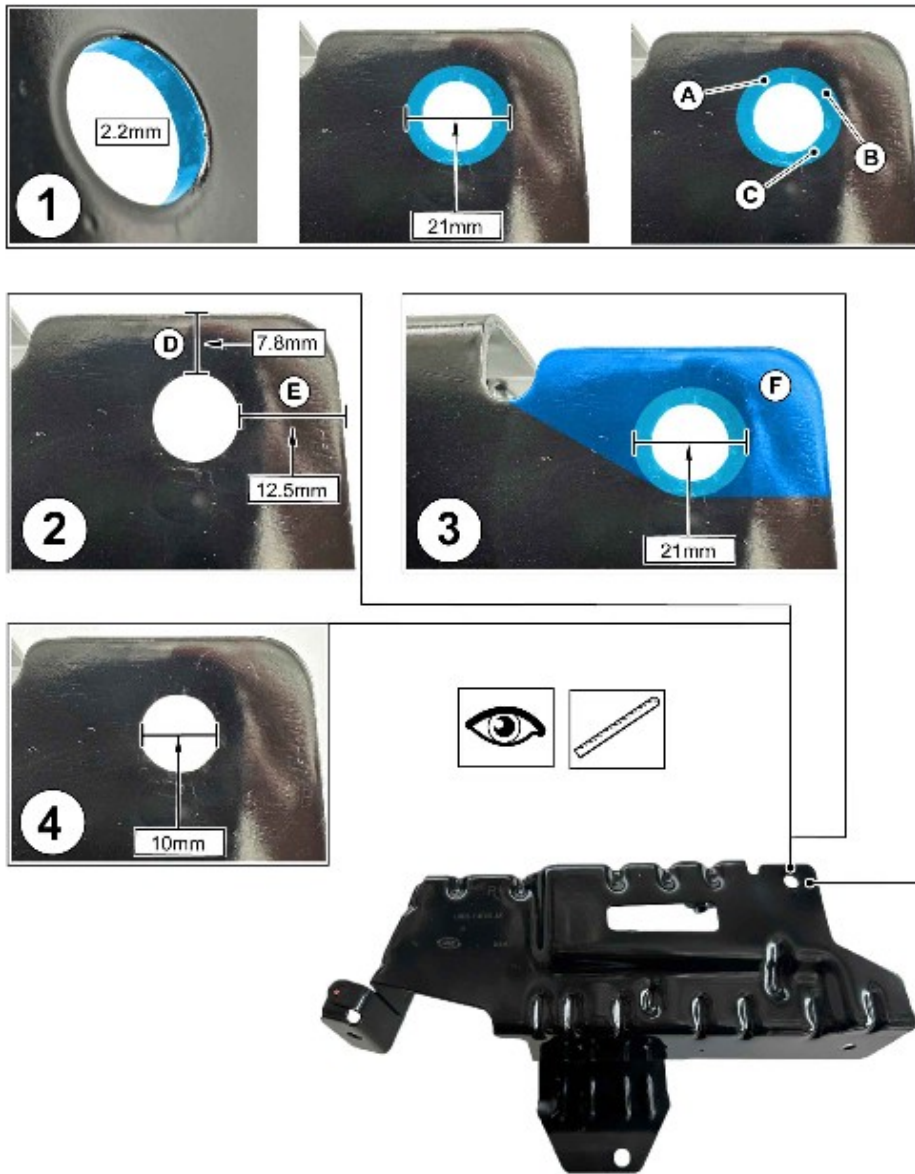
1. Using the images provided for reference, measure the thickness of the third row seatbelt anchor bracket. There must be a **minimum** thickness of 2.2 mm within the 21 mm perimeter around the drilled hole. Also, specifically measure the thickness of the areas marked A, B, and C. The deviation in thickness across points A, B, and C **MUST NOT** exceed 0.5 mm.

2. Measure from the edge of the drilled hole to the edge of the third row seatbelt anchor bracket, in the areas shown.
  - D) There **MUST** be a **minimum** of 7.8 mm from the edge of the drilled hole to the edge of the third row seatbelt anchor bracket, in the area shown.

- E) There **MUST** be a **minimum** of 12.5 mm from the edge of the drilled hole to the edge of the third row seatbelt anchor bracket, in the area shown.

3. Visually inspect the wider area of the third row seatbelt anchor bracket shown as Dark Blue in the illustration and marked F. Inspect for any incidental damage caused during steps 9 to 12. Any incidental damage present **MUST NOT** reduce the thickness of the third row seatbelt anchor bracket to less than 2.2 mm in the area shown.

4. Measure the diameter of the drilled hole. The diameter of the drilled hole **MUST** measure between 10 mm - 10.5 mm.

If **1 or more** of the below requirements cannot be achieved, a new third row seatbelt anchor bracket **MUST** be installed, continue to quarantine the vehicle and await a further communication. Do **NOT** install any third row seatbelt anchor bracket which does not meet **1 or more** of the below requirements.
