**SAFETY RELATED RECALL**Global Recall Action  
Number: D113v2

| <b>Subject:</b><br><br><b>Defender 110 Third Row Seatbelt Mounting Bracket - Incorrect Specification</b> | Publication No.: D113v2 |
| | Model: Defender (LE) |
| | Model Year: 2026 |

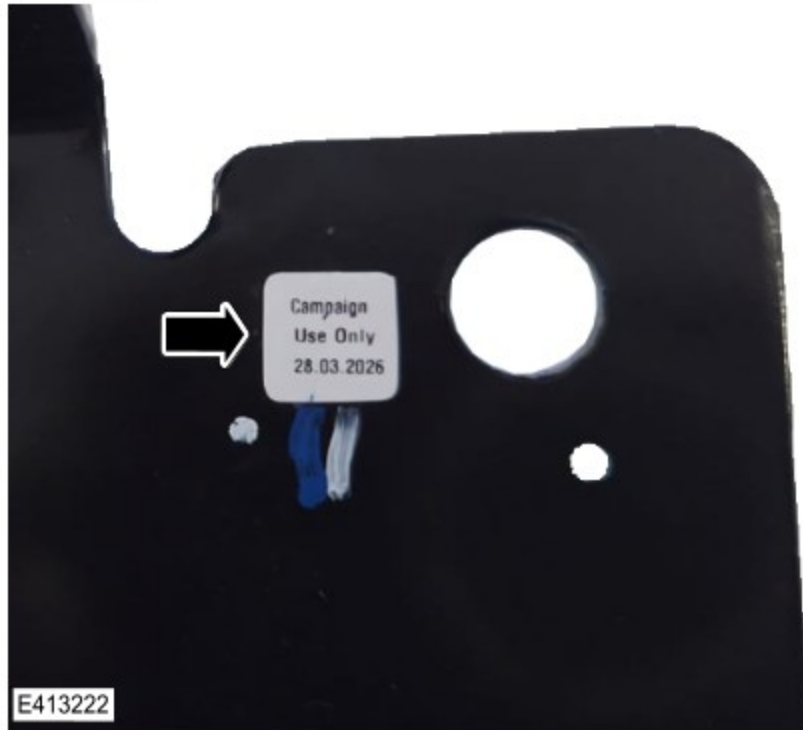
1. Part numbers 522123473 and 522123474 **MUST** have the sticker stating '**Campaign Use Only**' as shown in the illustration.
