## IMPORTANT SAFETY RECALL

NHTSA Recalls No. 26V-167, 26E-016

## SN-737

SUBJECT: *Pole Guide 450543 Plate Weldment*

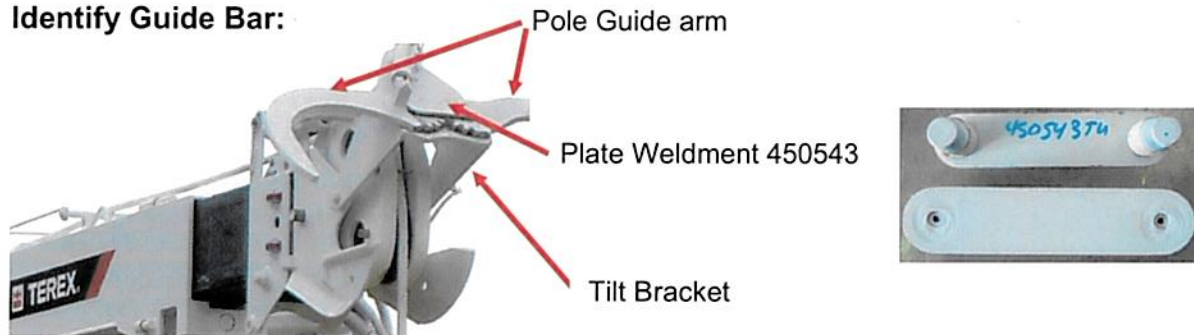
### **Identify Guide Bar:**

1. The top surface of the bar will have a grease zerk.
2. The grease zerk will be on the upper side above the pole guide arms not recessed.

Affected Plate Weldment 450543, may be on machines which use these Pole Guide assemblies: 9143641, 618527, 608863, 494477, 491558, 488466, 483997, 481644, 479606, 479604, 469357, 464832, 463513, 458141, 479606HDG, 403186, or purchased as replacement parts.

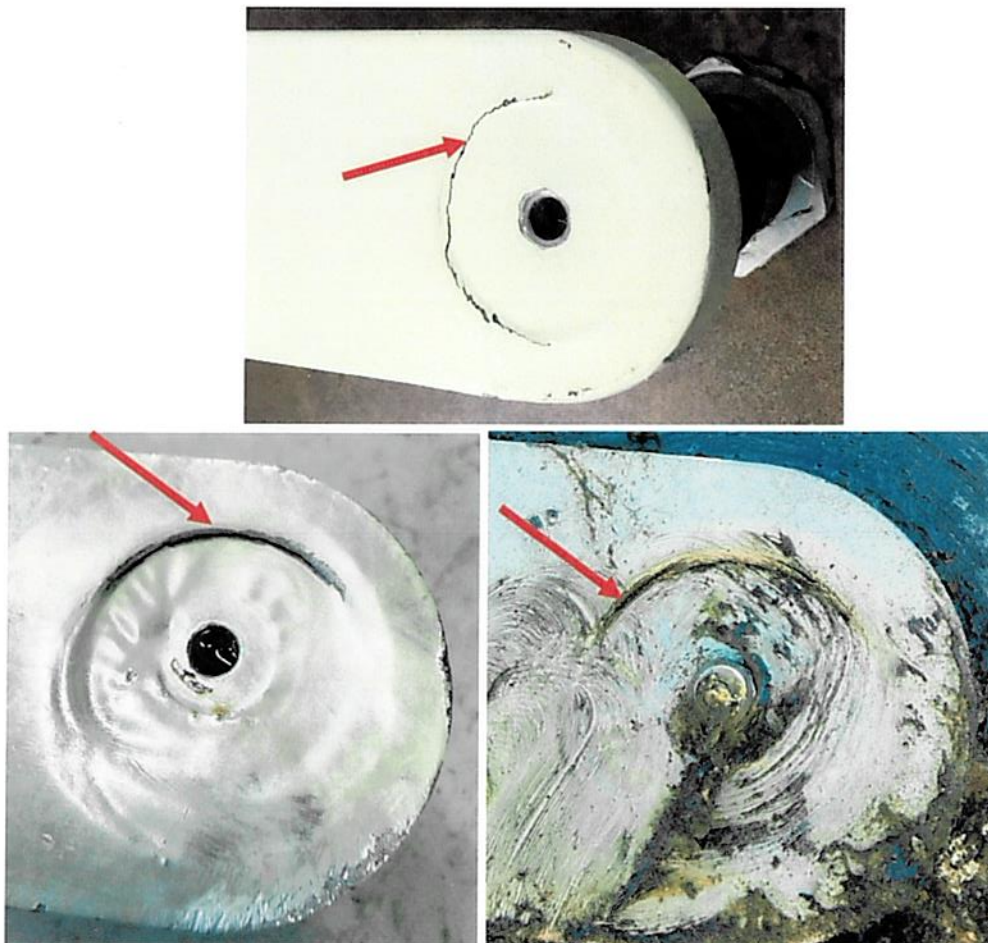
### **Examples of cracks:**

The 450543 Plate Weldment attaching the pole guide arms to the pole guide tilt bracket may have an issue with weld quality on units built and replacement parts purchased from January 2019 to February 10, 2026. All plate weldments must be inspected for cracks and replaced if cracks are found. **If cracks develop the stud holding the pole guide arm can separate and allow the pole guide arm to fall. If the pole guide arm falls it can cause injury to ground personnel.**

Terex will provide a replacement plate weldment (Z1523) for parts which show a crack at no cost to the owner, for a period of 4 years from the issuance of this safety notice..

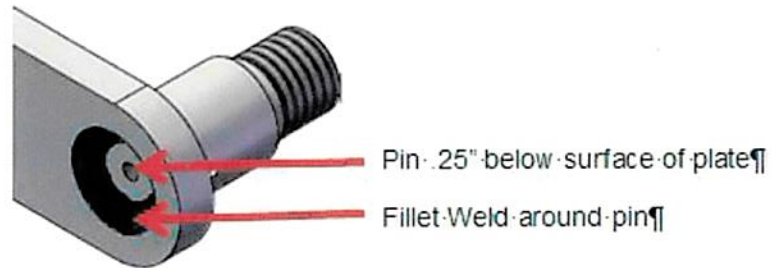
1. Weldments with a fillet weld around the pin and the top of the pin recessed below the surface of the bar.

Fillet weld around recessed pin

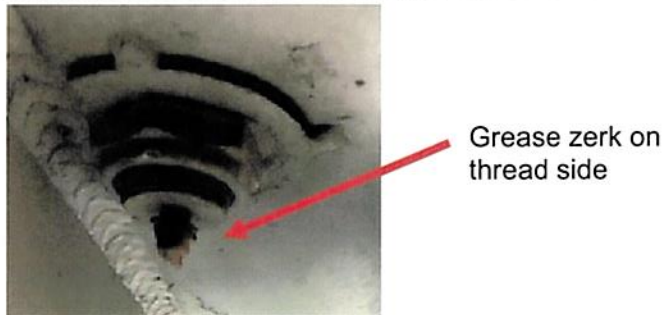
2. The zerk is on the threaded side next to the nut, or there is no zerk on either end of both pins.

Grease zerk on thread side
