| <b>NHTSA Recall:</b> | 26V-174 | <b>Product:</b> | Lineage Power Entry Steps |
| <b>TC Recall:</b> | 2026-164 | <b>Repair Time:</b> | 0.5h |

## Purpose

This document outlines the procedure to reinstall the power entry step switch on affected Lineage motorhome units. The original configuration installs the plunger switch in the door and the magnetic sensor on the hinge; this repair discards the magnetic sensor and relocates the plunger so that the plunger is installed on the hinge and the contact plate is installed in the door.

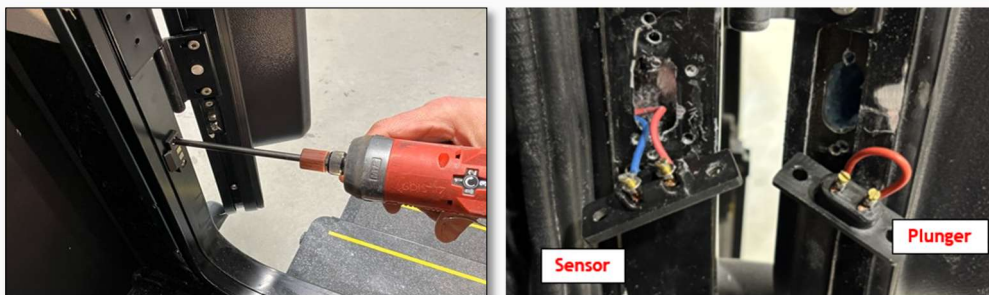
**Fig. 2** — Magnetic sensor (hinge side) and plunger switch (door side) removed to expose wiring.

**Step 1** — Remove the mounting screws from both the magnetic sensor and the plunger switch, and pull each unit out far enough to access its wiring.

**Step 2** — Using a flathead screwdriver, loosen the wire connections on both the magnetic sensor and the plunger switch.

***Note:** Inspect the wires on the hinge side of the door for missing or broken strands. Cut and re-strip as necessary before proceeding.*
