Noncompliance Turn Lights

Recall 203

Description RECALL #203 NONCOMPLIANT LIGHTS

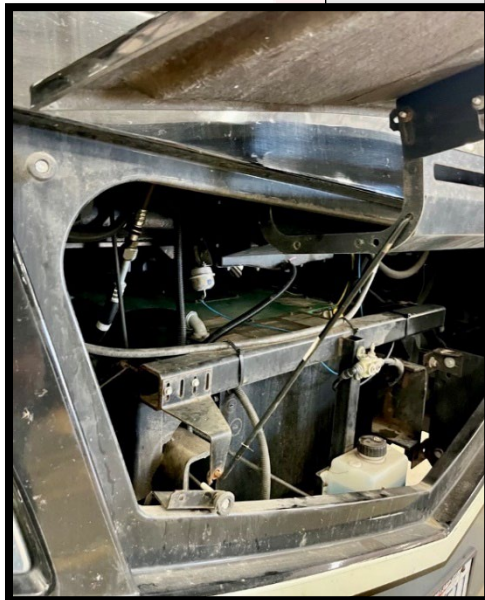
Figure 1

Some Winnebago vehicles have front turn signal lamps that do not meet the luminous lens area requirements, resulting in non-compliance with Federal Motor Vehicle Safety Standard FMVSS No. 108, regarding lamps and reflective devices. The smaller lens may hinder visibility for other drivers, thereby increasing the risk of a collision.

Step 1 – Open the hood to gain access to the back side of the turn signals (See Figure 1). Some vehicle models may require access to the lights through under the front-end panel.
