# Campaign Service BULLETIN

**BULLETIN NUMBER:**  
CB26-N-001

## IMPORTANT SAFETY RECALL

### N-SERIES CAB AND CHASSIS HARNESS – 26V-210

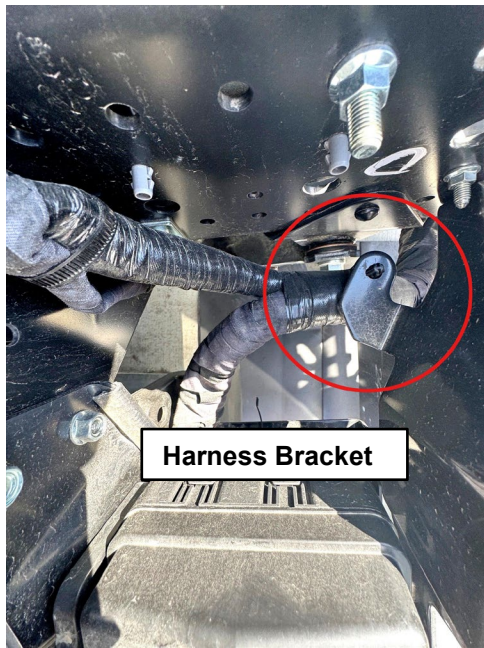
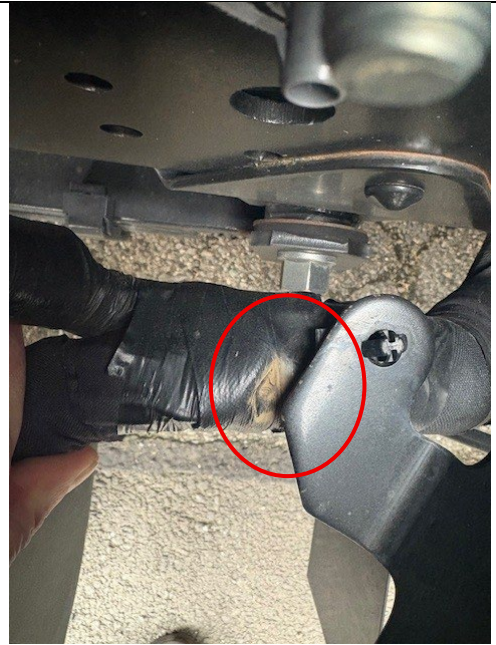
5. **Single Cab Models** - from the top view, locate the wiring harness under the harness bracket tab and check for any damage. (See Figures 4 and 5.)

**Crew Cab Models** - from the side view, look past and between the fuse box and fuel sedimenter to locate the harness under the harness bracket tab. Use a telescoping inspection mirror and a flashlight to check for any damage. (See Figures 4 and 5.)

- b. If the harness is chafed but does not have any exposed bare wiring, wrap the affected area with Tesa tape 51006 and continue to the next step.
- c. If bare wiring is exposed, stop and take a digital photo of the damaged area. Make notation of the damage on your repair order and continue to the next step.

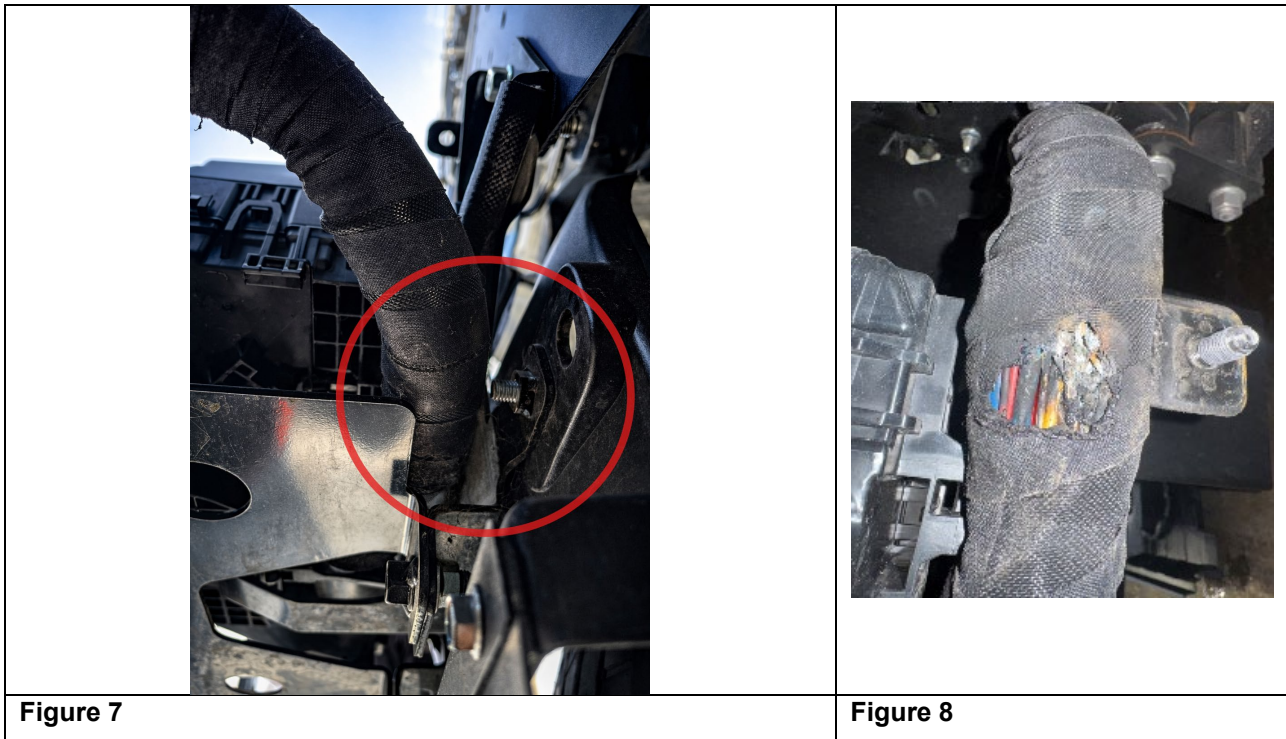
7. From underneath the fuse box, locate the wiring harness near the mud flap bolt and check for any damage. (See Figures 7 and 8.)
- If there is no noticeable damage to the harness, continue to the next step.
  - If the harness is chafed but has not exposed any bare wiring, wrap the affected area with Tesa tape 51006 and continue to the next step.
  - If bare wiring is exposed, stop and take a digital photo of the damaged area. Make notation of the damage on your repair order and skip to Step 10.

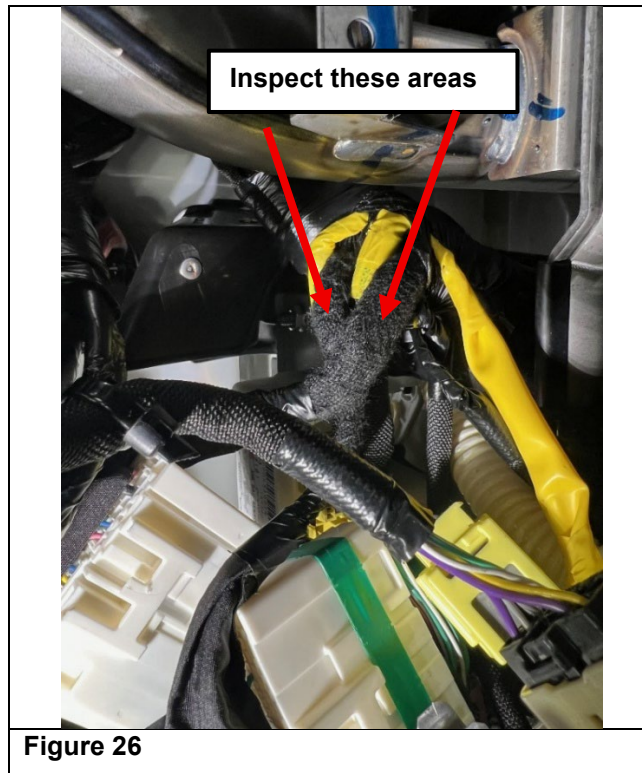
28. Inspect each black wiring harness going to H98 and H99 for signs of chafing. (See Figure 26.)

- a. If there is no noticeable damage to the harness, continue to the next step.
- b. If the harness is chafed but has not exposed any bare wiring, wrap the affected area with Tesa tape 51006 and continue to the next step.
- c. If bare wiring is exposed, stop and take a digital photo of the damaged area. Make notation of the damage on your repair order and continue to the next step.
