# Campaign Service BULLETIN

**BULLETIN NUMBER:**  
CB26-N-002

### **NRR-EV CAB HARNESS EXPANDED SAFETY RECALL – 26V-210 (Transport Canada 2026-386)**

- 2025-2026MY Isuzu NRR-EV (Electric Vehicles)

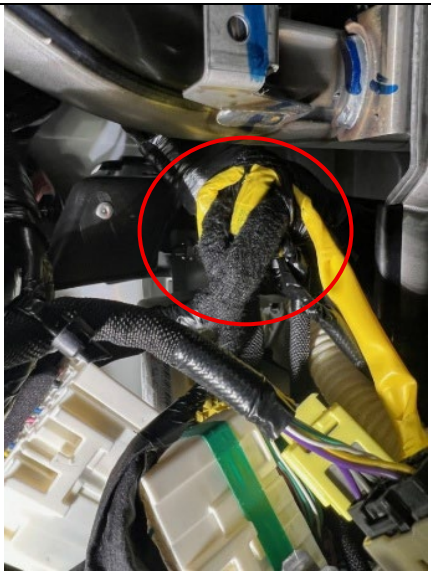
| <p><b>Step 21 – Inspection (H98 &amp; H99 Connector Harness)</b> may be previously repaired if V2602EV is already closed.</p> | <p><b>Step 28 – Inspection (Harness Above Accelerator Pedal)</b></p> | <p><b>Step 40 – Inspection (Module Stack Harness Point A)</b></p> |

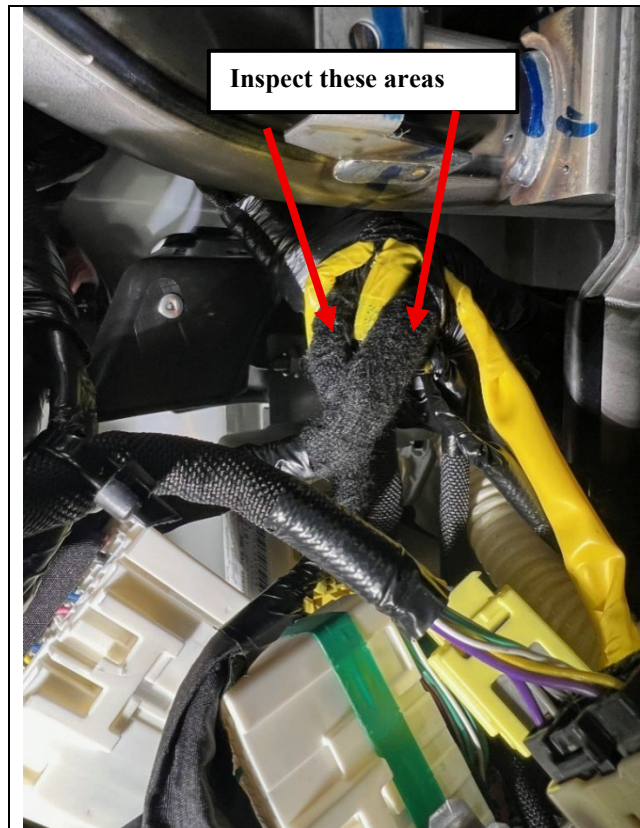
**Figure 17**

21. Inspect each black wiring harness going to H98 and H99 for signs of chafing. (See Figure 17.)

- a. Any harness chafing that has not damaged the colored insulation should be rewrapped with Tesa tape 51006. After wrapping continue to the next step.
- b. If bare wiring is exposed, stop and take a digital photo of the damaged area. Make notation of the damage on your repair order and skip to Step 58.

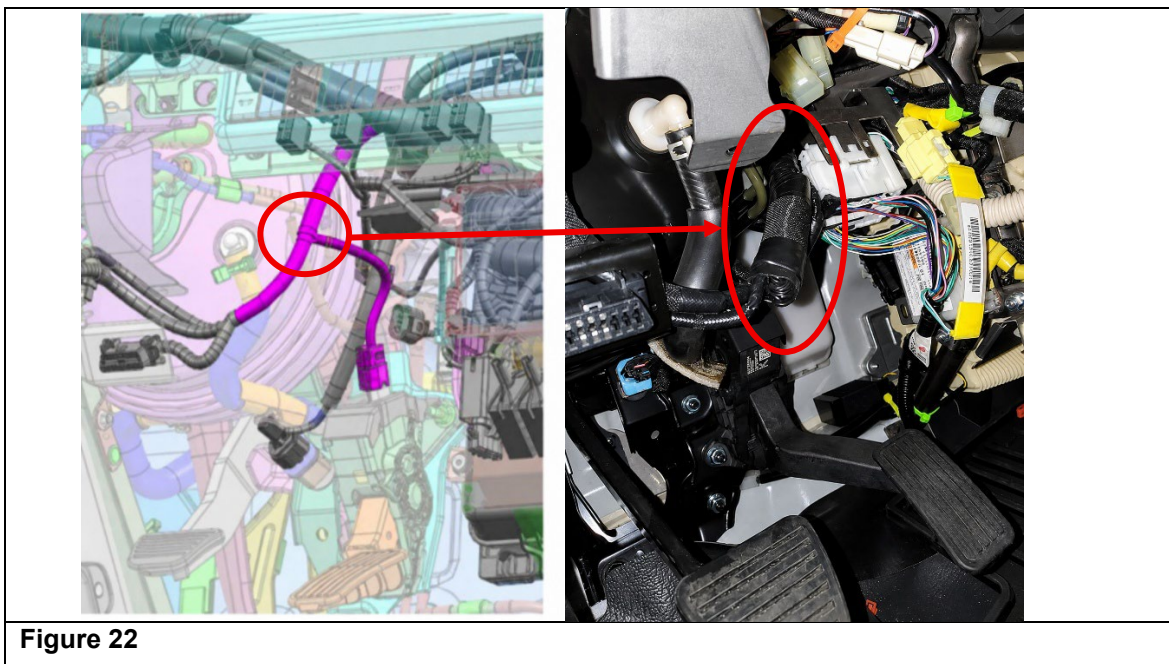
28. Inspect the wiring harness branch above the accelerator pedal for any signs of chafing. (See Figure 22.)
- If there is no noticeable damage to the harness, continue to the next step.
  - If the harness is chafed but has not exposed any bare wiring, wrap the affected area with Tesa tape and continue to the next step.
  - If bare wiring is exposed, stop and take a digital photo of the damaged area. Make notation of the damage on your repair order and skip to Step 58.

29. Prepare a strip of Tesa tape about 16" inches long.
30. Wrap the strip of Tesa tape to the wiring harness as shown. Tape the accelerator pedal branch harness going together with the main wiring harness. (See Figures 34 and 35.)

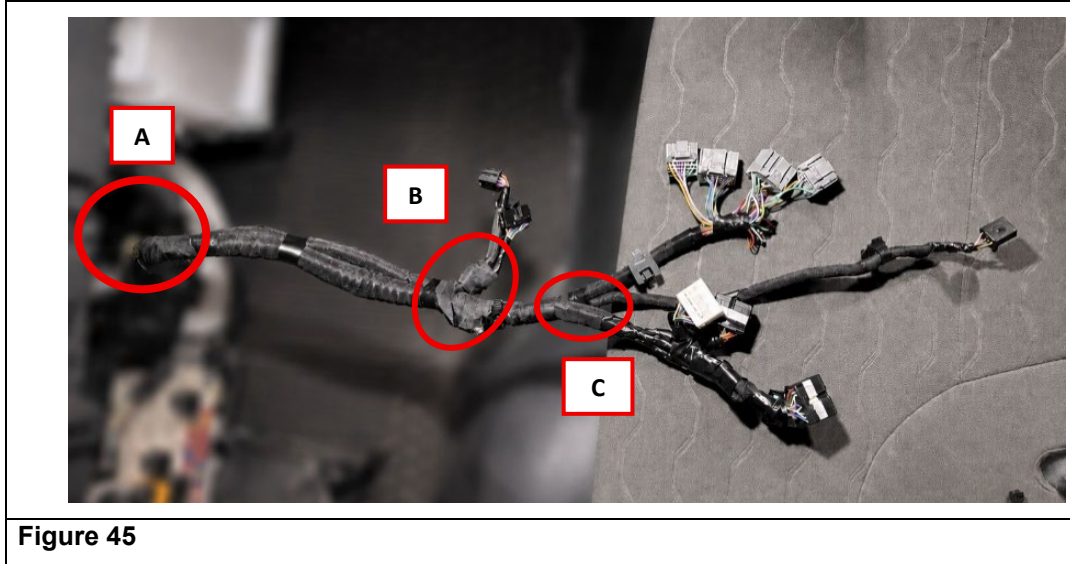
40. Inspect the three locations: [A] Root of the branch to the unit assembly harness [B] Branch to the I/O Controller and BCM [C] CGW branch on the harness for signs of chafing. (See Figure 45.)
- If there is no noticeable damage to the harness in any location, continue to the next step.
  - If the harness is chafed but has not exposed any bare wiring in any location, wrap the affected area with Tesa tape and continue to the next step.
  - If bare wiring is exposed in any location, stop and take a digital photo of the damaged area. Make notation of the location that is damaged on your repair order and skip to Step 58.

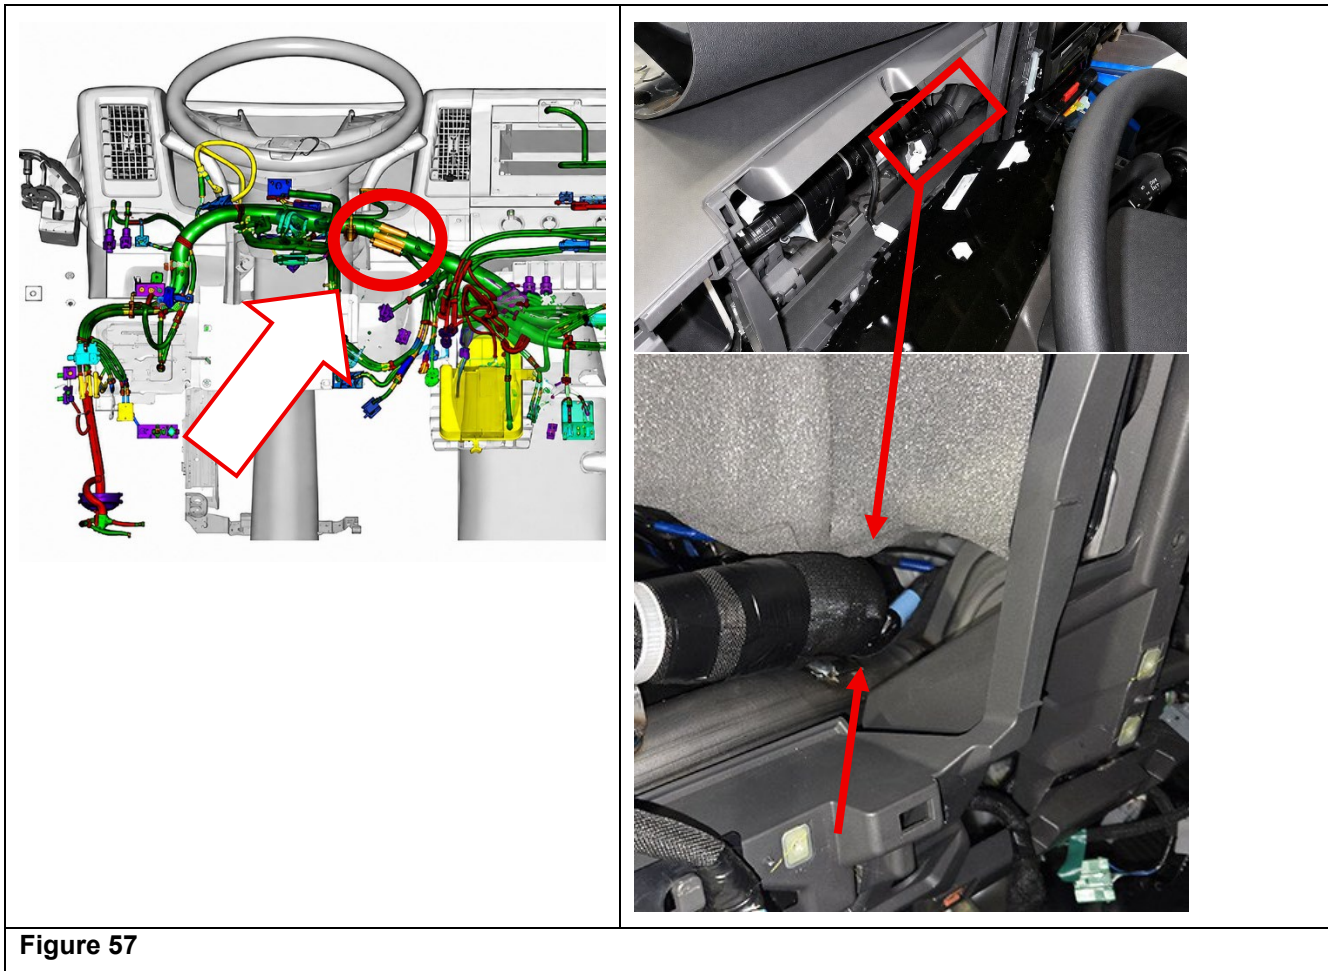
57. Inspect the harness branch behind the IPC for chafing in the area shown. (See Figure 57.)

- If there is no noticeable damage to the harness, continue to Step 59.
- If the harness is chafed but has not exposed any bare wiring, prepare the **band clip with protective tape** and continue to Step 59.
- If bare wiring is exposed, stop and take a digital photo of the damaged area. Make notation of the damage on your repair order and continue to the next step.
