# Campaign Service

**BULLETIN NUMBER:**  
CB26-G-001

## IMPORTANT SAFETY RECALL

### NRR-EV CAB HARNESS – V2602EV

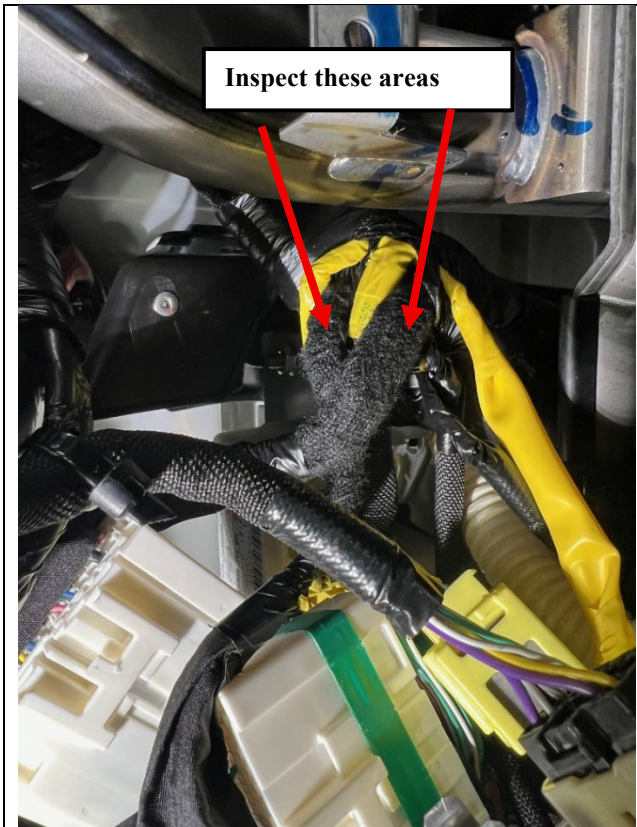
Figure 16

21. Inspect each black wiring harness going to H98 and H99 for signs of chafing. (See Figure 16.)

- a. Any harness chafing that has not damaged the colored insulation should be rewrapped with Tesa tape 51006. After wrapping continue to the next step.
- b. If harness chafing has exposed bare wiring, stop and take a digital photo of the damaged area. Then contact Technical Assistance either by phone or by using Isuzu Connect. Explain the extent of the damage and provide the photo for review. Additional direction will be provided as quickly as possible.
