# Campaign Service BULLETIN

**BULLETIN NUMBER:**  
CB26-N-001A

### **N-SERIES CAB AND CHASSIS HARNESS EXPANDED SAFETY RECALL – 26V-210**

- 2025-2027MY Isuzu N-Series Vehicles (Equipped with Diesel Engines)

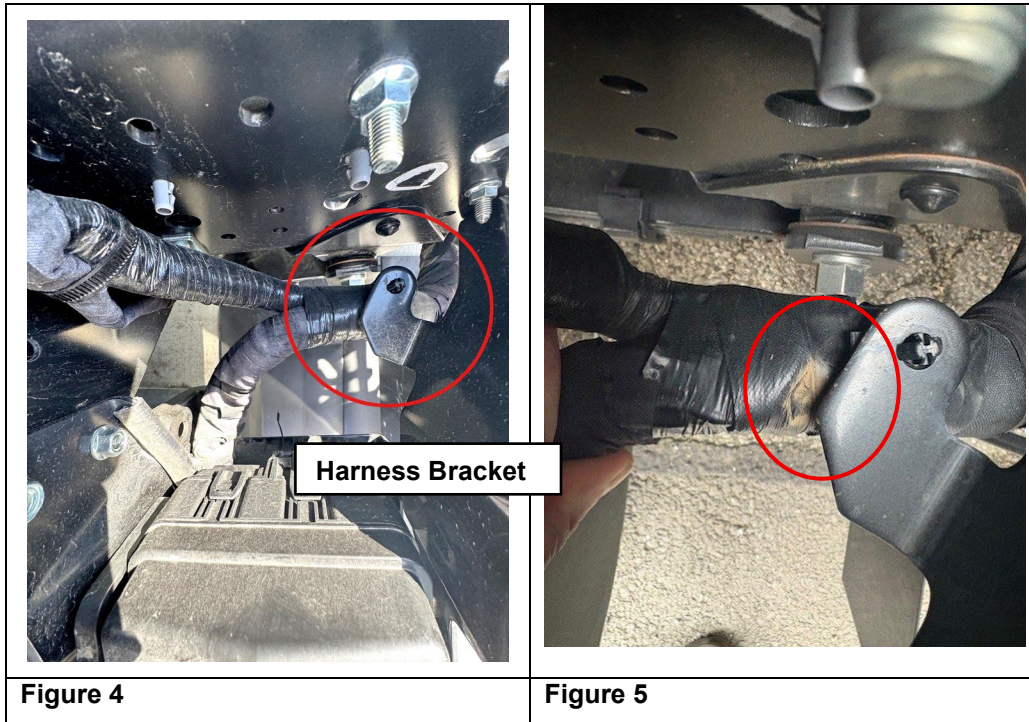
5. **Single Cab Models** - from the top view, locate the wiring harness under the harness bracket tab and check for any damage. (See Figures 4 and 5.)

**Crew Cab Models** - from the side view, look past and between the fuse box and fuel sedimenter to locate the harness under the harness bracket tab. Use a telescoping inspection mirror and a flashlight to check for any damage. (See Figures 4 and 5.)

- a. If there is no noticeable damage to the harness, continue to the next step.
- b. If the harness is chafed but does not have any exposed bare wiring, wrap the affected area with Tesa tape and continue to the next step.
- c. If bare wiring is exposed, stop and take a digital photo of the damaged area. Make a notation of the damage on your repair order and continue to the next step.

6. Install an edge protector by pushing it onto a clean harness bracket that is free of any dirt or debris as shown in Figure 6 until it is completely seated.

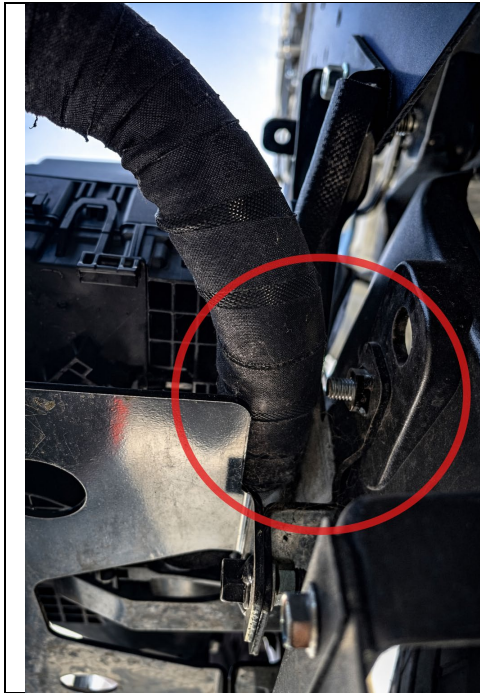
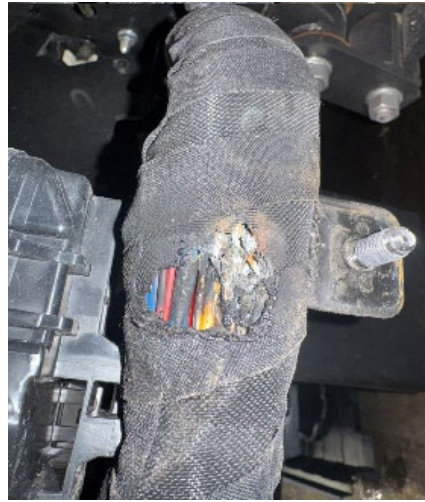
Figure 7

7. From underneath the fuse box, locate the wiring harness near the mud flap bolt and check for any damage. (See Figures 7 and 8.)
- If there is no noticeable damage to the harness, continue to the next step.
  - If the harness is chafed but has not exposed any bare wiring, wrap the affected area with Tesa tape and continue to the next step.
  - If bare wiring is exposed, stop and take a digital photo of the damaged area. Make notation of the damage on your repair order and skip to Step 10.

8. Insert the tie strap into the center tab of the bottom of the fuse box in the exact orientation shown in Figure 9. Wrap the tie strap around the outside of the harness, route it back and insert the end into the tie strap clip, and cinch tight. (See Figure 10.)

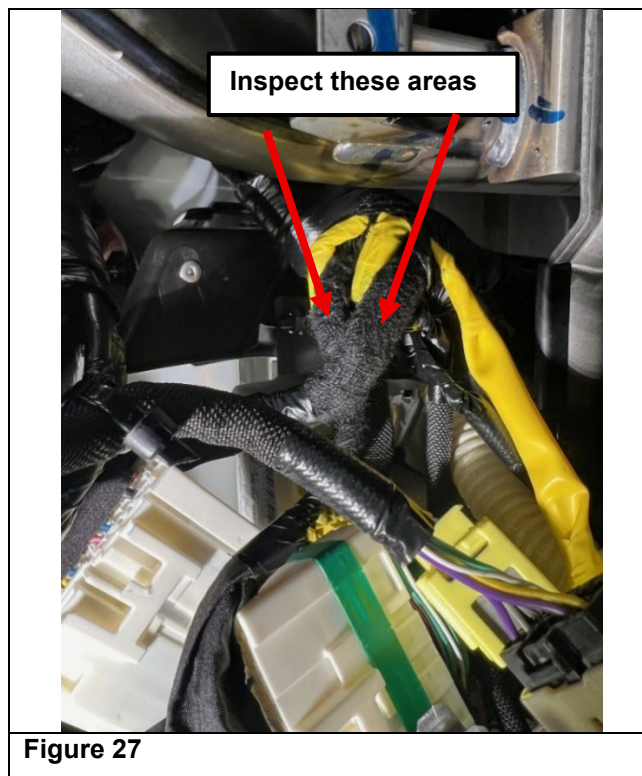
28. Inspect each black wiring harness going to H98 and H99 for signs of chafing. (See Figure 27.)

- a. If there is no noticeable damage to the harness, continue to the next step.
- b. If the harness is chafed but has not exposed any bare wiring, wrap the affected area with Tesa tape and continue to the next step.
- c. If bare wiring is exposed, stop and take a digital photo of the damaged area. Make notation of the damage on your repair order and skip to Step 66.

30. Use a strip of Tesa tape to tape the black wiring harness going to H99 to the right-hand side of H99. (See Figures 28 and 29.)

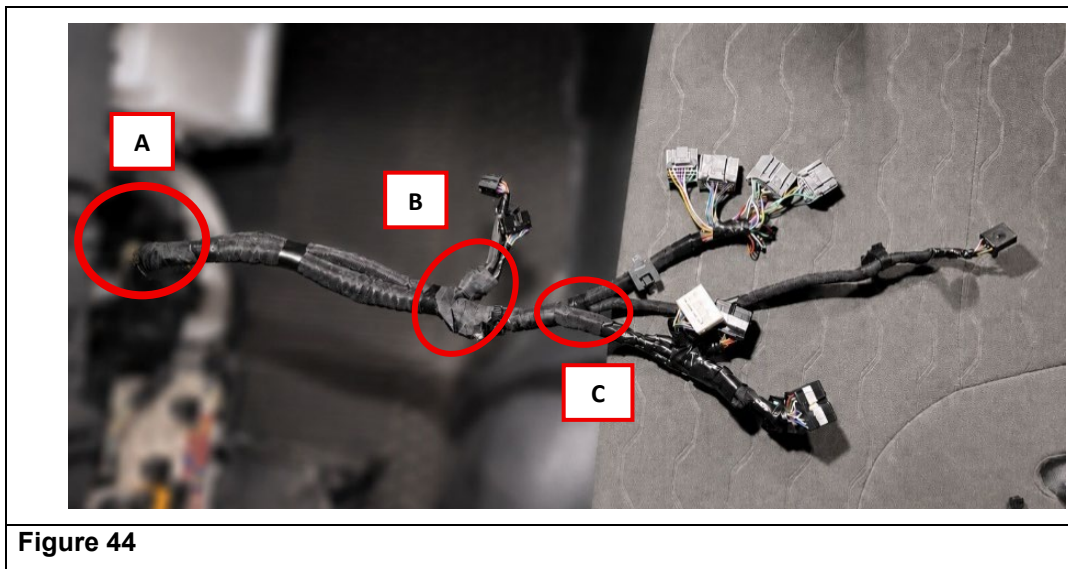
47. Inspect the three locations: [A] Root of the branch to the unit assembly harness [B] Branch to the I/O Controller and BCM [C] CGW branch on the harness for signs of chafing. (See Figure 44.)

- If there is no noticeable damage to the harness in any location, continue to the next step.
- If the harness is chafed but has not exposed any bare wiring in any location, wrap the affected area with Tesa tape and continue to the next step.
- If bare wiring is exposed in any location, stop and take a digital photo of the damaged area. Make notation of the location that is damaged on your repair order and skip to Step 66.

49. Location [A]: Wrap the Tesa tape from the branch root to the end of the factory harness braided sleeving as shown. (See Figure 45.)

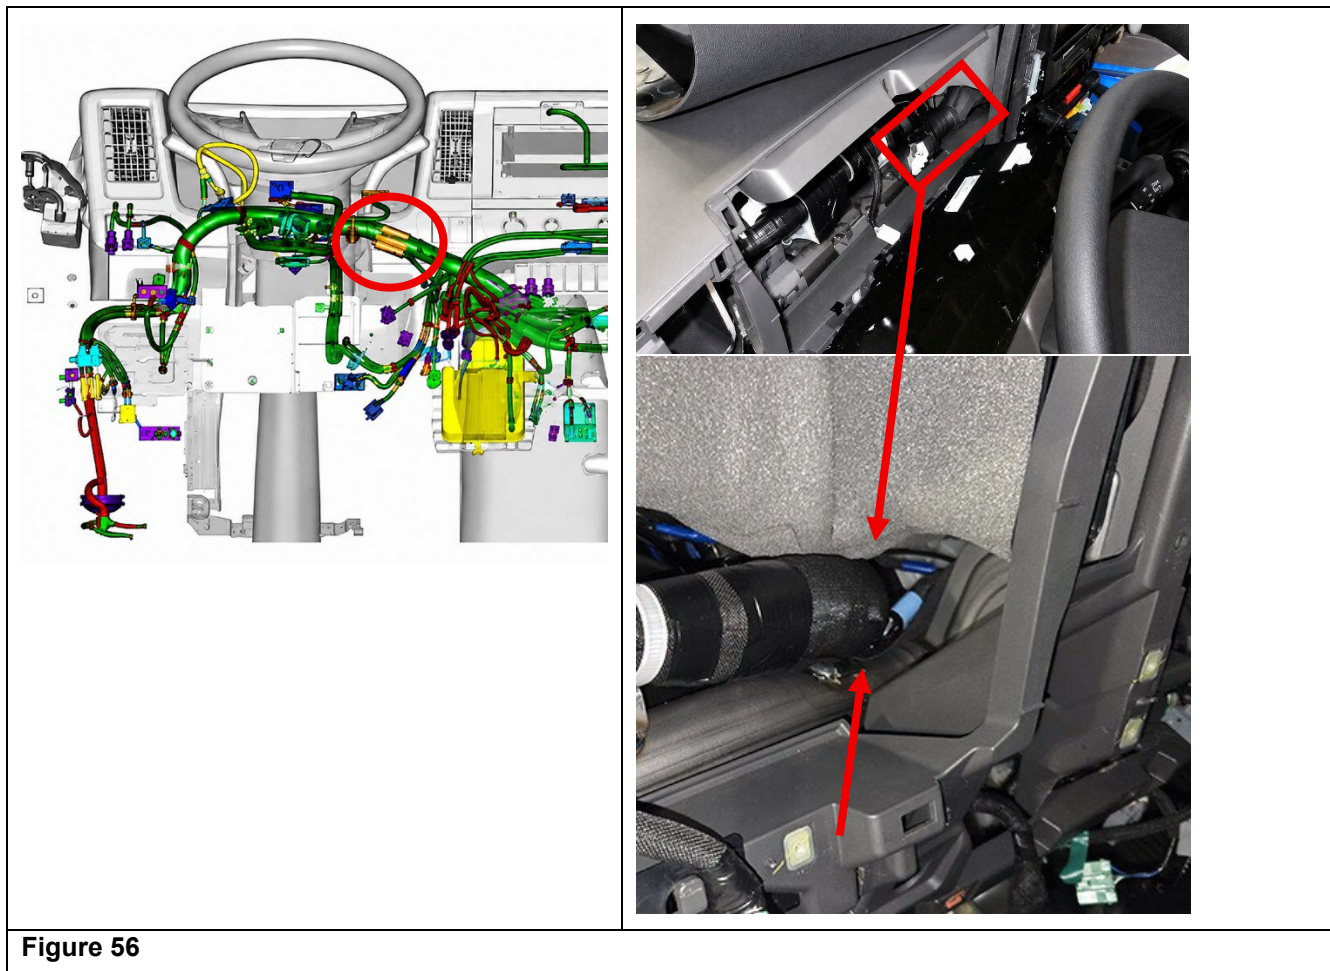
65. Inspect the harness branch behind the IPC for chafing in the area shown. (See Figure 56.)

- a. If there is no noticeable damage to the harness, continue to Step 67.
- b. If the harness is chafed but has not exposed any bare wiring, prepare the **band clip with protective tape** and continue to Step 67.
- c. If bare wiring is exposed, stop and take a digital photo of the damaged area. Make notation of the damage on your repair order and continue to the next step.

66. If any inspection revealed bare wiring, refer to the “Preface” for additional information about photos and inspection step numbers to Isuzu Technical Assistance (TAC) via “Isuzu Connect”. TAC will respond via “Isuzu Connect” with additional instructions. After completing additional repairs be sure to complete any skipped steps and continue through the remainder of the bulletin.
67. Place the band clip with protective tape between the harness and the reinforcement bar. (See Figure 57.) Using both hands, slide the band clip with protective tape towards the right of the harness until it reaches the base of the wire branch with blue tape. (See Figure 58.) After confirming that the harness is fully protected, tighten and lock the band clip around the wiring harness.

**NOTE: The band clip with protective tape should act as a barrier between the base of the blue-taped branch that is only covered by electrical tape or exposed wiring.**
