GROUP	MODEL
Safety Recall Campaign	2022-2026MY Carnival (KA4)
NUMBER	DATE
SC368	June 2026

# HIGH-PRESSURE CROSS-OVER FUEL PIPE TORQUE INSPECTION / REPLACEMENT (SC368)

This bulletin provides information to inspect and, if necessary, replace the high-pressure crossover fuel pipe on certain 2022-2026MY Carnival (KA4) vehicles produced from January 4, 2021 through November 20, 2025. The high-pressure crossover fuel pipe nuts may loosen over time, resulting in a fuel leak. A fuel leak in the presence of a ignition source increases the risk of fire, thereby increasing the risk of injury. In addition, the subject vehicles may be releasing air pollutants which exceed California and federal standards. These standards were established to protect the public's health and welfare from the dangers of air pollution. Follow the procedure outlined in this publication to inspect the high-presure crossover fuel pipe. If a leak is identified, dealers are to replace the high-pressure crossover fuel pipe with a new one. If no leak is identified, dealers are to securely fasten the high-pressure crossover pipe nuts on the applicable vehicle. Before conducting the procedure, verify that the vehicle is in

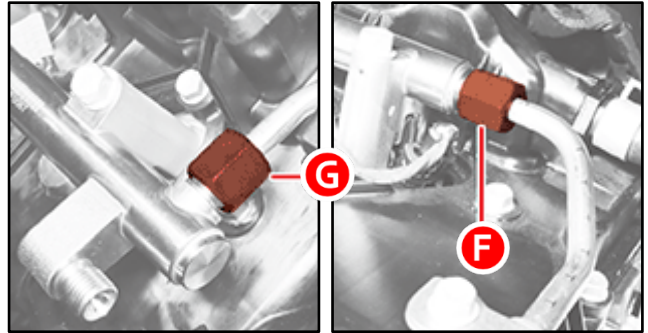
4c. Inspect both Bank 1 and Bank 2 high-pressure cross-over delivery pipe flanges for fuel leakage (including any trace of residual fuel onto surrounding parts):

- Bank 1 (F) flange nut
- Bank 2 (G) flange nut

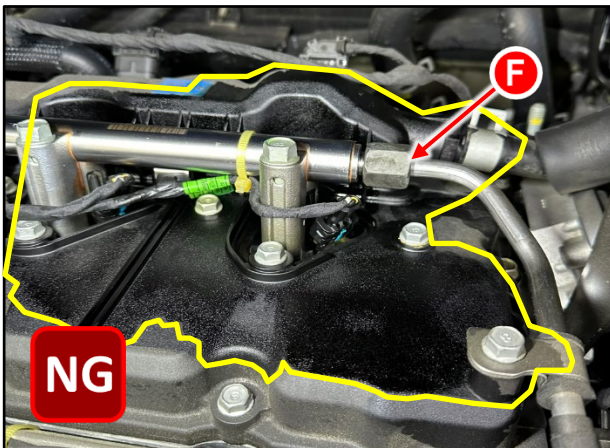
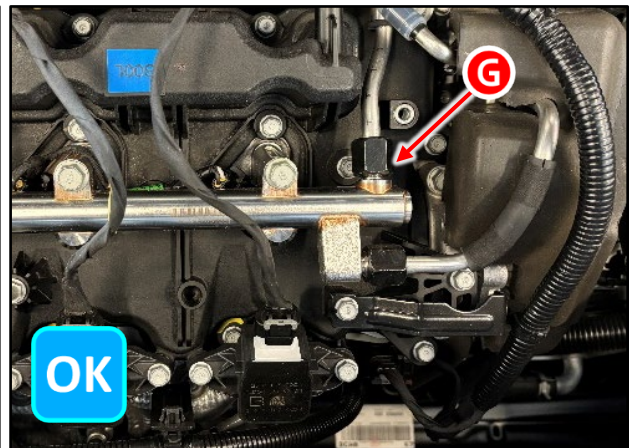
5a.  Fuel leak **is** present from Bank 1 and/or Bank 2 flange (**NG**). **Stop**, and skip to the 'Replacement Procedure' on page 6 to replace the crossover high-pressure fuel delivery pipe with a new part.

Sample (left): Contaminated residual fuel leak area is outlined. - Sample (right): No visible fuel leak present.
