Safety Recall

Code: 46P7

Subject	Brake Booster				
Document History	Date		Summary		
	04/17/2026		Original publication		
Affected Vehicles	Country	Beginning Model Year	Ending Model Year	Vehicle	Vehicle Count
	USA	2019	2024	E-TRON QUATTRO	14,102
	USA	2020	2024	E-TRON SPORTBACK QUATTRO	4,751
	CAN	2019	2024	E-TRON QUATTRO	1,106
	CAN	2020	2024	E-TRON SPORTBACK QUATTRO	754
	<p><i>Check Campaigns/Actions screen in Elsa on the day of repair to verify that a VIN qualifies for repair under this action. Elsa is the <u>only</u> valid campaign inquiry & verification source.</i></p> <ul style="list-style-type: none"> ✓ Campaign status must show "open." ✓ If Elsa shows other open action(s), inform your customer so that the work can also be completed at the same time the vehicle is in the workshop for this campaign. 				
Problem Description	The screw connection from the input rod on the brake pedal to the actuator rod on the brake booster was not performed according to manufacturing specifications. Because of this, the screw connection may disconnect. If a complete separation occurs, vehicle braking would only be possible using the emergency braking function, increasing the risk of a crash.

Sub

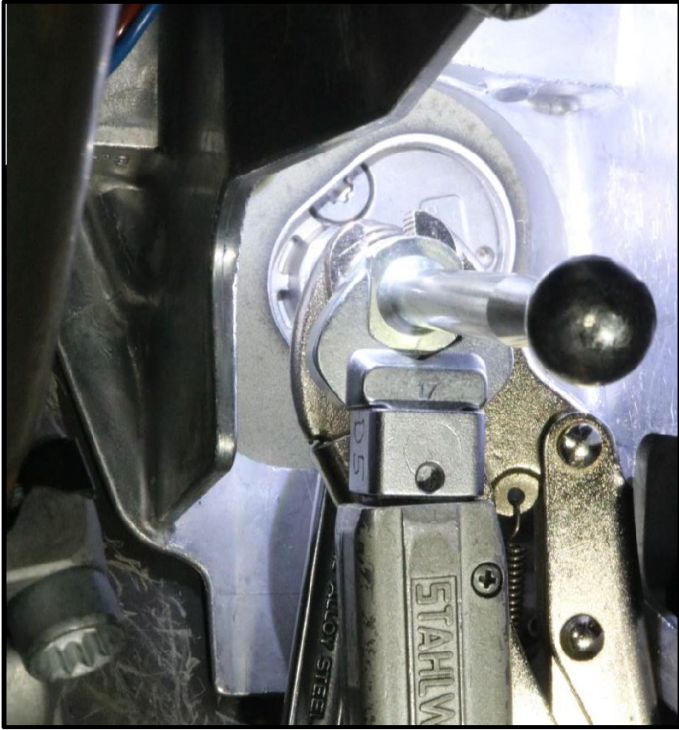
Repair Overview

The screw connection from the input rod on the brake pedal to the actuator rod on the brake booster was not performed according to manufacturing specifications. Because of this, the screw connection may disconnect. If a complete separation occurs, vehicle braking would only be possible using the emergency braking function, increasing the risk of a crash.

- Disconnect brake pedal from brake booster and retighten input rod.

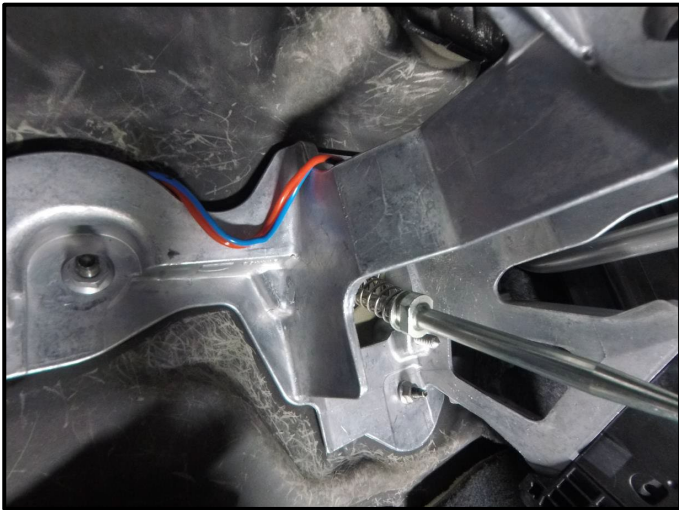
Access Ball Head/Push Rod:

If the screw connection has completely separated from the brake booster actuator rod, replace the brake pressure unit.

- Pull the dust boot off the ball head push rod with the filter to gain access to the components underneath.
- The following components are then exposed:
 - Ball Head Push Rod
 - Spring
- To prevent contamination, place the dust boot and spring in a clean location for later assembly

The dust sleeve with filter and the spring are not available as spare parts. If one of these components is defective, the brake pressure unit must be replaced.
