# Safety Recall

## Code: 46P7

**Brake Booster**

### Subject: Safety Recall 46P7 – Brake Booster

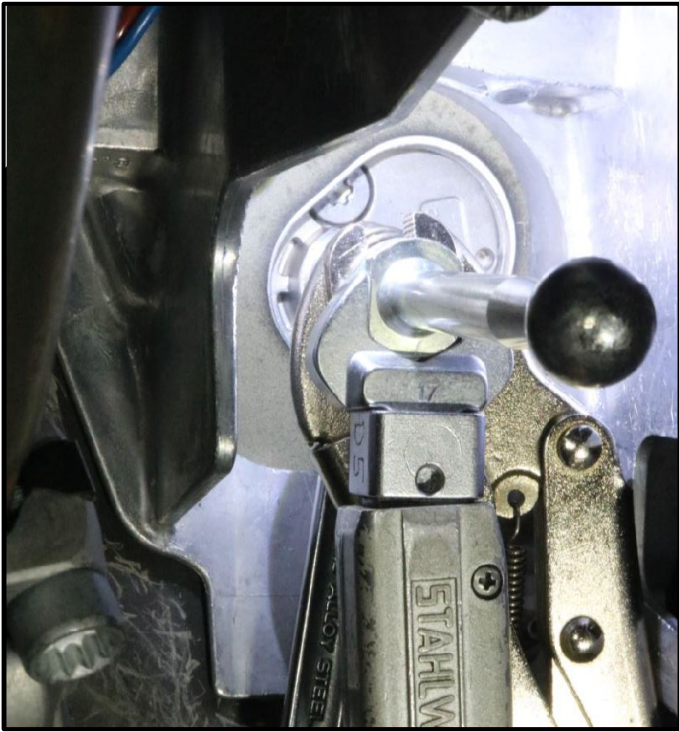
The screw connection from the input rod on the brake pedal to the actuator rod on the brake booster was not performed according to manufacturing specifications. Because of this, the screw connection may disconnect. If a complete separation occurs, vehicle braking would only be possible using the emergency braking function, increasing the risk of a crash.

- Disconnect brake pedal from brake booster and retighten input rod.

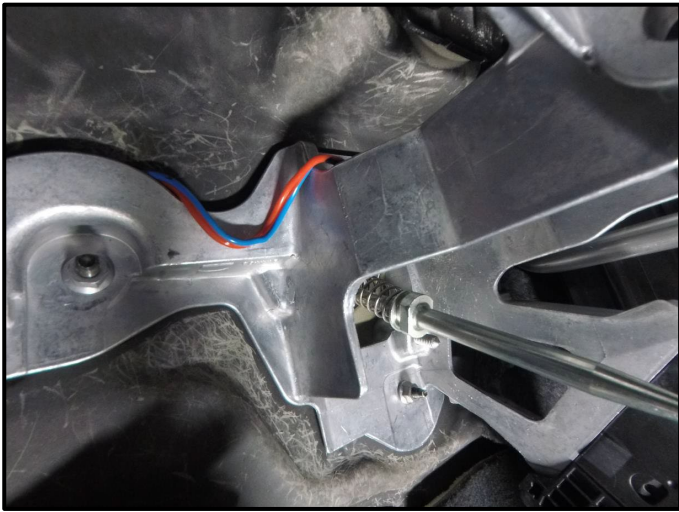
#### Access Ball Head/Push Rod:

If the screw connection has completely separated from the brake booster actuator rod, replace the brake pressure unit.

- Pull the dust boot off the ball head push rod with the filter to gain access to the components underneath.
- The following components are then exposed:
  - Ball Head Push Rod
  - Spring
- To prevent contamination, place the dust boot and spring in a clean location for later assembly
