# SAFETY RECALL

## Steering Column Control Module

Reference: 36D / NHTSA 26V-244

2026 (DJ) RAM 2500

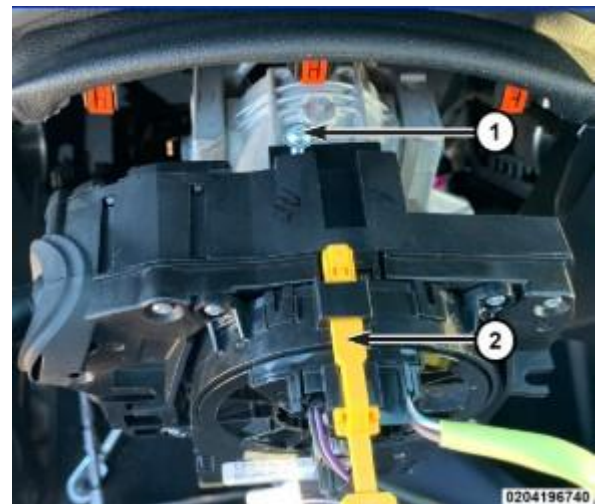
**Figure 1 – SCCM Upper Screw**

1 - Screw  
2 - Lock Tab

2. Place the front wheels in the straight ahead position.
3. Disconnect and isolate the negative battery cable(s). Refer to the detailed service procedures available in DealerCONNECT/ Service Library under: Service Info> 08 - Electrical / 8F - Engine Systems / Battery System / Standard Procedure.
4. Remove the upper and lower shrouds from the steering column. Refer to the detailed service procedures available in DealerCONNECT/ Service Library under: Service Info> 19 - Steering / Column / SHROUD, Steering Column / Removal and Installation.
5. Secure the SCCM in the straight ahead position.
6. Remove the upper SCCM screw (1) (Figure 1).

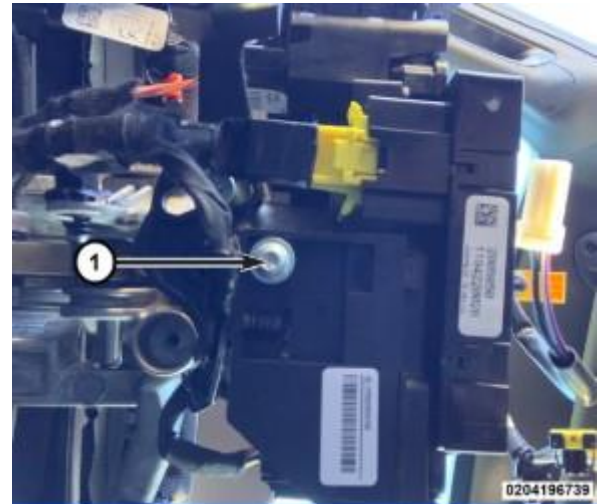
**Figure 2 – SCCM Lower Screw**

1 - Screw

7. Remove the lower SCCM screw (1) (Figure 2).

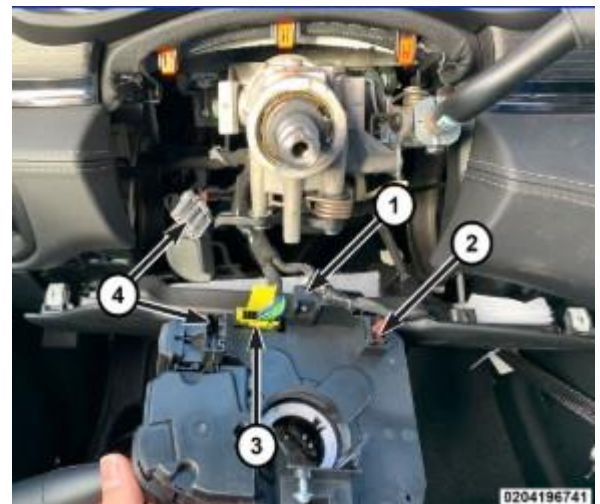
**Figure 3 – SCCM Connectors**

1 - Wire Harness Routing Clip  
2 - Wire Harness Connector  
3 - Wire Harness Connector  
4 - Pedal Adjustment Wire Harness Connector

8. Pull the SCCM slightly away from the steering column and disconnect the pedal adjustment wire harness connector (4), if equipped (Figure 3).
9. Remove the SCCM from the steering column.
10. Disengage the wire harness routing clip (1) (Figure 3).
11. Disconnect the wire harness connectors (2-3) (Figure 3).
12. Remove the adjustable pedal switch blank filler or switch from the clockspring, if required. Refer to the detailed service procedures available in DealerCONNECT/ Service Library under: Service Info> 05 - Brakes / SWITCHES / Removal and Installation.
