HYUNDAI Technical Service Bulletin

GROUP RECALL	NUMBER 26-01-045H
DATE MAY 2026	MODEL(S) SEE BELOW

SUBJECT: AIRBAG SIDE IMPACT SENSORS (SIS) ID INSPECTION & REPLACEMENT (RECALL 299)

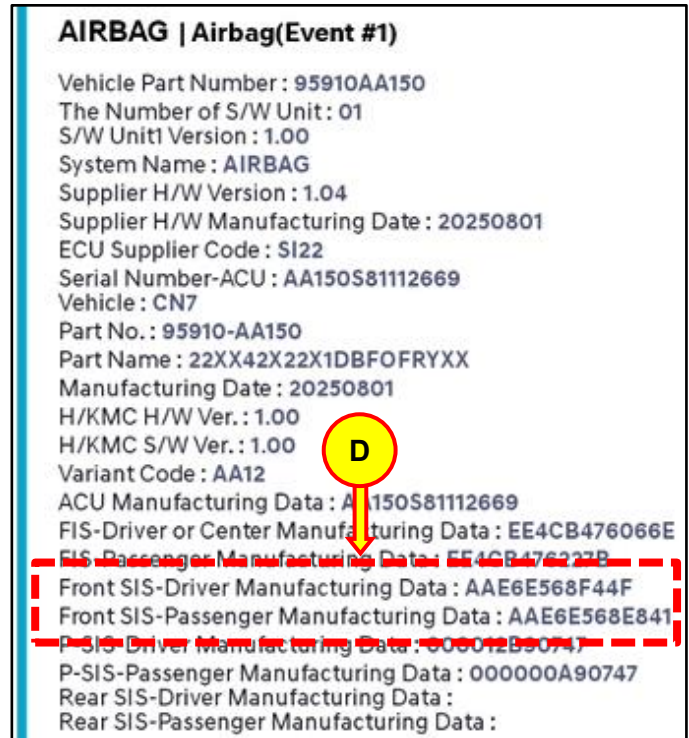
4. Check the ID of the Side Impact Sensor (SIS)
Front SIS-Driver Manufacturing Data and
Front SIS-Passenger Manufacturing Data (D).

Determine if the Sensor ID matches the replacement target ID by referring to the [SIS Replacement Target ID](#) table on **page 4**:

- **PASS:** If the Sensor ID does **NOT** match any of the replacement target IDs, then proceed to **step 5**.
- **FAIL:** If the Sensor ID matches any of the replacement target IDs, then proceed to **step 5** and the [Airbag SIS Replacement](#) section.

6. If the sensor ID **matched** any of the replacement target IDs on **page 4**, proceed to the [Airbag SIS Replacement](#) section.

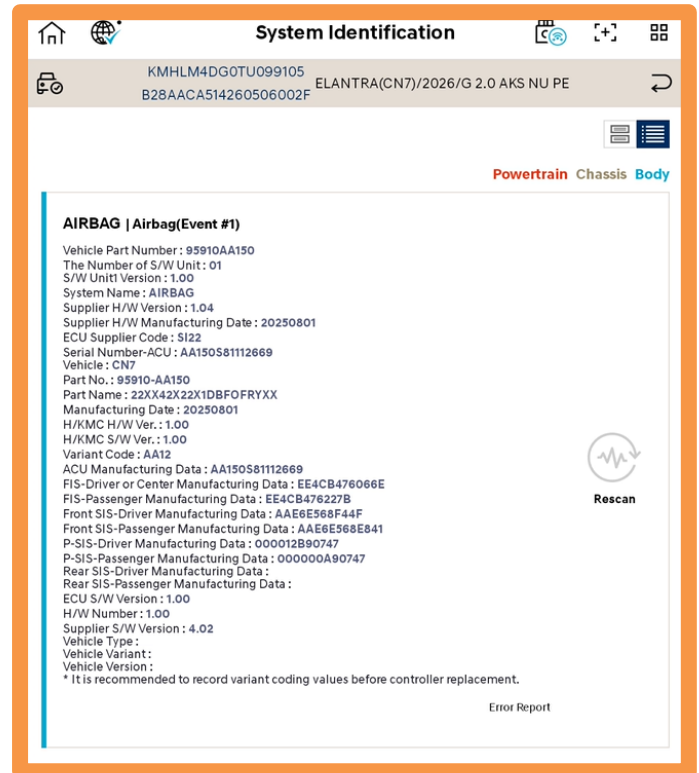
Using the tablet or GDS screen capture function, take a screenshot of the Airbag System Identification screen listing the sensor ID number sequence.

Upload the photo to STUI.
