| <b>WINNEBAGO®</b> | | <b>Generator Unintended Self-Start</b> | | | |
| Recall # 205 | | <b>Part #</b> | NA | <b>Description</b> | NA |

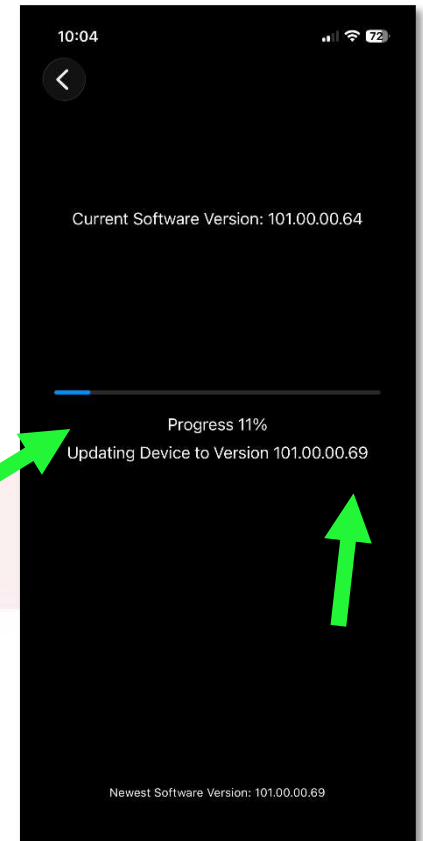
c. Once the application finds your RV, it will automatically update the touchscreen to the latest version (**101\_00\_69** or **101.000069**). You will see a progress bar on both your app and on the touch screen. Please wait as this could take over a minute. If a freeze warning appears, clear the error if you want to see the progress.

f. To avoid these issues, wait until the update has finished. Turn your system off for two minutes and then turn it back on again.

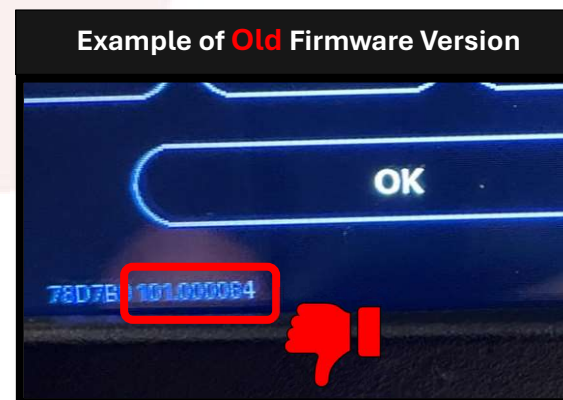
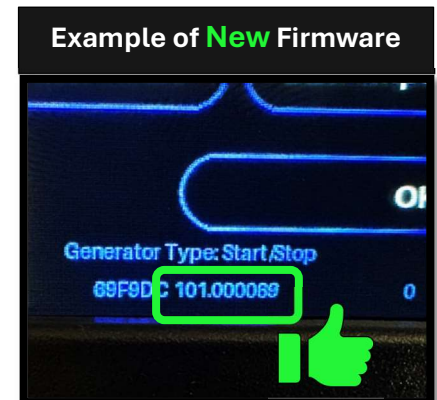
a. To ensure a successful update, verify that your current firmware version is at **101.000069**.

You can check this on the PCI touchscreen by navigating to the Settings Screen; the version number can be found in the lower-left corner.
