SAFETY RECALL

Volvo Trucks North America

Date	Number	Release	Page
06.2026	RVXX2605	01	1 (5)

EPM X3 Connector Exposed VN (4)

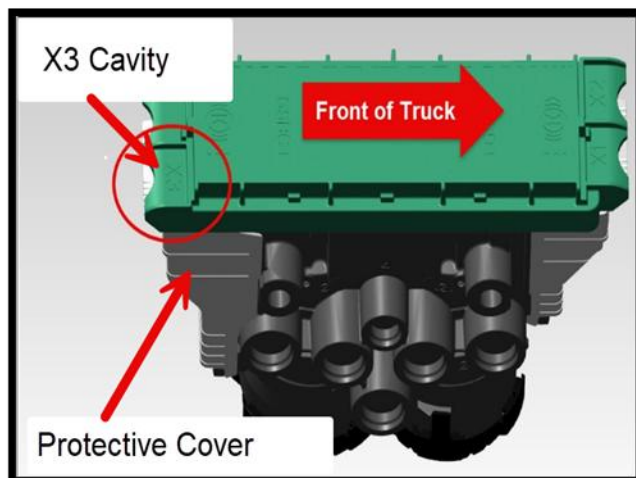
3. Locate the EPM on the rear of the truck. (Driver's side frame rail above the axle).
4. Locate the X3 connector on the EPM and remove the protective cover.

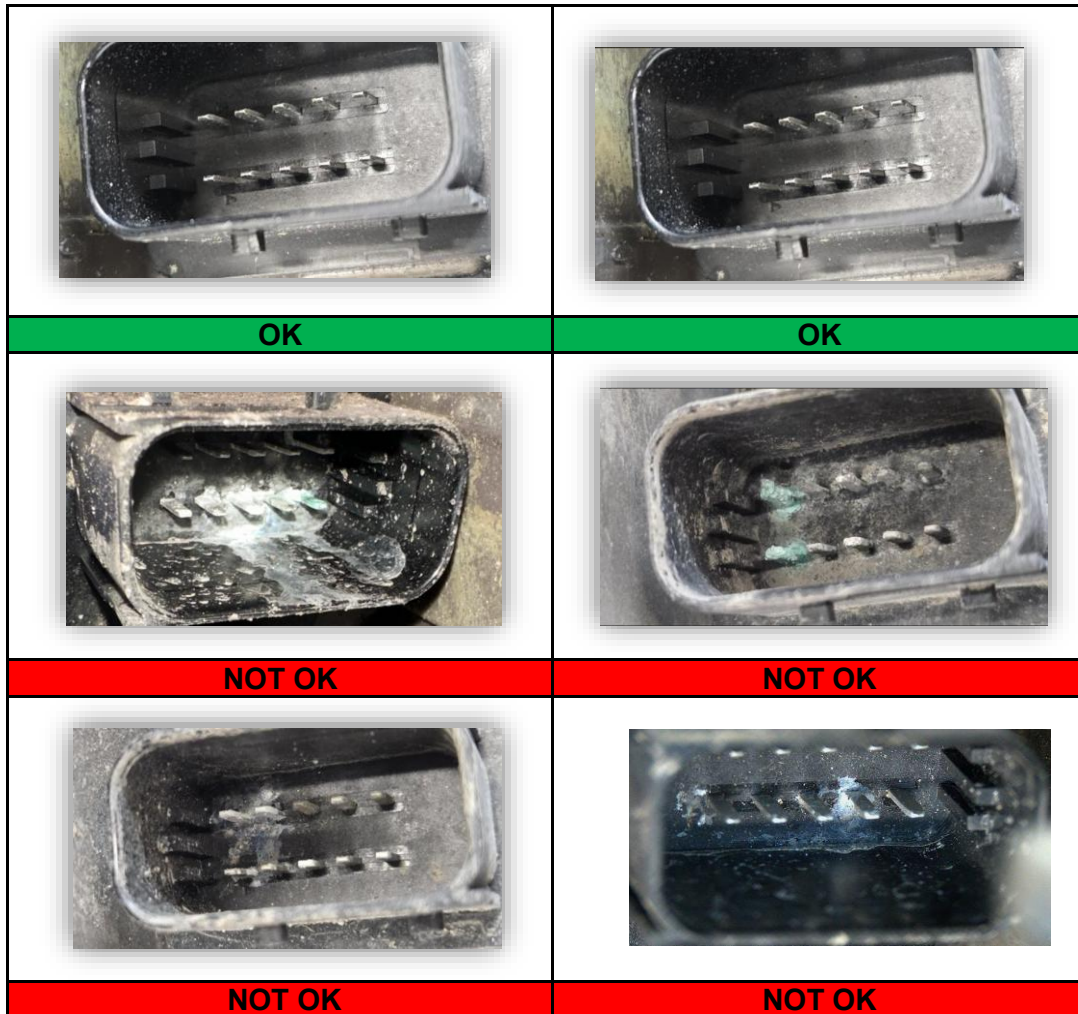
5. Inspect the X3 cavity for any corrosion.
 - a. If corrosion is found in the X3 cavity, continue to **Step 6**.
 - b. If the X3 cavity is free of corrosion, continue to **Step 7**.

Only replace the EPM if corrosion is found.

6. Replace the EPM with a new one following Impact operation **5600-03-02-02 Modulator, Rear, Replacement**. Before installing the EPM add the protective cap **995115** to the X3 cavity.
7. Ensure cavity is clean and dry.
8. Install a protective cap **995115** on the X3 cavity.
9. Install and latch the protective cover.
