# SAFETY RECALL

Mack Trucks Inc.  
Greensboro, NC USA

| Date | Number | Release | Page |
|---|---|---|---|
| 06.2026 | SC0494 | 02 | 1(5) |

## EPM X3 Connector Exposed AN(4), PR(4)

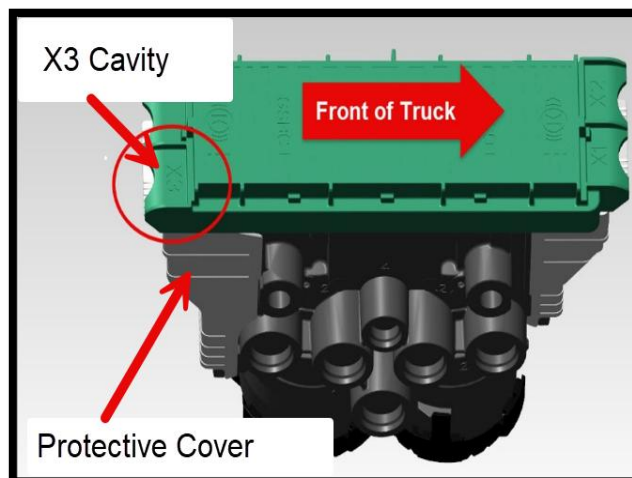
3. Locate the EPM on the rear of the truck. (Driver's side frame rail above the axle).
4. Locate the X3 connector on the EPM and remove the protective cover.

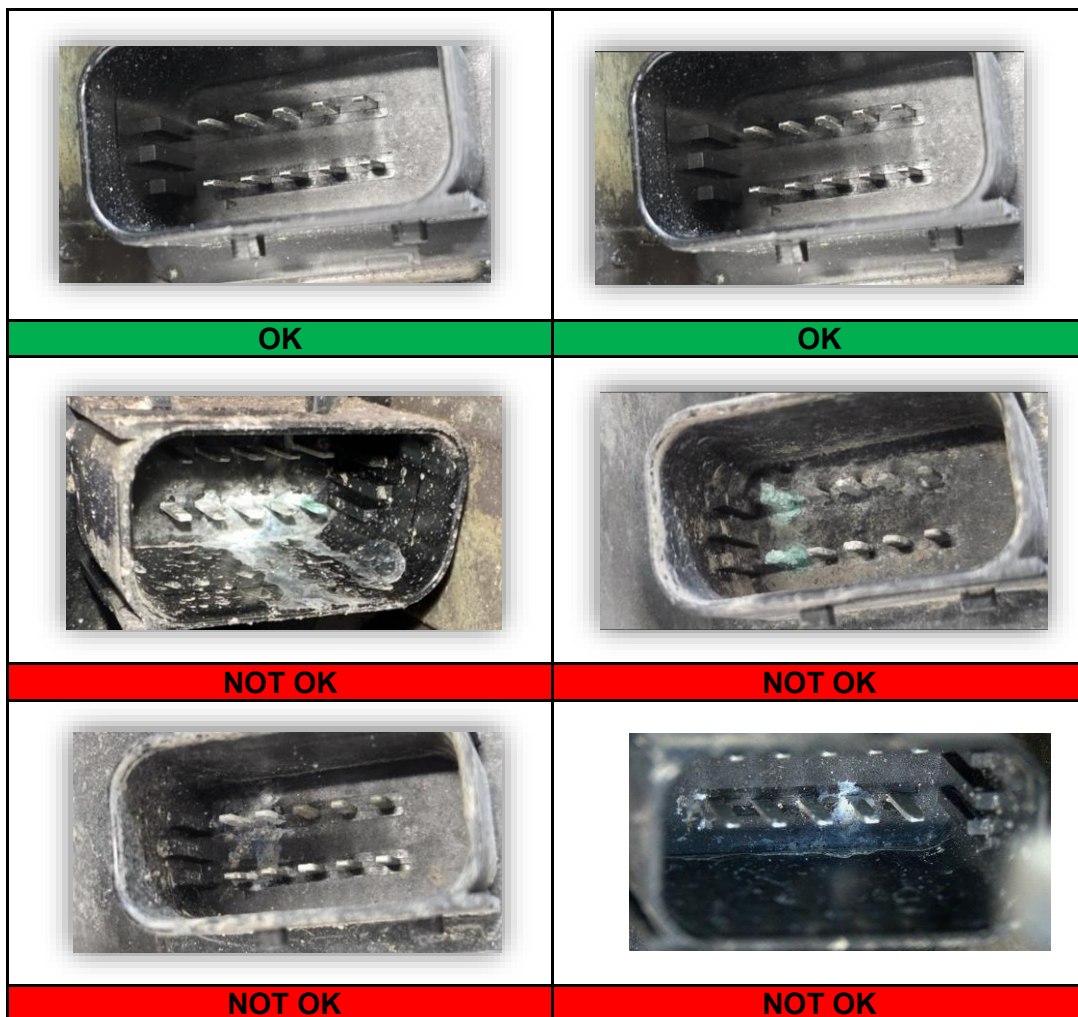
5. Inspect the X3 cavity for a cap or for any corrosion if a cap is not installed.
  - a. If a protective cap is installed on the connector, continue to **Step 9**.
  - b. If corrosion is found in the X3 cavity, continue to **Step 6**.
  - c. If the X3 cap is not installed and the cavity is free of corrosion, continue to **Step 7**.

Only replace the EPM if corrosion is found.

6. Replace the EPM with a new one following Impact operation **5600-03-02-02 Modulator, Rear, Replacement**. Before installing the EPM add the protective cap **995115** to the X3 cavity.
7. Ensure cavity is clean and dry.
8. Install the protective cap **995115** on the X3 cavity.
9. Install and latch the protective cover.
