# SAFETY RECALL

| Date | Number | Release | Page |
|---|---|---|---|
| 06.2026 | <b>SC0494</b> | <b>01</b> | <b>1(5)</b> |

## **EPM X3 Connector Exposed AN(4), PR(4)**

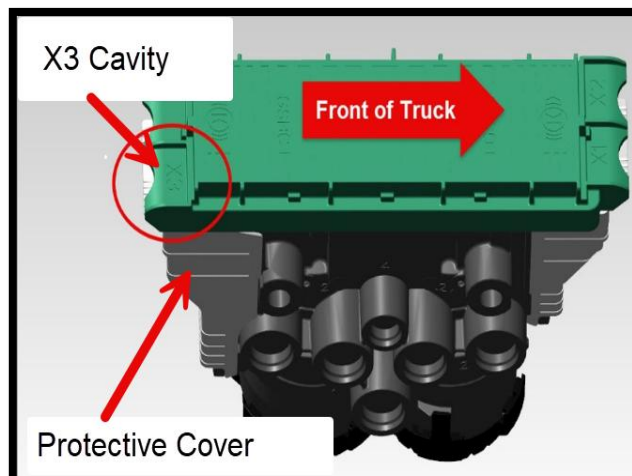
3. Locate the EPM on the rear of the truck. (Driver's side frame rail above the axle).
4. Locate the X3 connector on the EPM and remove the protective cover.

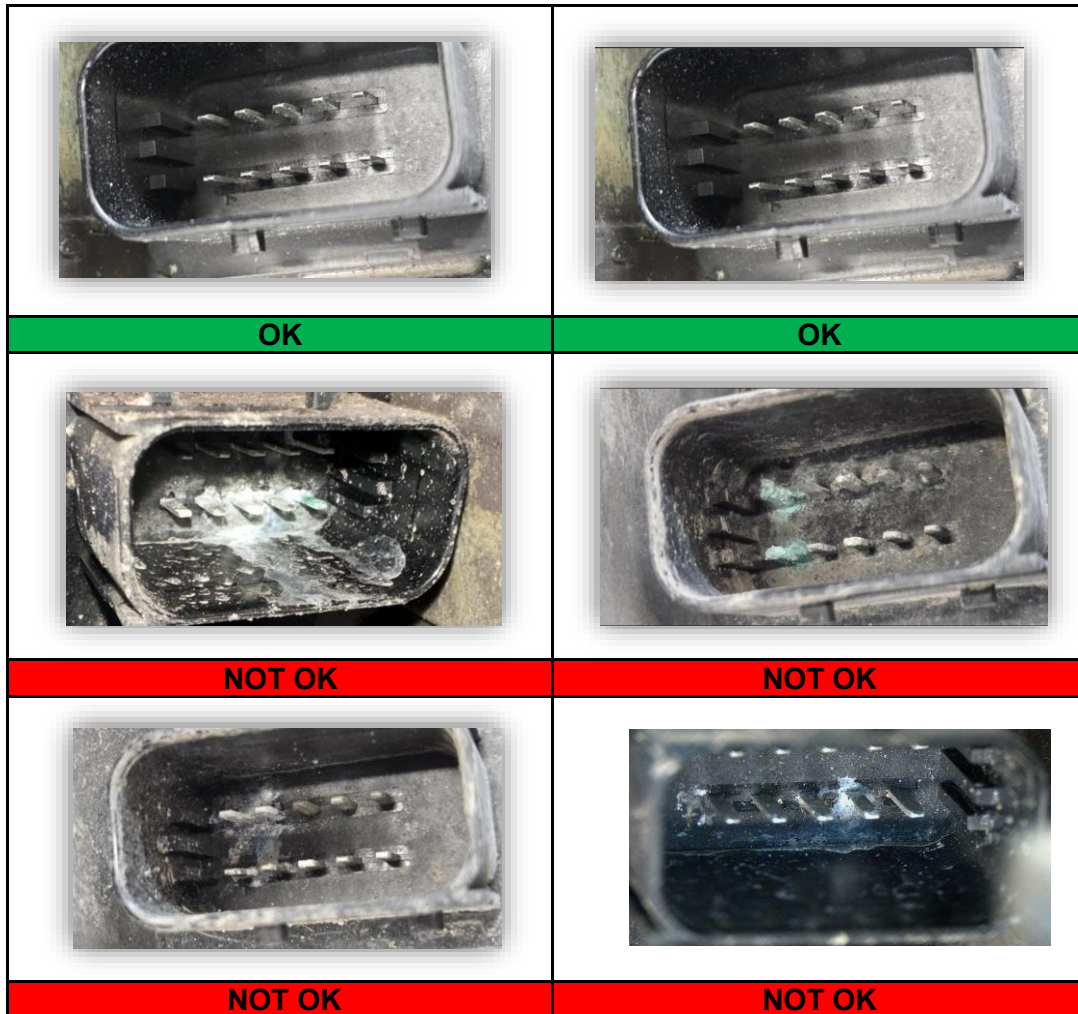
5. Inspect the X3 cavity for any corrosion.
  - a. If corrosion is found in the X3 cavity, continue to **Step 6**.
  - b. If the X3 cavity is free of corrosion, continue to **Step 7**.

6. Replace the EPM with a new one following Impact operation **5600-03-02-02 Modulator, Rear, Replacement**. Before installing the EPM add the protective cap **995115** to the X3 cavity.
7. Ensure cavity is clean and dry.
8. Install the protective cap **995115** on the X3 cavity.
9. Install and latch the protective cover.
