# SAFETY RECALL

## Incorrect Speed Calibration

Reference: 43D / NHTSA 26V-288

2023-2026 (DJ) RAM 2500

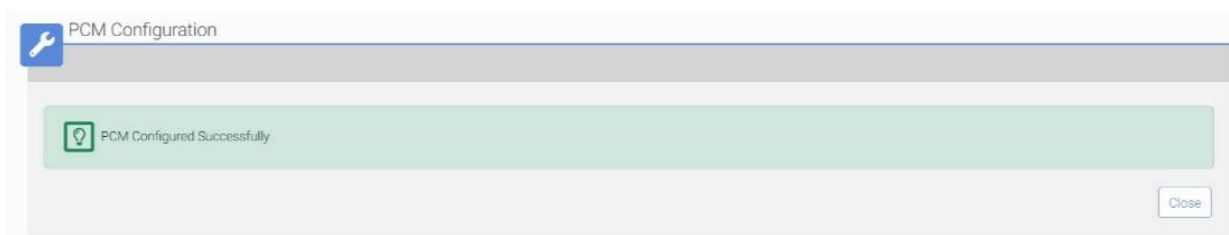
**Figure 1 – PCM Configured Successfully**

2. Connect the wiTECH MDP to the vehicle data link connector.
3. Place the ignition in the **“RUN”** position.
4. Open the wiTECH 2.0 website.
5. Enter your **“User id”** and **“Password”** and your **“Dealer Code”**, then select **“Sign In”** at the bottom of the screen. Click **“Accept”**.
6. From the **“Vehicle Selection”** screen, select the vehicle to be updated.
7. From the **“Action Items”** screen, **“Topology”** tab, select the **“PCM”**.
8. From the **“PCM”** screen, select the **“Miscellaneous Functions”** tab.
9. From the list, select **“PCM Configuration”** and follow on-screen prompts.
10. When completed, the **“PCM Configured Successfully”** message will appear.
