# ***SERVICE PROCEDURE***

**26506  
June 2026**

**SUBJECT: SAFETY RECALL**

**2026 and 2027 International® HV™ Series trucks built 10/15/2025 thru 02/12/2026, with the following unique configurations (feature codes):**

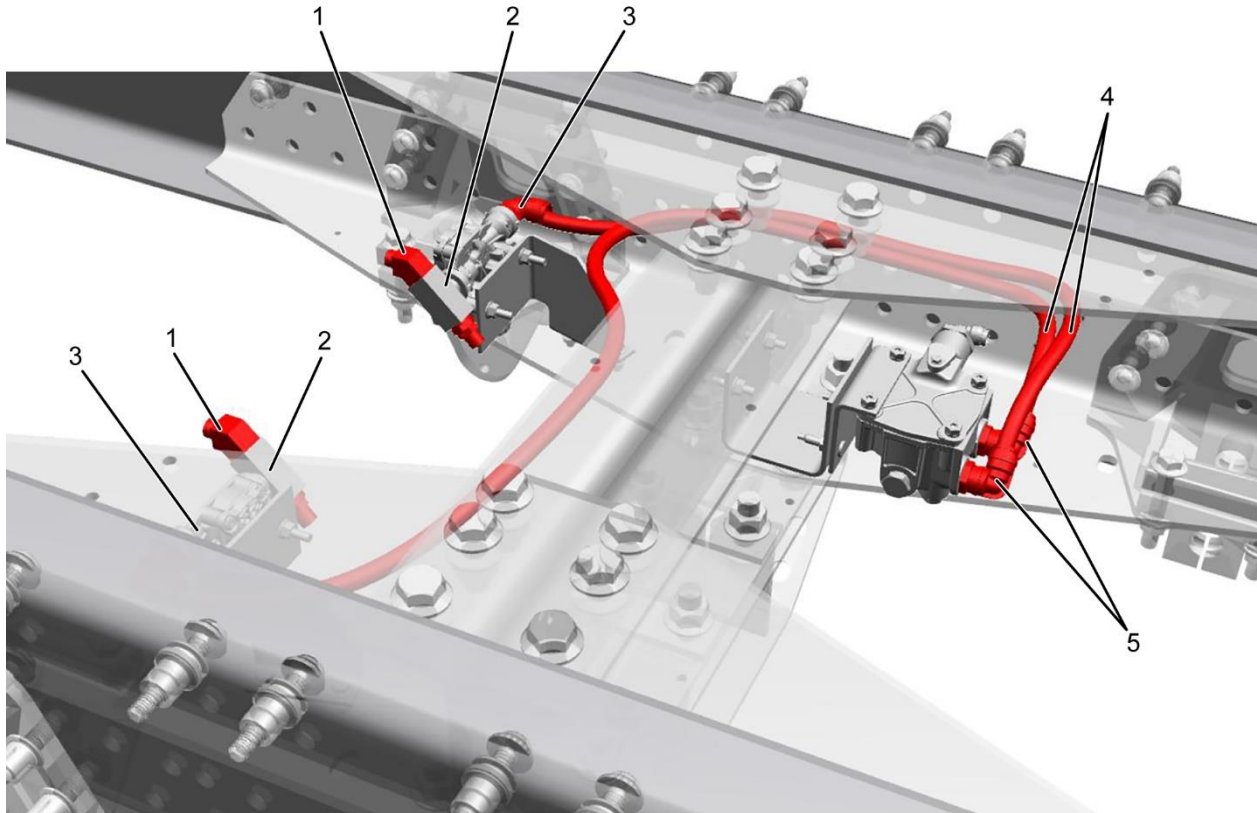
**Figure 1. Fitting Locations**

1. 45-degree fitting for rear rear brake chambers (2)
2. Tee fitting on modulator valve (2)
3. 90-degree fitting at modulator valves (2)
4. Air line from relay valve to modulator valve (2)
5. 90-degree fitting on relay valve (2)

6. Starting on the driver-side, remove the 5/8-inch air line from the relay valve to the modulator valve (Figure 1, Item 4).
7. At the relay valve, remove the 5/8-inch 90-degree elbow and install the 3/4-inch 90-degree elbow. (Figure 1, Item 5).
8. At the modulator valve, remove the 5/8-inch 90-degree elbow and install the 3/4-inch 90-degree elbow. (Figure 1, Item 3).

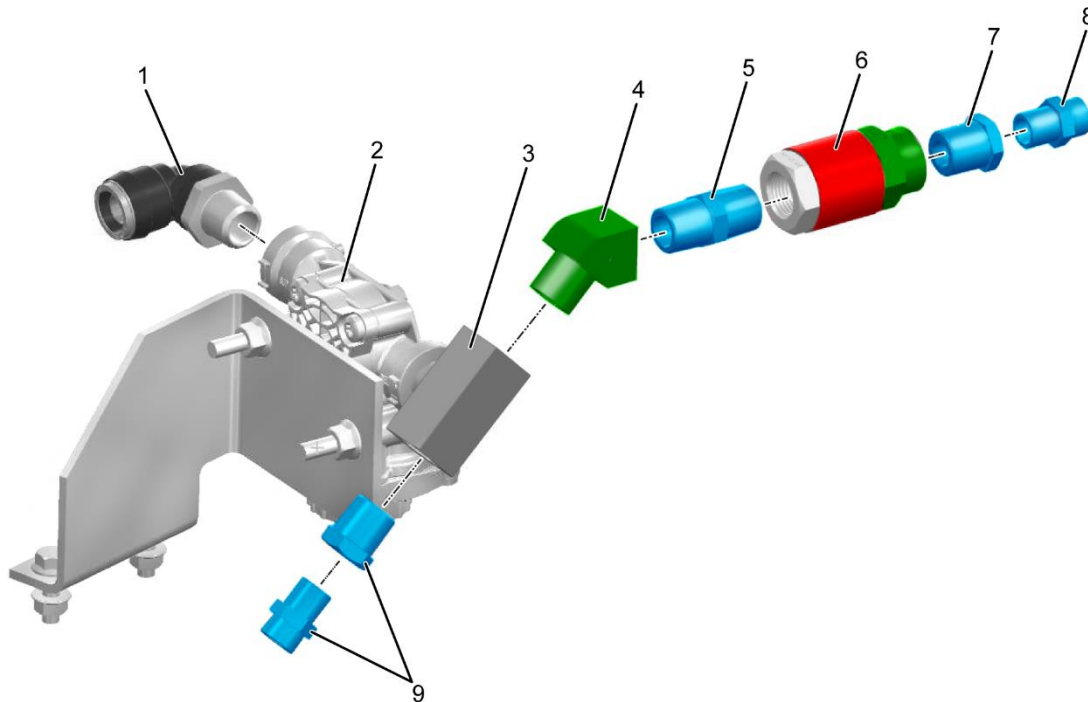
**Figure 2. Modulator Valve with Quick Release Valve Installed**

1. 90-degree elbow installed in Step 8 (2017520C1)
2. Modulator valve
3. Tee fitting
4. Elbow (444058)
5. Nipple (443982)
6. Quick release valve (3548736C1)
7. Reducer bushing (444034)
8. Adapter (3572104C1)
9. Fitting for forward rear axle (2 shown)

13. Starting on the driver-side, remove the air hose going to the rear rear brake chamber from the 45-degree fitting at the modulator valve (Figure 2, Item 2).

14. Note the angle of the 45-degree fitting and using a backup wrench, remove the 45-degree fitting from the tee fitting (Figure 2, Item 3).

15. Using a backup wrench in the same orientation notated in Step 14, install and tighten new elbow (Figure 2, Item 4) into 90-degree fitting on relay valve (Figure 1, Item 5).

16. Install and tighten nipple (Figure 2, Item 5) into elbow (Figure 2, Item 4).
17. Install and tighten quick release check valve (Figure 2, Item 6) into nipple (Figure 2, Item 5) with air pointing toward the rear rear brake chamber hose.

18. Install and tighten reducer bushing (Figure 2, Item 7) into the quick release valve (Figure 2, Item 6).
19. Install adapter (Figure 2, Item 8) in recently installed reducer bushing (Figure 2, Item 7).

20. Install and tighten air hose that was removed in Step 13 into the adapter (Figure 2, Item 8).
21. Repeat Steps 13 through 20 on passenger-side.
22. In the cab, release the parking brake and check for air leaks at hoses and fitting just installed. Repair any leaks if found.
