**SIB 61 05 26****Recall 26V-305: C Evolution Connector Check and Cable Replacement**  
**2026-07-21**This Service Information Bulletin replaces SIB 61 05 26 **dated June 19<sup>th</sup>, 2026.****What's New** (Specific text highlighted):

**0C03 - C evolution****00 61 005 Install wiring harness repair kit****1**

## RECALL 26V-305: C EVOLUTION CONNECTOR CHECK AND CABLE REPLACEMENT

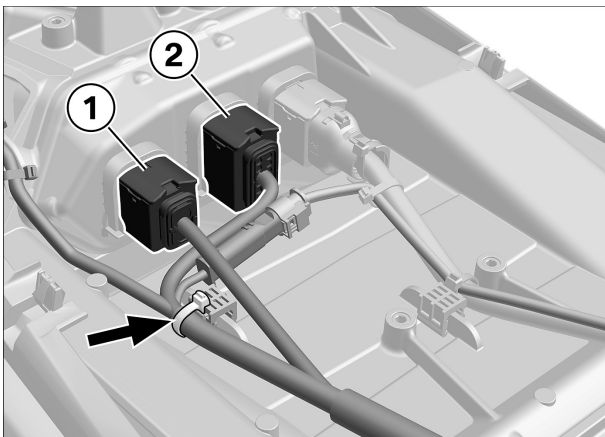
- Remove cable strap (**arrow**).
- Disconnect connector **(1)** for the DCDC power supply line.
- Disconnect connector **(2)** for high-voltage communication.

- for moisture
- for corrosion

- **Install the wiring harness repair kit and seal terminal 31.**

- Create a TSARA message.
