Keystone RV Company

SAFETY ADVISORY # 26-483

Touring Coil Suspension Shock Bolt Replacement

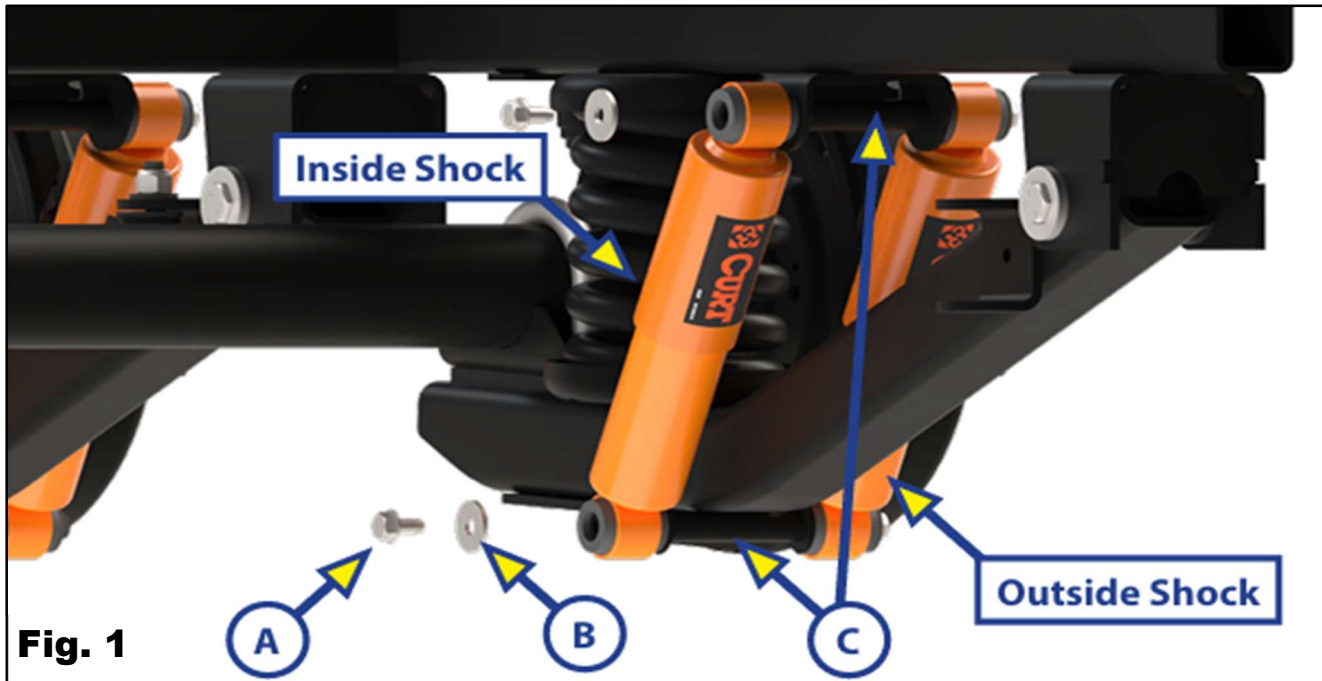
Keystone is conducting a voluntary RECALL notification campaign in accordance with the National Highway Transportation and Safety Act. It has been decided that the vehicles in the recall population may have improperly torqued shock bolts. Under certain conditions during travel, the vehicle may experience excessive bouncing or swaying with decreased stability, leading to an increased risk of a vehicle crash.

Starting with the inside shocks, loosen and remove the two existing 3/8"-16 x 3/4" thread forming screws (Fig. 1A) and washers (Fig. 1B) securing each shock absorber onto its posts (Fig. 1C). Retain the washers for reinstallation in Step 3.
