Safety Recall

N262557310 Roof Rail Airbag Inflator May Rupture

Release Date: May 2026

Revision: 01

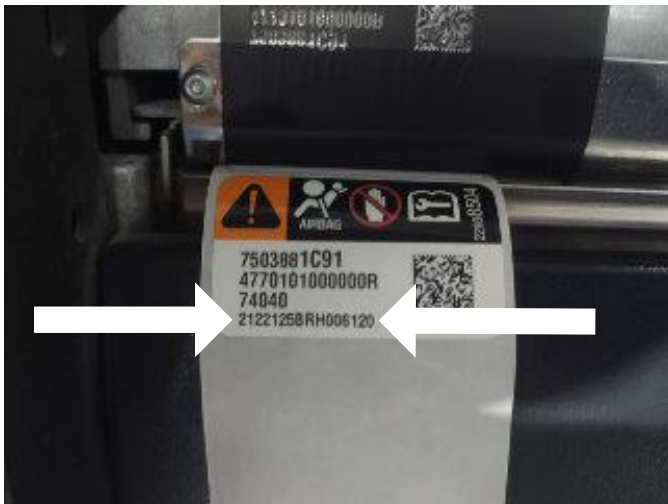
6070604

Important: Enter the serial number of the LEFT roof rail airbag in the 'General Comments' comments section. Failure to enter these serial numbers will cause the claim to reject.

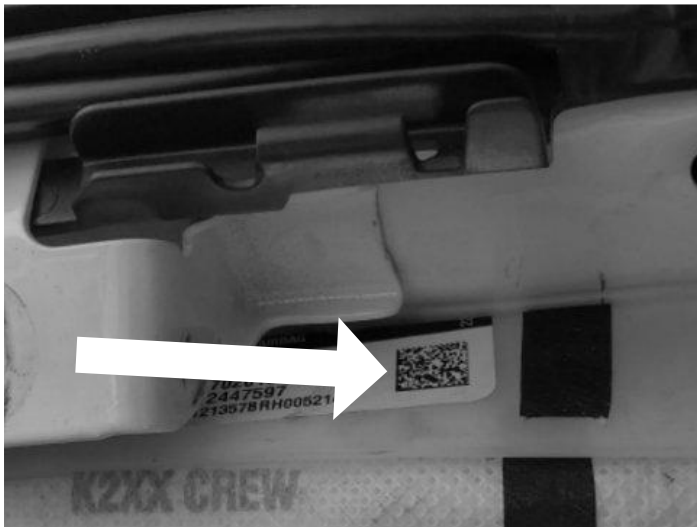
6058834

Record the serial number on each of the white airbag labels.

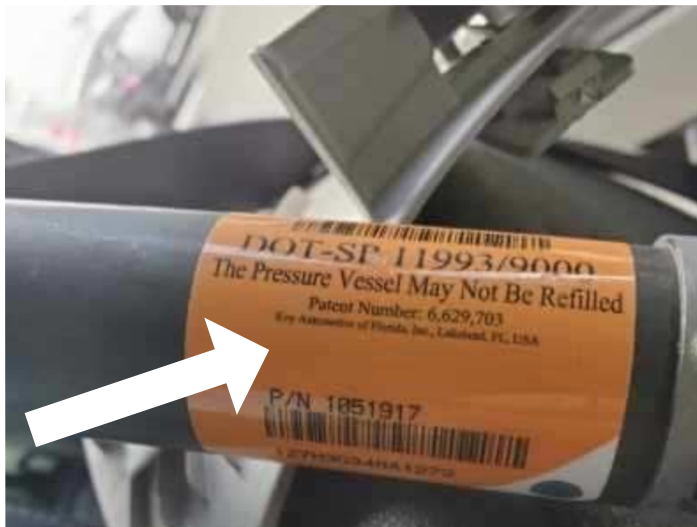
6058836

DO NOT record the serial number (orange label) on the inflator.
